Duke Power Company
Catawba Nuclear Station

Report Number: SD 413-414/83-03

Facility: Catawba Nuclear Station, Units 1 & 2

Identification of Deficiency:

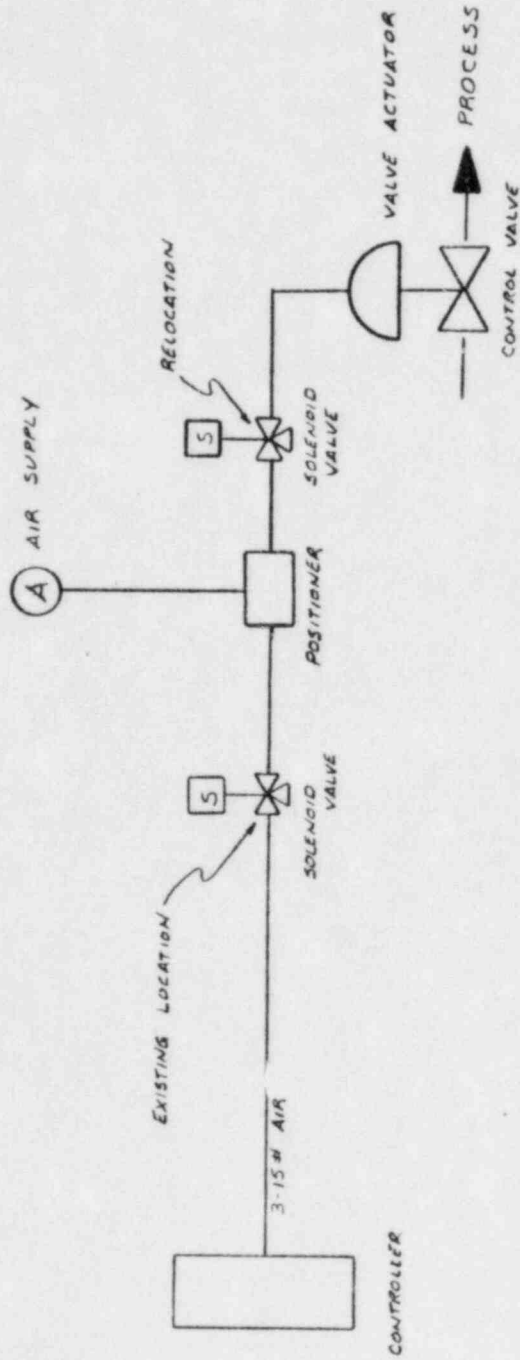
SCHEMATIC OF MODULATING ACTIVE VALVE CONTROLS

Present control schemes for modulating active valves may not allow the valves to reach their fail-safe mode in a harsh environment and/or seismic event concurrent with a LOCA. With the present configuration, non-qualified positioners must allow air to vent from valve actuators for the valves to reach their fail-safe position. This is due to the safety solenoid valves being located between the controllers and positioners (positioners are between Class 1E solenoid valves and valve actuators). See Attachment. Therefore, the potential exists for these control valves to not reach their fail-safe positions.

Failure of these control valves to reach their fail-safe mode could result in inadequate emergency core cooling capabilities by means of:

- 1) Inadequate Nuclear Service Water flow to Component Cooling heat exchangers.
- 2) Inadequate Component Cooling flow and/or Residual Heat Removal flow through Residual Heat Removal heat exchangers.

Duke will relocate Class 1E solenoid valves between valve actuators and valve positioners. This will eliminate dependency on the positioner for venting the valve actuator to the fail-safe position and resolve this deficiency. This corrective action will be completed by September 15, 1983.
