AFFIDAVIT OF ROBERT H. TURNER

INSPECTION OF DAM CONSTRUCTION

PROJECT P.V.N.G.S. Evaporation Pond (7-54) SHEET 1 of 1CONTACTS Dick McGregor - APSKen Euge & Bill DuBois - Ertec WesternIMPORTANT ACTIONS TAKEN:

INSPECTION OF DAM CONSTRUCTIONPROJECT P.V.N.G.S. Evaporation Pond (7-54)

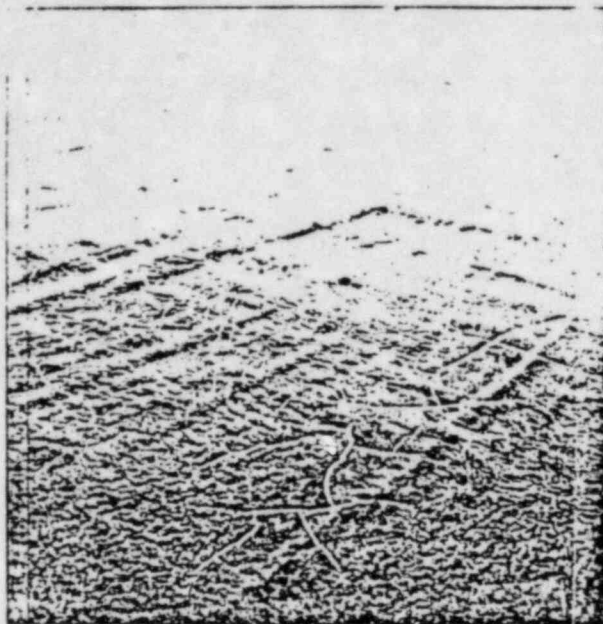
P.V.N.G.S. Evap. Pond (7-54)
K.M. Hussain
9-1-81

It appears that with aging, the lining is already developing shrinkage cracks (alligator pattern). As can be seen in the photographs, these cracks start appearing 3 to 4 days after the placement. Probably because of the unusually hot weather, the lining is still too soft to walk on the surface. Hence it wouldn't be determined whether these cracks are rupturing the lining material or they are only surficial. I checked with Ken Euge and Bill DuBois on the finished thickness (after shrinkage) of the lining and was told the tests are indicating the contractor is providing the specified thickness of $2/10"$. I believe that the contractor should be asked to recheck his mix design or make some more trial runs to accurately estimate the shrinkage factor and viscosity etc. It is important to correct the error at this stage since it will be difficult to run any equipment on the liner to make up for the deficiency. I have asked Dick McGregor of APS to discuss this matter with ARCO, Granite and Bechtel staff.

Pond lining at bottom.
View looking north. Layer
placed 4 days ago (8-28-81).
Notice development of
shrinkage cracks.

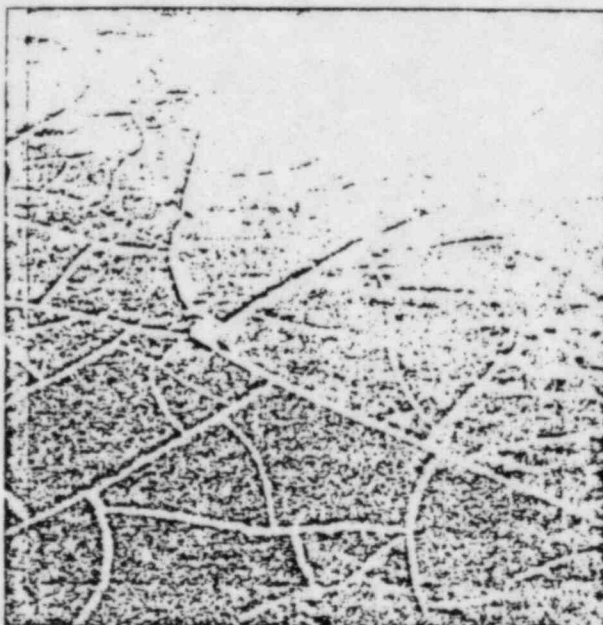
Pond ling at bottom. View
looking north. Layer
placed a week ago.

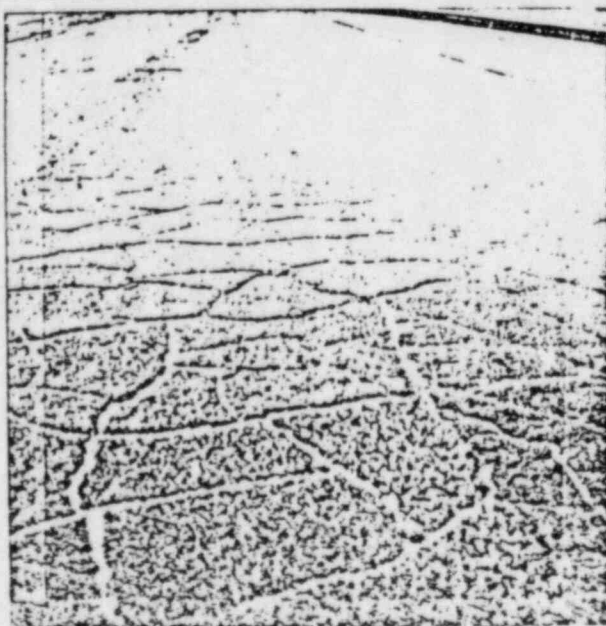
P.V.N.G.S. Evap. Pond(7-54)
K.M. Hussain
9-1-81

Same as above.

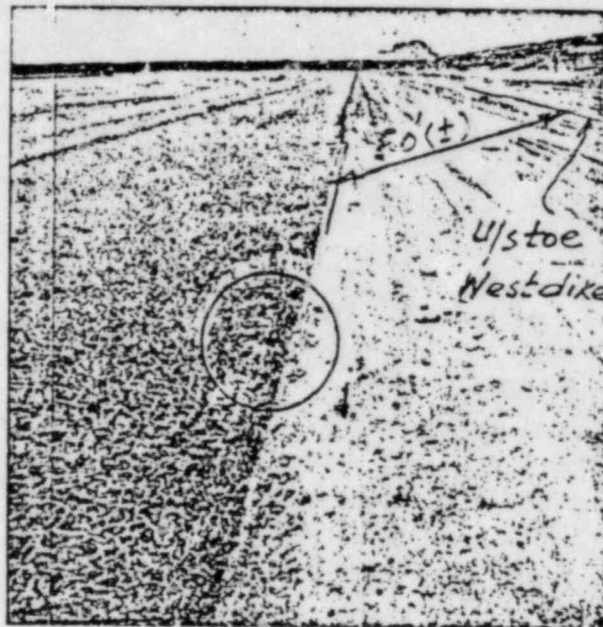
First layer of pond lining
at bottom starting near
the u/s toe of the west
dike. View looking south.
Notice gravel sticking out
of the lining material
and the surface
irregularities.

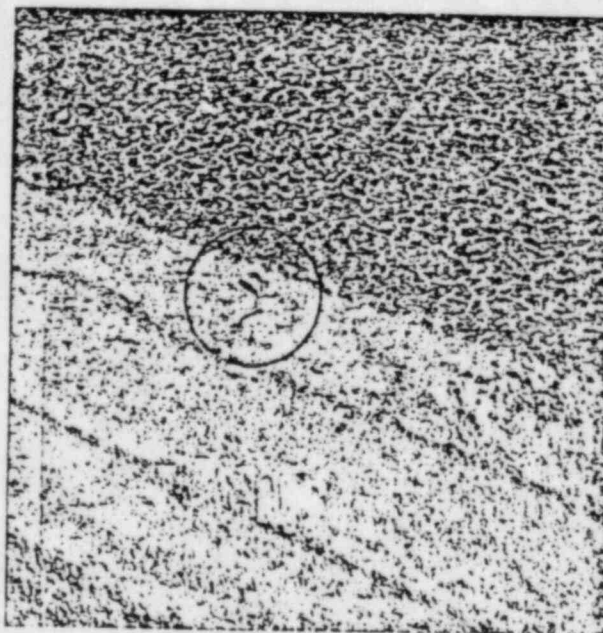
View looking east.
A 2.5" ^{hr} rattlesnake
in the foreground

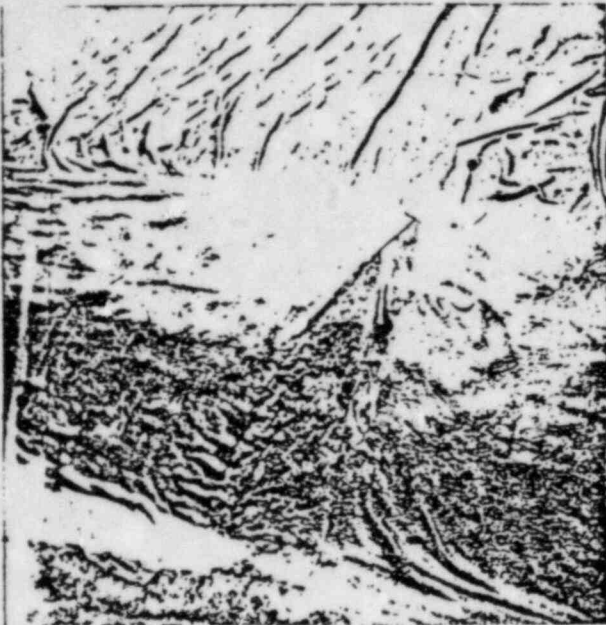
1. The liner appears to be sound and sturdy and quite satisfactory.
2. The jointing of the different sections and the 3 ft. overlap is in accordance with the specifications.
3. The rupture in the lining material noticed at few locations is patched up with sufficient overlap.
4. Termination of the liner at the downstream toe is not completed.
5. There are some questions about the contractor's methods of terminating the upper end of the liner on the upstream end of the crest. The construction drawings (which were reviewed and approved with the understanding that the liner will be placed according to the manufacturer's specifications) call for 12" deep trench, whereas the manufacturer's specifications require a minimum of 18" deep trench.

Notice rupture in the hypalon liner near the u/s toe. Location: South dike, near southwest corner, Station 27+00.

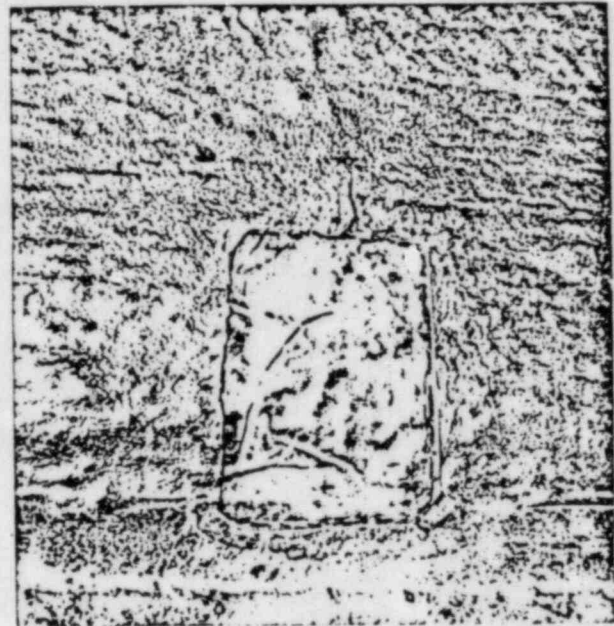
Similar rupture in the liner patched up. Location: Approx. 150 feet west of Station 27+00, near southwest corner.

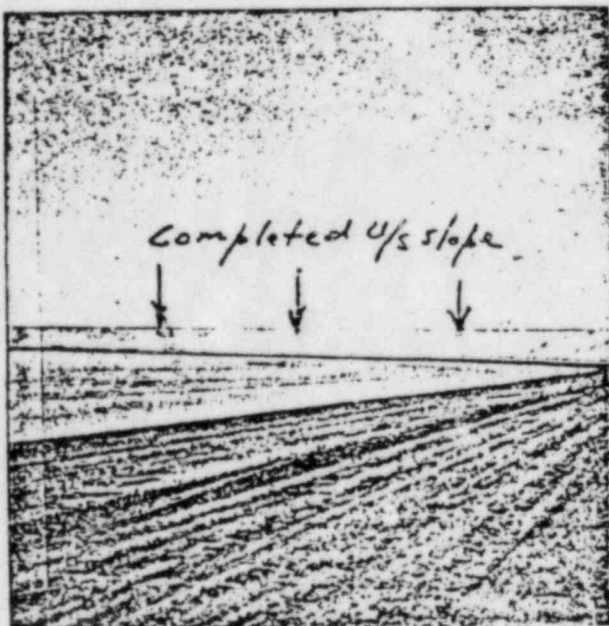
Hypalon liner placed on the upstream slope of the south dike at the southwest corner. View from West Dike.

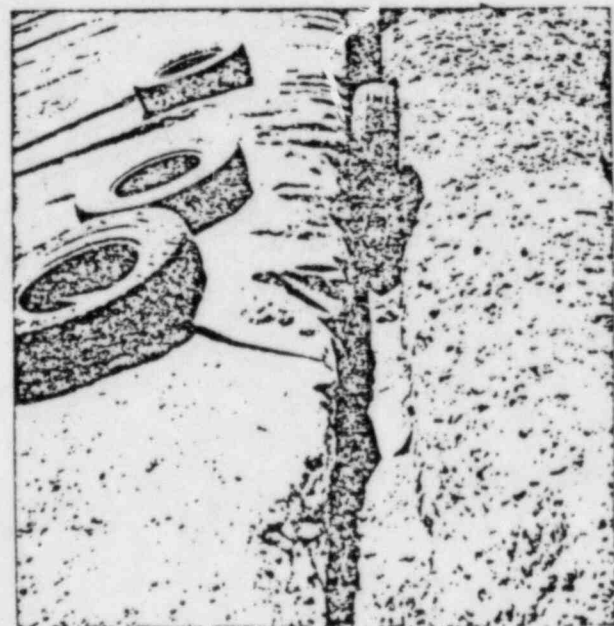
In my opinion, the trench depth giving a soil cover of 12" is not sufficient to prevent movement or the downward drag of the liner due to settlement, wave action and the hydrostatic forces.

The hypalon liner being terminated on the upstream side of the crest. Trench dimensions: 12" w x 12" d.

I discussed this with Dick McGregor at the site and Joe Kanovich (both of APS) after my return to the office and asked them to look into the matter before it is too late. To insure sufficient anchorage we would require that the manufacturer's specifications of the 18" minimum trench depth be followed. Further, the contractor is presently backfilling the trench without compaction. I suggested, 6" layers of uncompacted thickness should be hand tamped with proper care taken to protect the liner from damage. Joe Kanovich told me he will discuss these points with Goodrich and Bechtel staff and call me back.
