UNIVERSITY OF MISSOURI-COLUMBIA

Research Reactor Center

REFERENCE: Docket No. 50-186  
University of Missouri Research Reactor  
License R-103

SUBJECT: Report as required by Technical Specification 6.1.h(2) regarding Personnel  
Airlock Door Failure

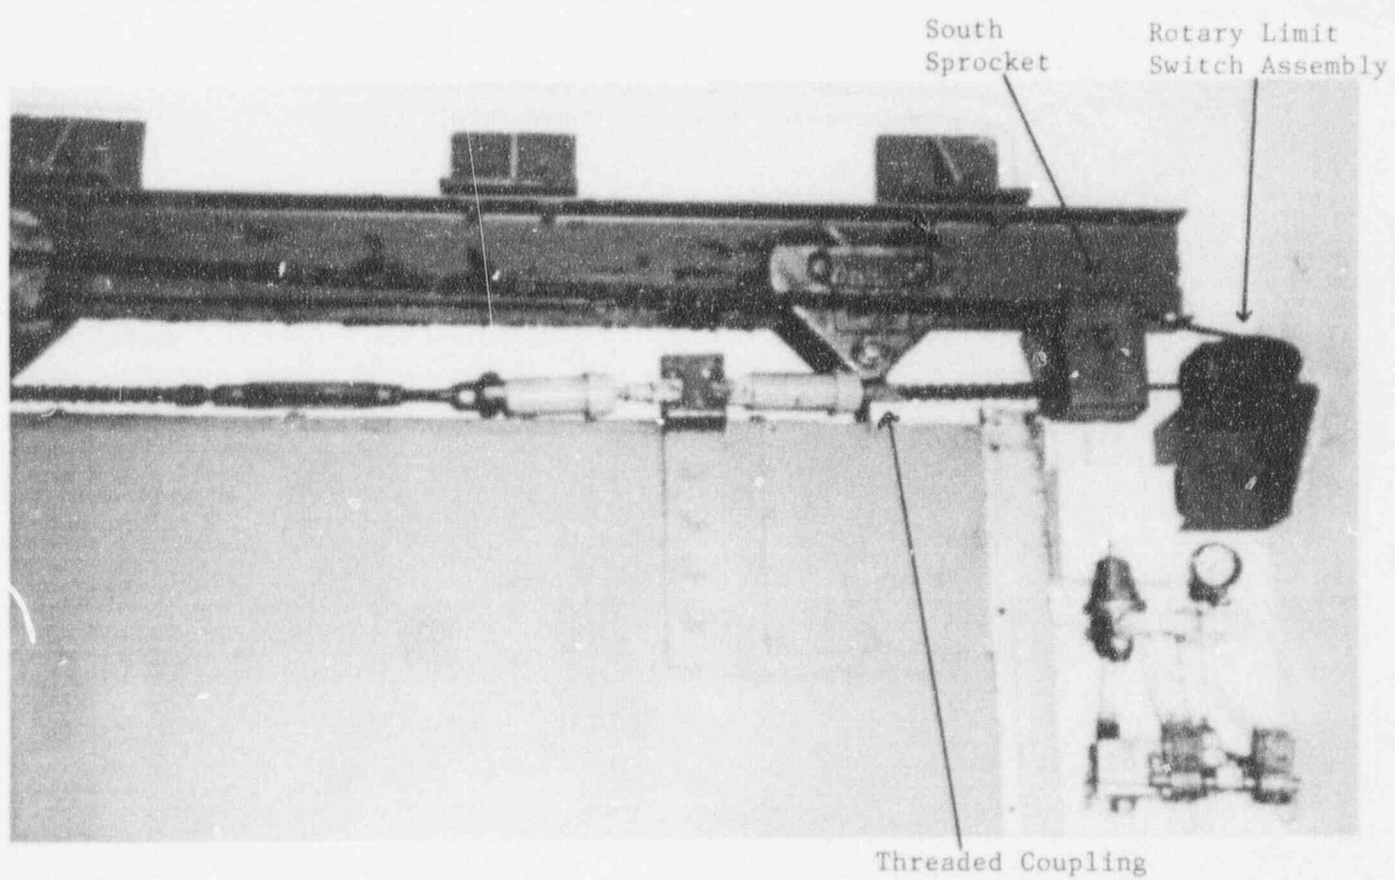
Figure 1. Inner Personnel Airlock Door Drive Chain

At 2332, September 2, 1994, an experimenter exited the containment building through the personnel airlock doors. The inner airlock door began to shut when the drive chain became detached from the door. The drive chain attaches to the door through a threaded coupling into a shock absorber, and the coupling became unthreaded. This allowed the chain to continue to drive the sprocket ("south sprocket") that also drives the rotary limit switch assembly.

The rotary limit switch assembly continued to drive to the point where the door "closed" relay contacts made up and the inner door seal inflated. The inner door then electronically appeared to be closed and sealed and the airlock door interlock satisfied. This enabled the outer airlock door to sequence open causing a momentary loss of containment.

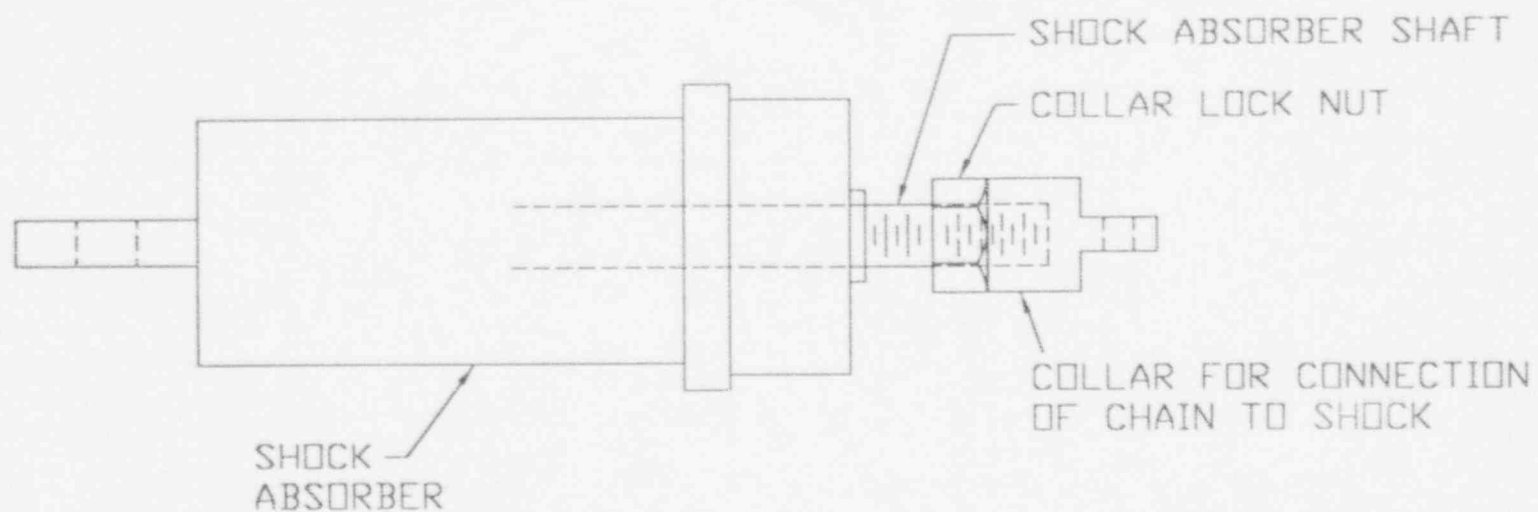
AIR LOCK DOOR SHOCK ABSORBER - BEFORE MODIFICATION

Analysis of the failure indicated that the degree of thread engagement into the coupling could not be detected by either the semiannual preventive maintenance inspection done by reactor operators, or by the daily mechanical routine inspection done by the machine shop staff. Based on this evaluation, the engineering staff decided to modify the threaded coupling to include a 1/8" roll pin to prevent the coupling from unthreading (see Fig. 2).
