Beaver Valley Power Station, Unit No. 1
Docket No. 50-334, License No. DPR-66
LER 91-011-00

LER 91-011-00, 10 CFR 50.73.a.2.vii.c, "Failure of Safeguards Pit Ventilation Isolation Damper".

Failure of Safeguards Pit Ventilation Isolation Damper

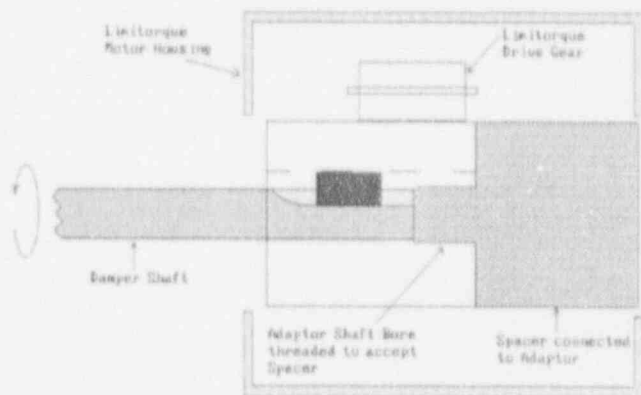
Figure 2

Modified Spline Adaptor

- 1) The adaptor for the train A Safeguards Pit Isolation Damper was adjusted to be fully engaged to the motor operator drive gear.
- 2) The station is currently inspecting all Shan-Rod dampers to determine if they have experienced adaptor slippage.
- 3) The station has contacted the damper's manufacturer and is developing a modification to the adaptor that will prevent future movement. This modification involves installing a spacer to prevent the spline adaptor from sliding along the shaft. See figure 2 for proposed modification. Either this or a similar modification will be installed on all Shan-Rod dampers at the station.
