PEACH BOTTOM ATOMIC POWER STATION

SUBJECT: Licensee Event Report
Peach Bottom Atomic Power Station - Unit 3

This LER concerns the inoperability of the High Pressure Coolant Injection System due to high water level in the Turbine exhaust line.

Reference:	Docket No. 50-278
Report Number:	3-91-005
Revision Number:	00
Event Date:	04/10/91
Report Date:	05/09/91
Facility:	Peach Bottom Atomic Power Station RD 1, Box 208, Delta, PA 17314

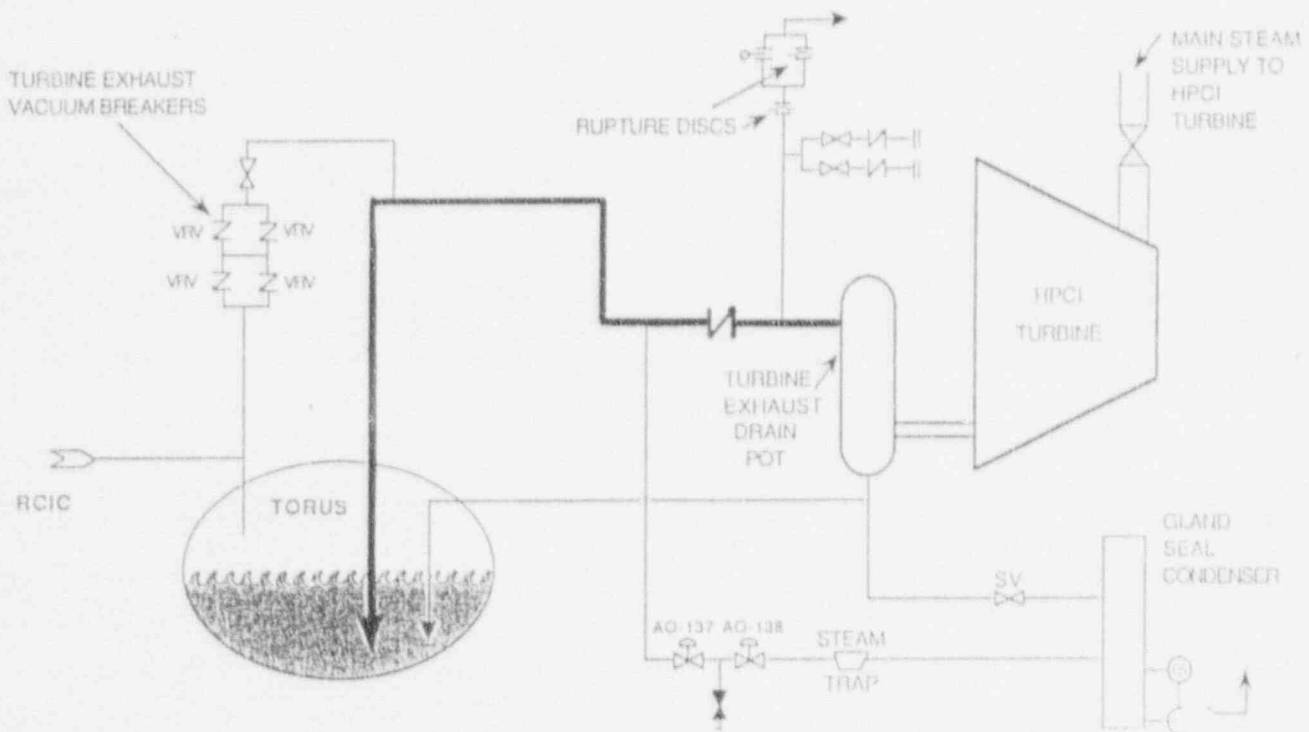
HPCI SIMPLIFIED PIPING DIAGRAM

The vacuum relief valves were found to have loose locking nuts which allowed the valve internals to disassemble and partially block vacuum relief flow (See Attached Diagram). The turbine exhaust line steam trap was found partially clogged. The valves were reassembled and steam trap was replaced. The HPCI system was then tested and returned to an operable status on 4/16/91 at 1630 hours.

The cause of the event has been attributed to the vacuum relief valve internals disassembling and partially blocking flow. This allowed torus water to be siphoned up into the exhaust line due to steam condensation following turbine operation. During the inspection of the valves, it was identified that the locking nuts were loose and the maintenance procedure did not provide the torquing requirements. Additionally, a contributing factor to the HPCI failure is that the turbine exhaust line steam trap was found partially clogged as a result of siphoning torus water into the turbine exhaust line draining system.

The Unit 3 HPCI vacuum relief valves were disassembled, inspected, and reassembled ensuring proper locking nut torque settings and the exhaust line steam trap was replaced.
