TOLEDO EDISON COMPANY  
DAVIS-BESSE NUCLEAR POWER STATION UNIT ONE  
SUPPLEMENTAL INFORMATION FOR LER NP-32-83-01

IDENTIFICATION OF OCCURRENCE: Current operating practice involving the Emergency Core Cooling System (ECCS) Room Coolers was less conservative than the assumptions in the Safety Analysis Report (SAR)

LER #83-012

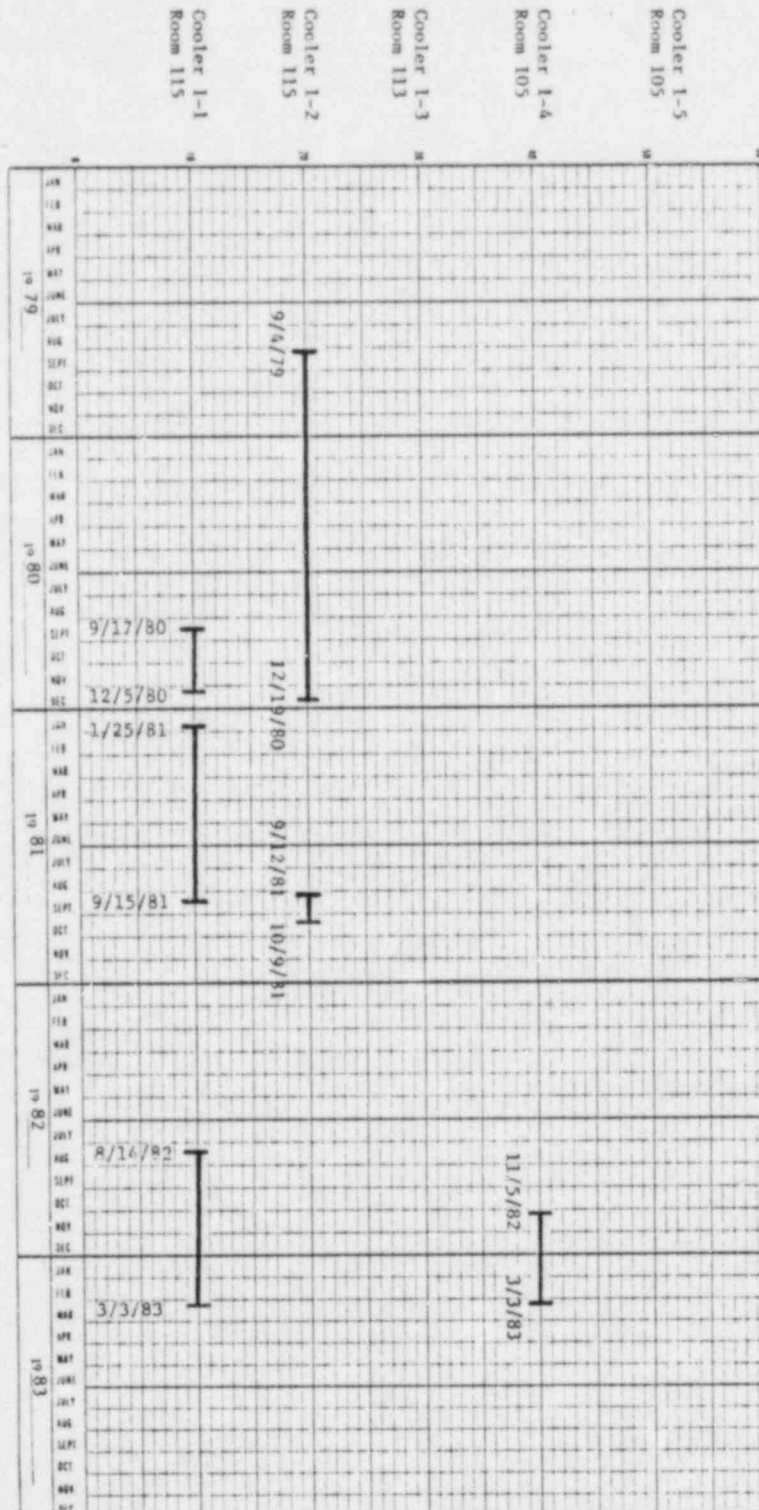
FIGURE 1: OUT OF SERVICE HISTORY FOR THE ECCS ROOM COOLERS

1 | During an investigation to determine the out of service history of the ECCS Room Coolers, it was discovered that both room coolers in Room 115 had been isolated during the time period of September 17 through December 5, 1980. This occurrence is being reported per Technical Specification 6.9.1.9.c. The complete history of when the ECCS Room Coolers have been taken out of service is shown in Figure 1.

As seen in Figure 1, there have been two time periods in which both ECCS Room Coolers in Room 115 have been taken out of service. These were:

- 1) From September 17 through December 5, 1980, and
- 2) From September 12 through September 15, 1981

During the first time period (September 17 through December 5, 1980, the unit was only at power from November 5 through December 3, 1980. The ECCS Room Coolers in Rooms 105 and 113 were in service during this time period ensuring that the ECCS train (Train 1) in Room 105 was operable. In

addition, at no time during this time period (November 5 through December 3, 1980) were there any equipment failures which would have rendered the operable ECCS train (Train 1) inoperable.

1 During the second time period (September 12 through September 15, 1981), the unit was at full power. The ECCS Room Coolers in Rooms 105 and 113 were in service, ensuring that ECCS Train 1 was operable. Again, there were no equipment failures of the ECCS Train 1 which would have rendered the operable ECCS train inoperable. This event has previously been reported in Licensee Event Report NP-33-81-70 (81-057).

Corrective Action: On March 3, 1983, ECCS Room Coolers 1-1 and 1-4 were valved into service.

1 Procedure modifications have been made to the Service Water System Procedure, SP 1104.11, and the Service Water Monthly Test, ST 5075.01, to ensure that (1) two ECCS Room Coolers which are located in the same ECCS room are never isolated simultaneously, and (2) that if one ECCS Room Cooler (or one ECCS cooler in each ECCS room) is isolated, ensure that the service water temperature is  $\leq 75^{\circ}\text{F}$ . In addition, portions of the SAR are currently being distributed with station operating procedures for periodic review to ensure that the design assumptions contained in the SAR are identified and integrated into the appropriate procedures.
