March 13, 2020
NRC-20-0019

Fermi 2 Power Plant
NRC Docket No. 50-341
NRC License No. NPF-43

Subject: Change in DTE Commitment Regarding Containment Coatings
and Additional Information

Clarifying Information Regarding Containment Coatings Commitment

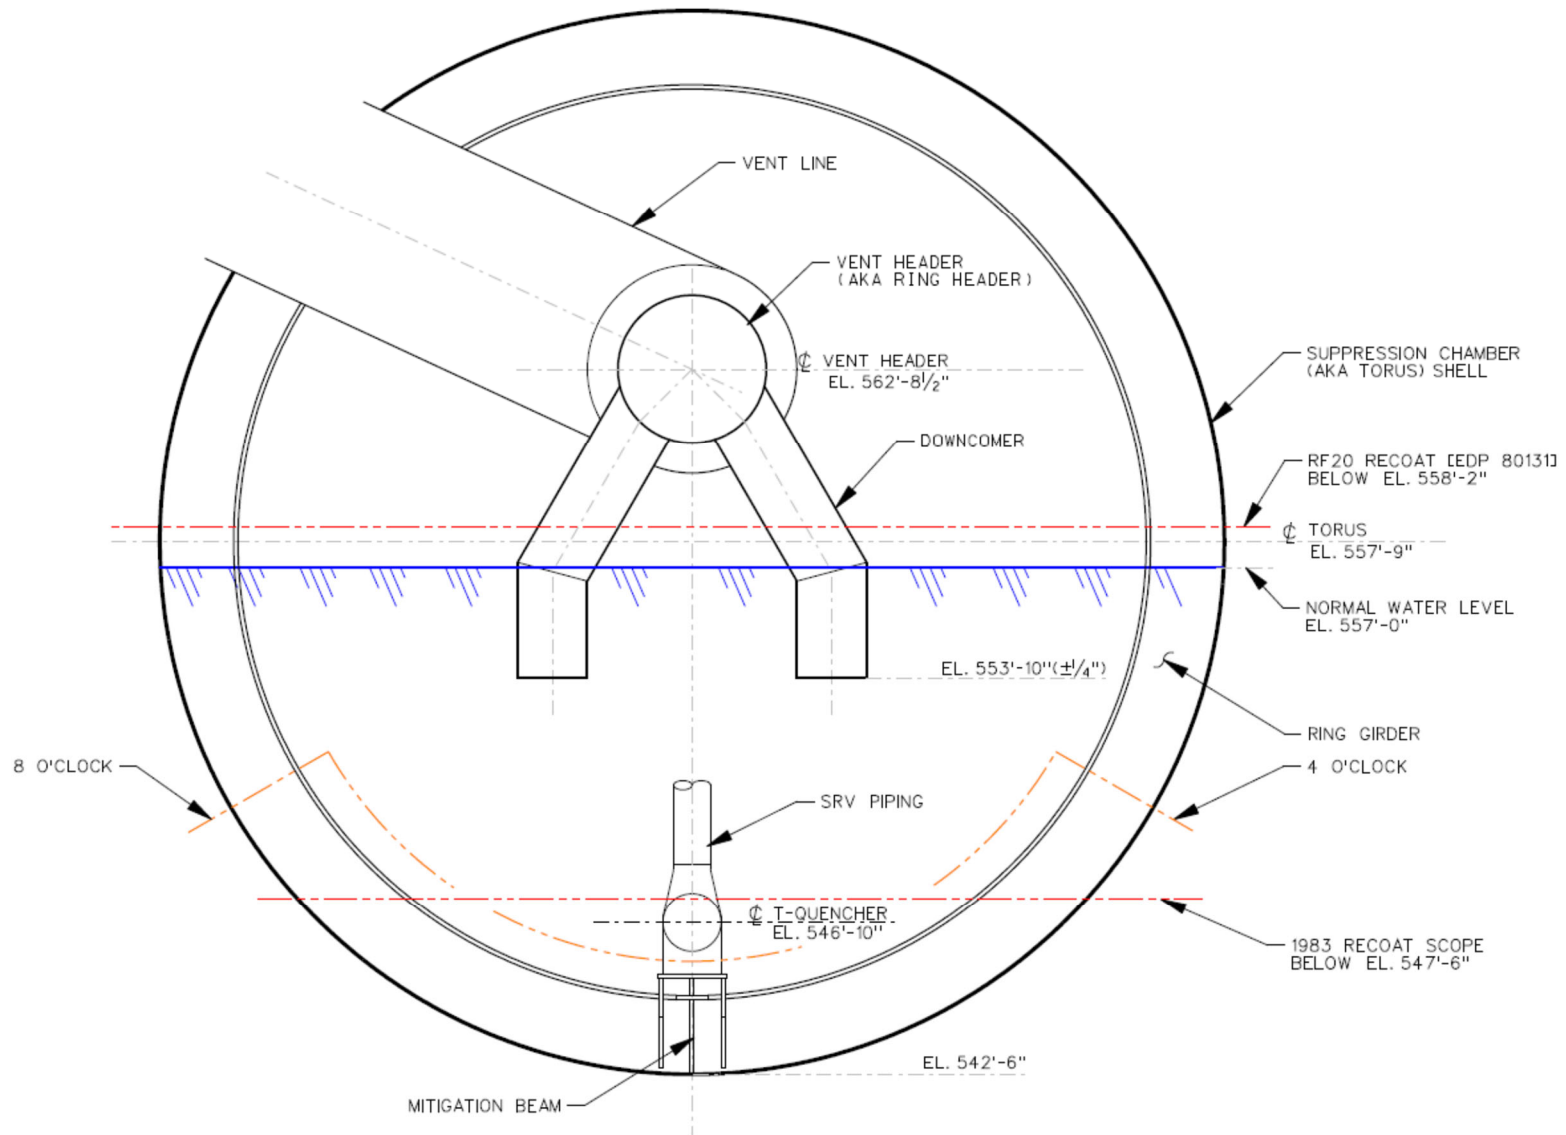
Figure 1: Pressure Suppression Chamber (Torus) Layout

As shown in Figure 1 in this Enclosure, the bottom of the inside of the torus is at an elevation of 542'6". The normal water level inside the torus corresponds to an elevation of 557'. Per the Fermi 2 Technical Specifications (TS), the torus water level is required to be within ± 2 " of this level during Modes 1, 2, and 3. The DTE commitment letter and the NRC CAL both refer to the "submerged portion of the torus." Conservatively using the maximum torus level allowed by the TS, the submerged portion of the torus therefore corresponds to internal areas of the torus below an elevation of 557'2".

Using the most conservative of these methods (based on surface area), the extent of the degraded coating region is the internal areas of the torus up to an elevation of 550'3". This extent of condition is well below the maximum torus water level of 557'2". Therefore, removing all coating below elevation 557'2" and applying a qualified coating capable of withstanding design basis accident conditions will fulfill the intent of the commitment to "mitigate the degraded coating in the submerged portion of the torus" with margin.

As described in the Fermi 2 Updated Final Safety Analysis Report (UFSAR) Section 6.2.1.2.1.3, 80 downcomer pipes, each 24" in diameter, extend downwards from the vent header and terminate below the surface of the water in the suppression chamber pool (refer to Figure 1 in Enclosure 1). Based on a downcomer bottom elevation of 553'10" as shown in Figure 1 of Enclosure 1 and the range of Technical Specifications (TS) allowable torus water level, the downcomer pipes are submerged between 3' and 3'4" during normal plant operations.

Consistent with this understanding, the DTE torus coating project plans to remove the current coating from the external surfaces of the bottom of the downcomers and apply the same DBA-qualified coating as will be used on the torus. Given the planned removal elevation of 558'2" as shown in Figure 1 of Enclosure 1, this will result in new DBA-qualified downcomer external coating with a foot of elevation margin above the normal submergence of the downcomers.

The DTE torus coating project plan is to remove and replace coatings below an elevation of 558'2", excluding downcomer and process piping internal surfaces as clarified in the commitment change and also in the above discussions. This project scope elevation is one foot above the 557'2" elevation of the submerged portion of the torus. Although beyond the requirement of the DTE commitment and NRC CAL, recoating to this higher elevation ensures that the interface between the new and existing coatings is well above the normal torus water line.
