SLNRC 83- 023 FILE: 0491.10.2
SUBJ: Significant Deficiency Report (SDR)
83-05 re GE AKR Circuit Breaker
Deficiency

SUMMARY REPORT
ON
AKR CIRCUIT BREAKER DEFICIENCY
PER
10CFR PART 50.55(e)

SNUPPS PROJECT
BECHTEL POWER CORPORATION
GAITHERSBURG, MD

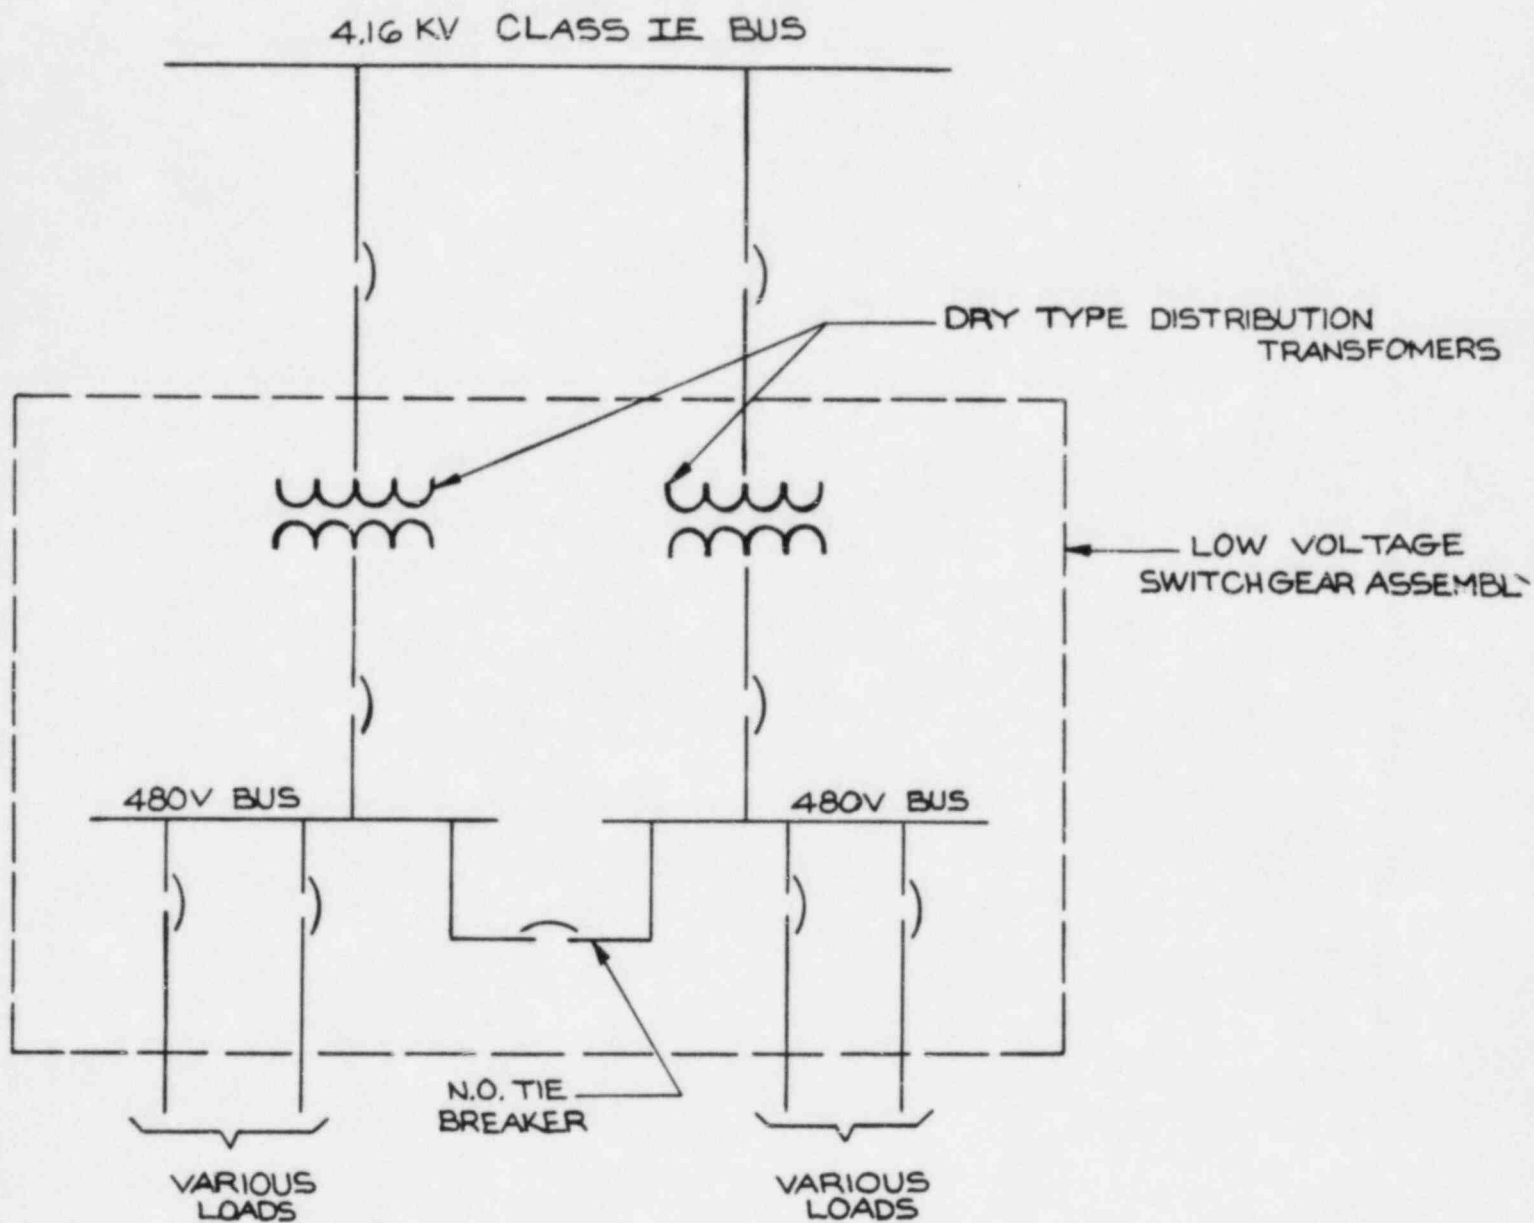
SKETCH 1

The circuit breakers are contained within low voltage switchgear assemblies. The assemblies are supplied from dry type distribution transformers, which are in turn supplied from the Class IE medium voltage busses. The low voltage switchgear assemblies are arranged in a double-ended configuration. Two busses, with each bus supplied from a separate transformer, are provided. A normally open tie breaker between the busses is also provided. Sketch 1, attached, depicts the electrical arrangement of the subject circuit breakers.

TYPICAL LOW VOLTAGE SWITCHGEAR
ELECTRICAL ARRANGEMENT
