THE CINCINNATI GAS & ELECTRIC COMPANY

April 29, 1983
LOZ-83-0021

RE: WM. H. ZIMMER NUCLEAR POWER STATION - UNIT 1
10CFR50.55(e), ITEM E-39, BROWN BOVERI 125V DC
CONTROL DEVICE FAILURE ON 6.9KV AND 4.16DV SWITCHGEAR
W.O. 57300, JOB E-5590, FILE NO. 956C, E-39

ANALYSIS OF HK CONTROL DEVICE (LIMIT SWITCH) FAILURE (HK BREAKER TYPES - 7.5KV THRU 15KV, 500 THRU 750 MVA; 5HK350, 3000) ALL HKV BREAKERS

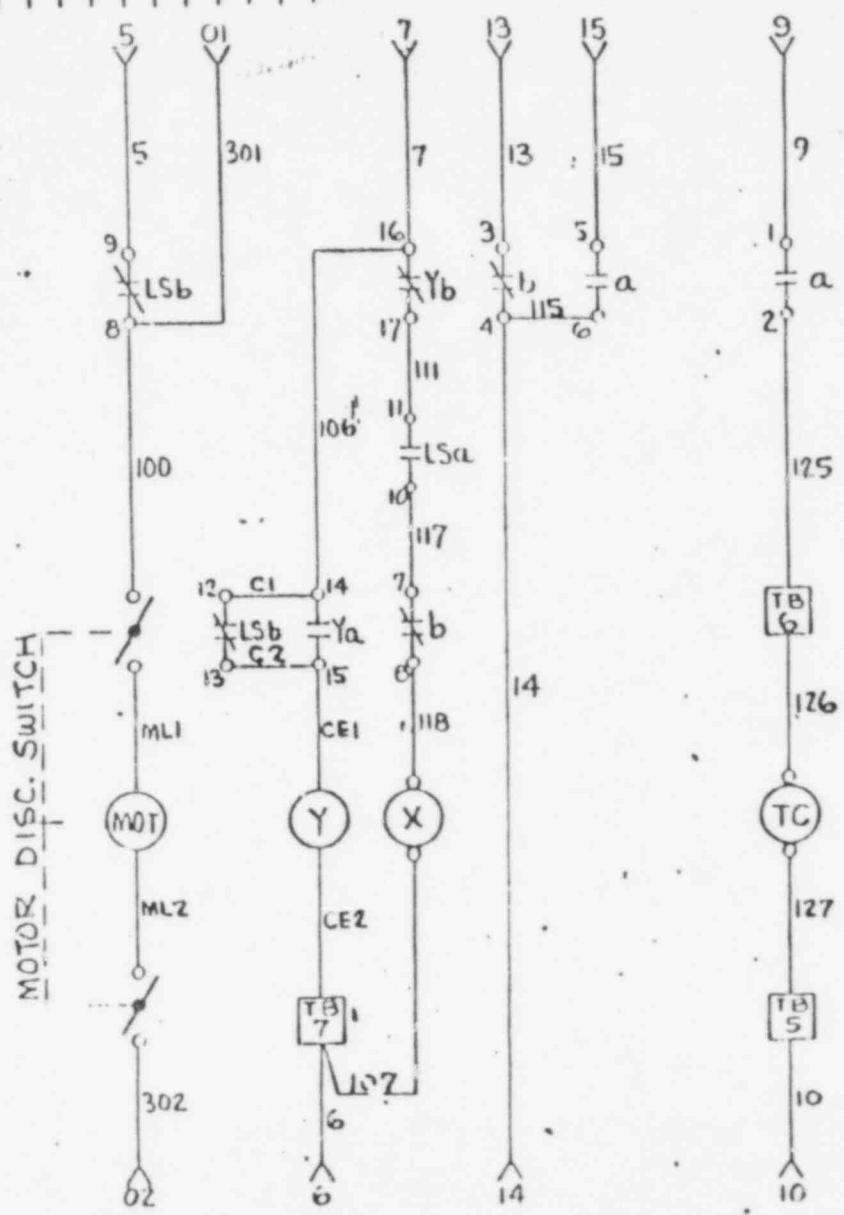
When the failed device was examined at Columbia, the plastic contact carrier, containing the three limit switch contacts (2-LSb contacts, 1-LSa contact), was found broken. Re: typical HK wiring diagram 196270 attached. The most common reason for breaking the carrier is due to excessive overtravel of the lever. See IB-8303 attached, Fig. 1. This overtravel overdrives the limit switch crank which causes breakage of the carrier. The overtravel of the lever is limited by the lever stop and as long as the dim "B", Fig. 2, is not greater than 1/16 inch, breakage should not occur. Tests conducted in July of 1978 have substantiated this.
