LICENSEE EVENT REPORT

TOLEDO EDISON COMPANY
DAVIS-BESSE NUCLEAR POWER STATION UNIT ONE
SUPPLEMENTAL INFORMATION FOR LER NP-32-83-01

2 | IDENTIFICATION OF OCCURRENCE: Current operating practice involving the Emergency Core Cooling System (ECCS) Room Coolers was less conservative than the assumptions in the Updated/Final Safety Analysis Report (USAR/FSAR)

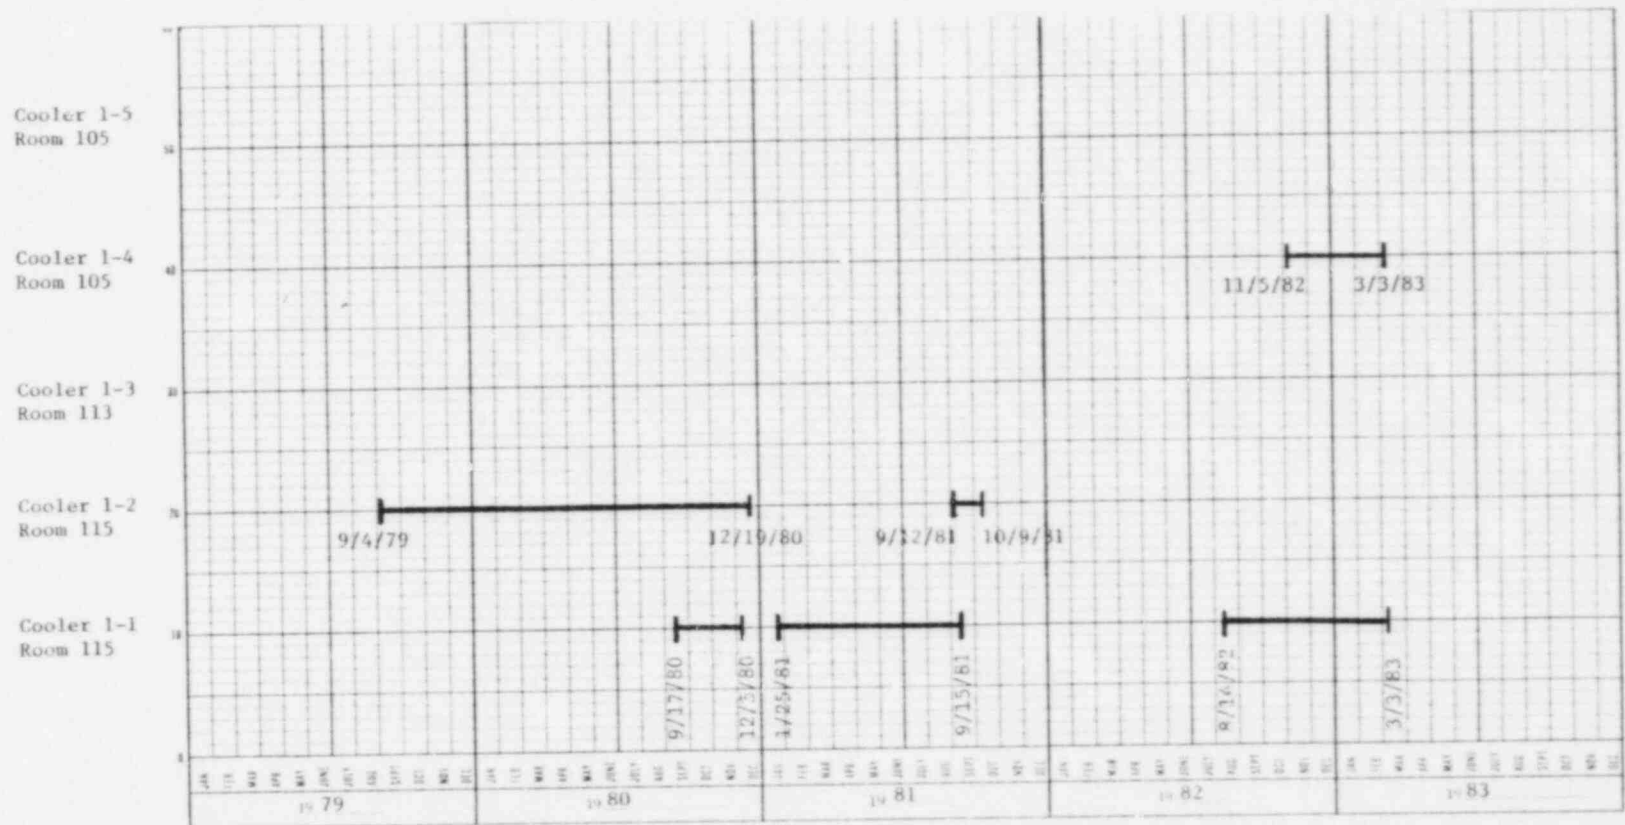
FIGURE 1: OUT OF SERVICE HISTORY FOR THE ECCS ROOM COOLERS

2 | During an investigation to determine the out of service history of the ECCS Room Coolers, it was discovered that both room coolers in Room 115 had been isolated during the time period of September 17 through December 5, 1980. This occurrence is being reported per Technical Specification 6.9.1.9.c. The complete history of when the ECCS Room Coolers have been taken out of service is shown in Figure 1.

As seen in Figure 1, there have been two time periods in which both ECCS
Room Coolers in Room 115 have been taken out of service. These were:

- 1) From September 17 through December 5, 1980, and
- 2) From September 12 through September 15, 1981
