NUCLEAR REACTOR LABORATORY
AN INTERDEPARTMENTAL CENTER OF
MASSACHUSETTS INSTITUTE OF TECHNOLOGY

Subject: Reportable Occurrence 50-20/1983-1, License R-37
Failure of Ventilation Valve Actuator

1. Report No: 50-20/1983-1
- 2a. Report Date: 29 April 1983
- 2b. Occurrence Date: 19 April 1983
3. Facility: MIT Nuclear Reactor Laboratory
138 Albany Street
Cambridge, MA 02139
4. Identification of Occurrence:

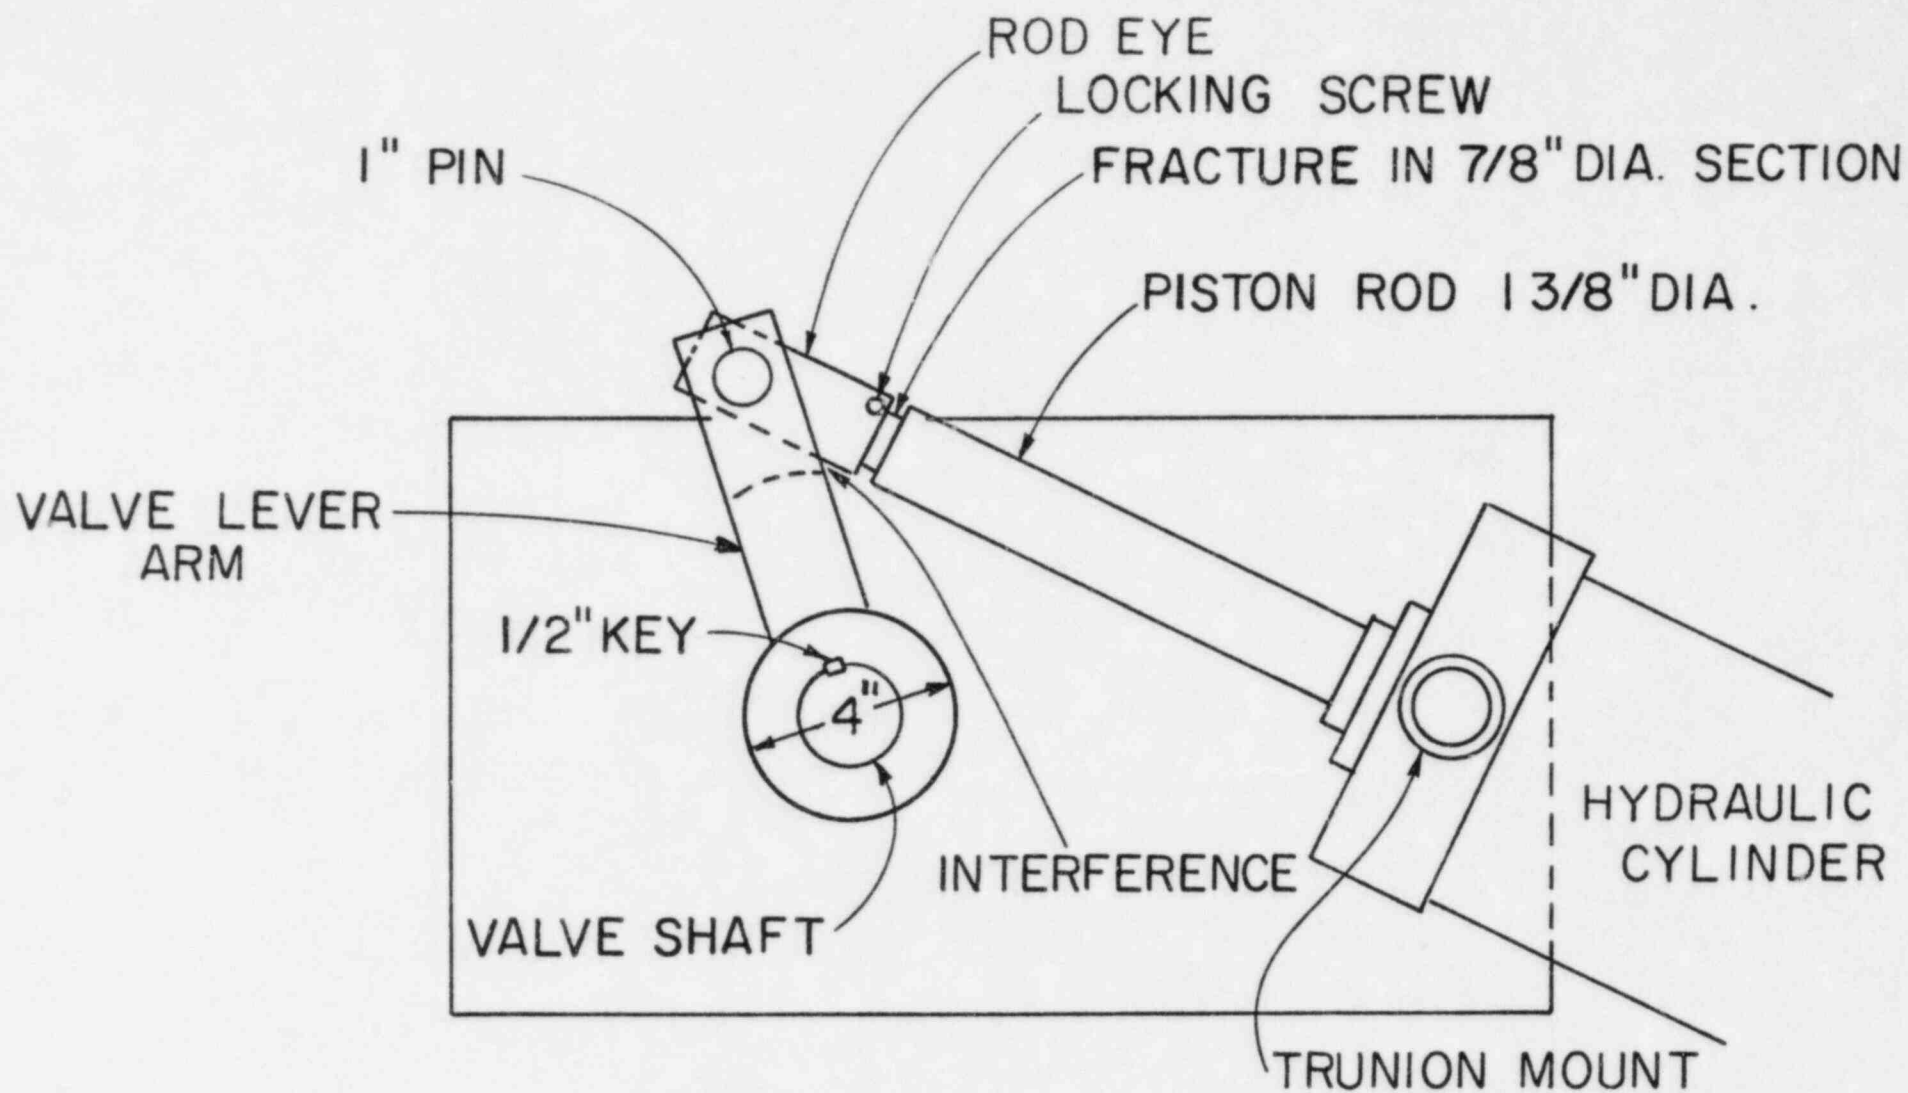
ISOLATION VALVE ACTUATING MECHANISM

A portion of the full power startup checklist requires that the four effluent monitors in the ventilation exhaust plenum be tested to assure that the ventilation isolation valves will close automatically in the event of abnormal amounts of airborne radioactive material in the effluent. The test consists of lowering the trip setting to the background level indicated by the monitor, acknowledging the alarm, checking that the valves both close, resetting the trip, and finally reopening the valves. Three out of the four plenum monitors had been tested successfully using the above procedure. The last monitor was tested and it was found that the ventilation valves closed successfully but one could not be reopened. The valve in question was the main intake damper. It had failed in the closed position. Investigation of the operating mechanism revealed that the 1-3/8" diameter piston rod of the valve's hydraulic cylinder had ruptured where its diameter reduces to 7/8". The fracture occurred approximately 1/4" from where it is threaded so that it can be connected to the rod eye. (See attached diagram.)

The piston rod is screwed into a rod eye which is in turn connected to the valve lever arm as shown in the attached diagram. The force from the hydraulic pressure is transmitted via the piston rod and the rod eye to the valve lever which rotates 90° from the OPEN position to the CLOSED position. The valve lever is attached to the shaft of the valve by means of a hub and a 1/2" key. The isolation valve is a steel butterfly valve with a diameter of thirty inches. It is five inches thick where it is attached to the shaft. A steel lever attached to the end of the shaft of the isolation valve operates two micro-switches which indicate the true position of the valve in the control room independently of the operating mechanism. A gas-tight seal

The manufacturer's catalogue data show that the piston rod is made of steel with a yield strength of 90,000 to 110,000 psi. The piston rod is turned down from 1-3/8" diameter to 1" diameter at the end to allow for a 1"-14 thread. A distance of about 1/4" between the 1-3/8" main diameter and the 1" threaded diameter is undercut to a 7/8" diameter. A rod eye piece is pinned to the isolation valve lever arm and the threaded end of the piston rod is screwed into the rod eye. The rupture occurred at the transition from 1-3/8" to 7/8" diameter.

The immediate cause of failure was found to be an interference, which developed over time under normal usage, between the valve lever arm and the rod eye. Evidence of contact between the above two parts was found when disassembling the failed mechanism. The interference is believed to have been caused by the normal wear and tear of the valve gasket. The valve lever arm has to travel further to form a tight seal as the rubber gasket becomes worn. It is probably because of this extra throw which is required to close the damper tightly that the interference occurred. The damper is designed with gasket adjustment clamps which can be tightened to push a section of the rubber gasket out further from its channel to form a round tight seal. These gasket adjustment clamps can be adjusted to insure that sufficient clearance exists between the valve lever arm and the rod eye.

In conclusion, the interference between the valve lever arm and the rod eye produces a bending moment and a shear force in the piston rod. The transition of the rod diameter from 1-3/8" to 7/8" where the radius of curvature of the surface is the minimum, is where the stress concentration is at its maximum. The tensile stresses in the top half of the piston rod, which were a direct result of the bending moment induced by the interference, coupled with the shear stress initiated a micro-crack normal to

the surface of the rod at this transition point. The crack grew and propagated along the circumference of the rod due to the fatigue cyclic loadings. This circumferential fatigue zone continued to propagate toward the center of the rod until the strength of the rod had decreased to the point that the rupture stress was reached. The rod finally failed by brittle rupture and the central zone formed.

Once the failed mechanism had been studied, further corrective action was taken. This consisted of adjusting the gasket on the isolation valve, shortening the throw on the valve lever arm, and relieving the rod eye by 1/16" to insure sufficient clearance between the rod eye and the valve lever arm. Given that these repairs might have affected the degree to which the valve sealed, a pressure test was performed after the repair in order to verify the proper adjustment of the throw on the valve lever arm and the valve gasket. The test was conducted in accordance with previously established standard procedures. It showed that the leakage through the repaired valve was well within the specified limits. In addition, specific steps have been added to the standard maintenance procedures to check that the clearance between the rod eye and the valve lever arm is sufficient when the isolation valve is in the closed position.
