LONG ISLAND LIGHTING COMPANY

NRC Inspection No. 82-35
Shoreham Nuclear Power Station, Unit No. 1
Docket No. 50-322

NRC Inspection Report No. 50-322/82-35 (page 8, item 6, Diesel Generator Testing) expressed concerns over the performance of Shoreham Preoperational Test PT.307.003B, "Emergency Diesel Generator 102 Electrical Test". The following includes the NRC concerns and LILCO's response for each observation:

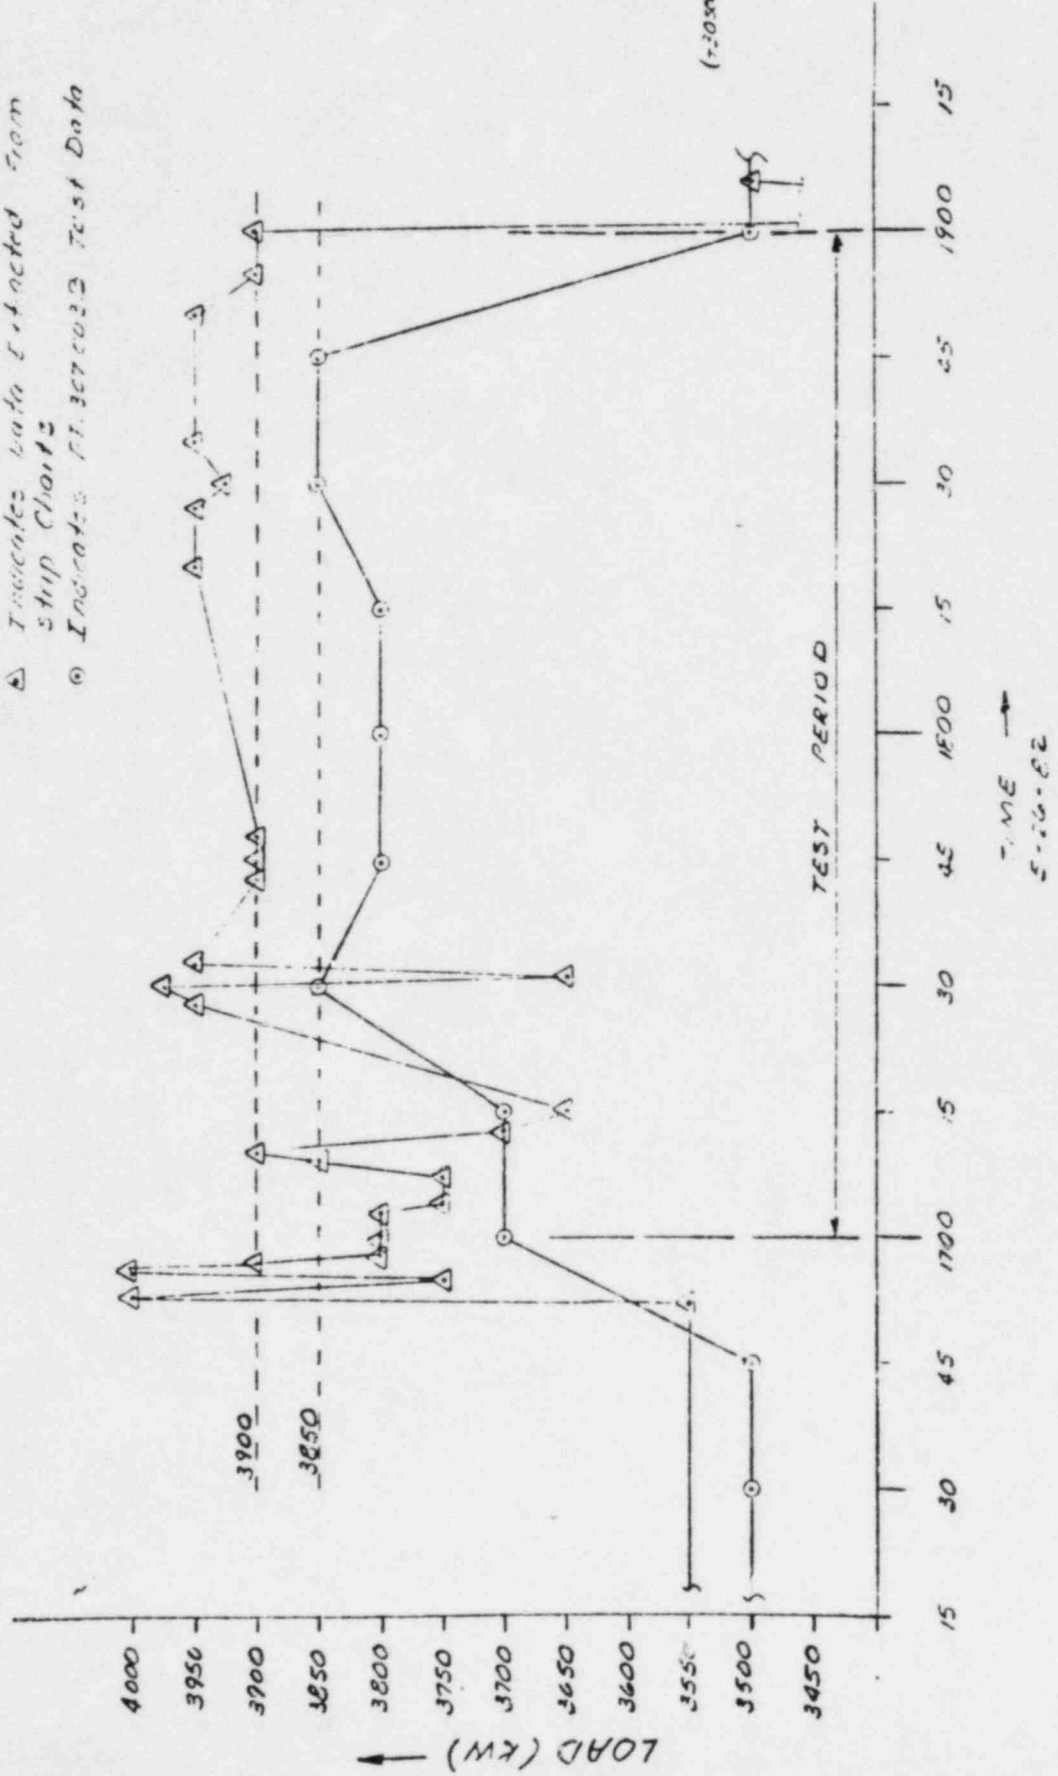
EMERGENCY DIESEL GENERATOR LOAD TEST

The data obtained during the test is presented in the attached graph entitled Emergency Diesel Generator Load Test, Emergency Diesel Generator 102 - PT.307.003B (Step 8.5.4). This attachment presents load data versus time for the diesel generator 2 hour rating test period and plots data taken from both the control room load indicator, which was recorded in Table II of the test procedure, and from the visirecorder charts. It should be noted that the load profiles from the visirecorder charts and control room indicator do differ. In fact for the 2 hour test period, the visirecorder charts show a general load profile ranging from a high load of 3975 KW to a low load of 3650 KW while the control room indicator load profile indicates a load between 3700 KW and 3850 KW. (The final control room data point was 3500 KW but it was confirmed that this reading was taken after the load was reduced at the end of the test.) The Test Engineer utilized the chart recorder as a more accurate indication of load because the control room load meter was responding to load fluctuations. In fact, the strip chart recorder has now been designated as the primary instrument to be used in the re-performance of this high load test.

Based on all of the above factors it was the Test Engineer's judgment that the intent of the diesel generator 2 hour rating load test had been satisfied. LILCO has since determined that the integrated load profile (KW-hours) for the strip chart recorder for the two hours represents a loading of 99% of the total load that would result from running the diesel generator for 2 hours at exactly 3900 KW. LILCO believes, however, that the Test Engineer's judgments and their basis should have been more explicitly noted in the test report.

1. As discussed with Region I personnel in your offices on January 25, 1983 during the meeting to discuss the results of the Readiness Assessment Team Inspection (50-322-83-02), LILCO committed to re-perform the Emergency Diesel Generator 102 24 hour high load test runs to alleviate any concern about the ability of the diesel generator to successfully operate under maximum service conditions. In addition it should be noted that in light of recent modifications and reworks to the 102 emergency diesel generator it would have been necessary to re-perform the high runs independent of the NRC concerns expressed.
