Commonwealth Edison Company

Preliminary Design Assessment
of the
Byron/Braidwood Generating Station Control Room
Human Factors Engineering Review
Supplement I

April 1983

Task Action Plan Item
I. D. 1. Control Room Design Reviews

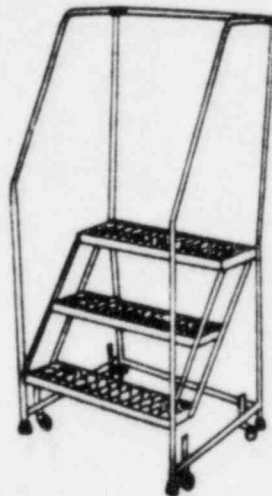
- 1 1.2 Some of the controls on the stand-up console are located out of reach of the 5% height operator. The highest control is located 65" from the floor (recommended maximum = 60").

A step ladder will be available to aid the fifth percentile female in reaching the switches. The ladder will also be equipped with handrails, as shown below, to prevent falls and minimize contact with the boards.

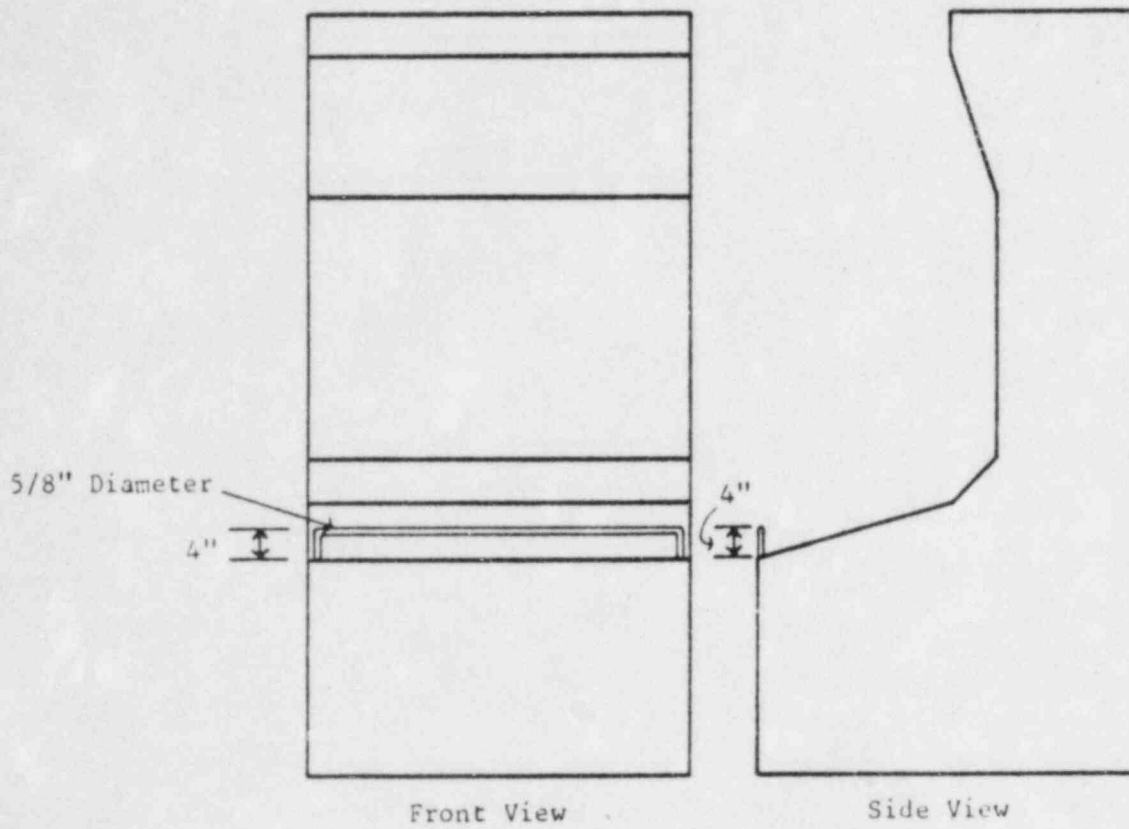
Figure A.

The J-Handle switches close to the edge of the benchboard section of 1PM02J, the Heater Drain and Turbine Control areas, and all switches on the common vertical panels (OPM01J, OPM02J and OPM03J) can be activated accidentally. (4.4.2) (2.2.1-2)

CE Response: J-Handle switches located close to the edge of the benchboard which could be inadvertently actuated have been inventoried. They are located on the 1PM01J, 1PM02J, and 1PM03J panels. To prevent an inadvertent actuation, a 5/8" round steel guardrail will be installed on these benchboards. These guardrails will be located 4" above the boards (Figure A) and will connect with the top of the benchboard at varying intervals (Figure B).
