LIMERICK GENERATING STATION

SUBJECT: Licensee Event Report
Limerick Generating Station - Unit 1

LICENSEE EVENT REPORT (LER)

| TITLE (4) This LER Reports Pressure Setpoint Drift of the Main Steam Safety Relief Valves due to Corrosion Induced Bonding within the valves which has been a Repetative problem. | | | | | | | | | | | | | | | | | | | | | | |

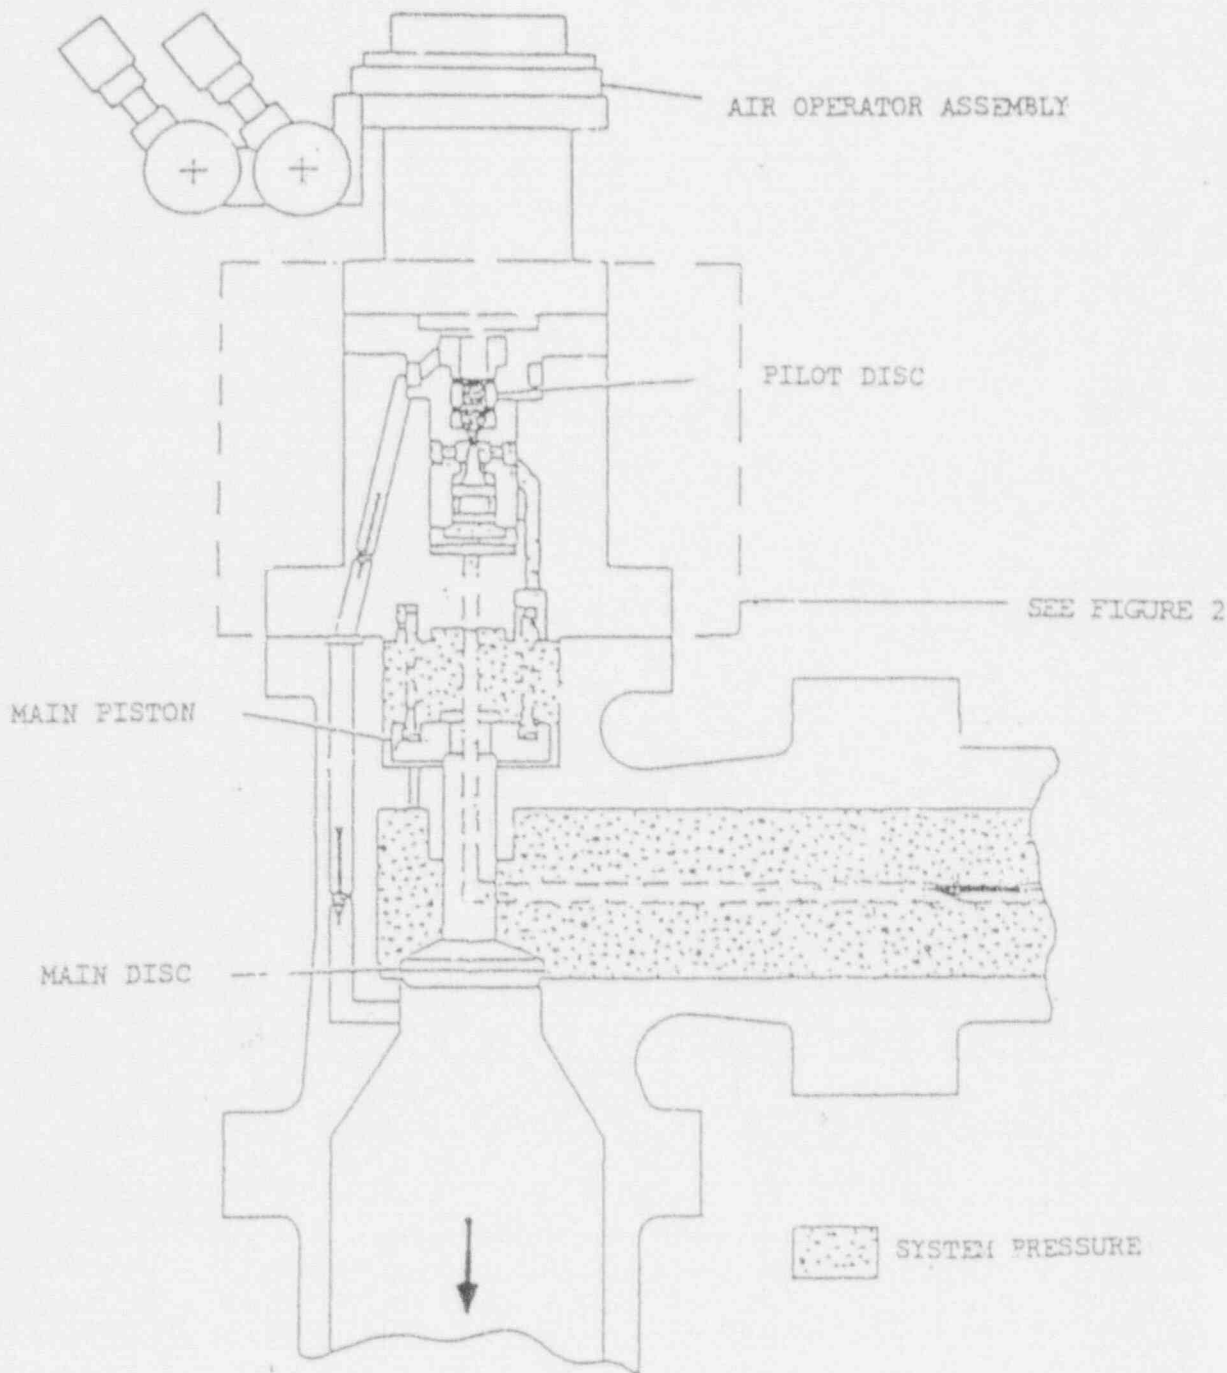
Figure 1

The root cause for the setpoint drift of eleven SRVs was primarily corrosion induced bonding between the pilot disc made of either stellite or PH13-8Mo (i.e., SS) and the stellite seat. The corrosion stems from oxidation product build-up due to the presence of moisture and the heated environment. Figures 1 and 2 are illustrations of the Target Rock Corp. SRV model 7567 F SRVs Assembly 77R-000.
