Millstone Nuclear Power Station, Unit No. 2
Temporary Repair to X-182 Heat Exchanger Tube

Millstone Nuclear Power Station, Unit No. 2
Details of Temporary Repair
to
X-182 Heat Exchanger Tube

LEAK IN X-182 HEAT EXCHANGER TUBE - SERVICE WATER SIDE

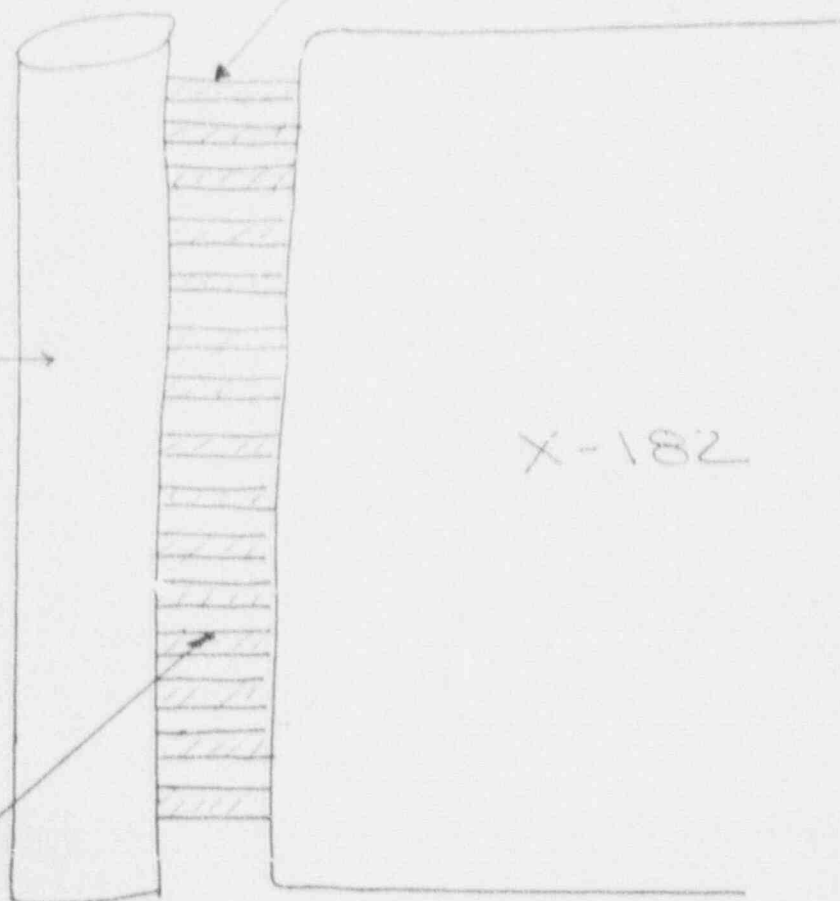
X-182

A visual inspection was performed on the affected tube and indicates that the hole is approximately 1/16 inch in diameter. The adjacent wall thickness could not be determined. There was only one hole found. The other tubes were visually inspected for leaks.

Flaw Location: 1 1/2 inches from the inlet header; see attached sketch.

Root Cause Description: The root cause of this defect is the erosion/
corrosion encountered during the fifteen year life of the heat
exchanger.

LEAK >

A reversible repair consisting of a soft patch will be placed over the
hole and held in place with a hose clamp.
