NORTHEAST UTILITIES

Millstone Nuclear Power Station, Unit No. 3
Request for Relief From ASME Section XI

Additional Information to Relief Request
for Pipe 3SWP-030-334-3

Request for Relief From
ASME Code Section XI Requirements

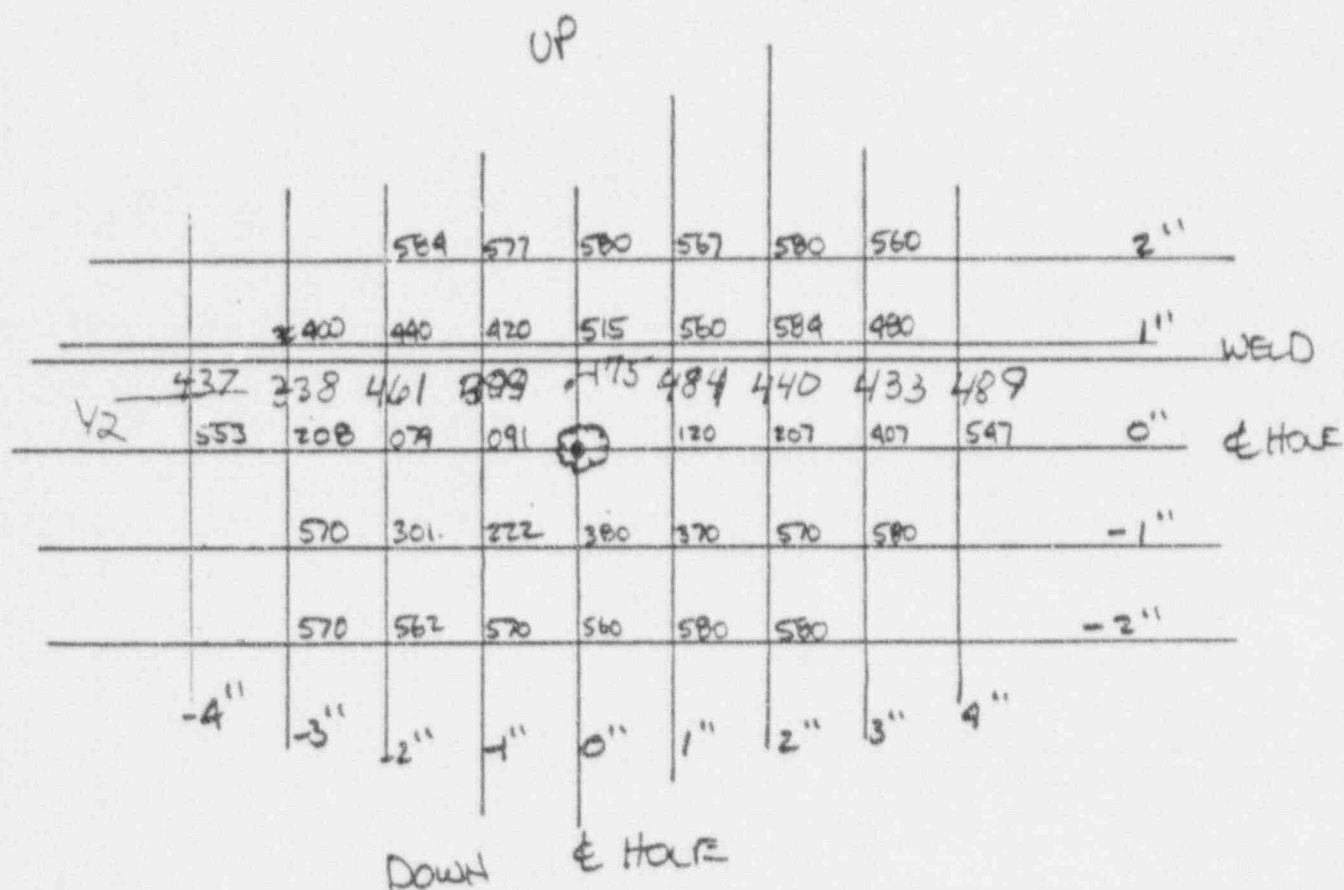
UT MAP - HOLE ON
3 SWP 030 334 03

See the attached drawing. The leak from a single 1/4" hole was discovered on May 2, 1991. An 8 by 5 inch area was examined by UT. The grid size was 1 inch square. The hole is located on the extrados of a 90° elbow downstream of a restricting orifice used to maintain backpressure on the system. The hole is 1" below a longitudinal fabrication weld. The area where piping has degraded below nominal wall is approximately 6 inches by 3 inches. The area below minimum wall thickness is approximately 3" long by 1/2" wide, with a minimum thickness of 0.079 inches.

Erosion/corrosion due to turbulence created by the restricting orifice upstream of the elbow.

- ① READINGS AT WELD BOUNCED AROUND. WELD TO LEFT SIDE OF HOLE APPEARS TO HAVE SOME MATERIAL LOSS BUT AVERAGED AROUND 0.400"
- ② ALL OTHER READINGS WERE REPEATABLE
- ③ HOLE \approx 1/4" DIA.

The hole has been covered by a 6" by 5" soft patch (rubber with a metal stiff back plate) held in place by metal bands. This temporary repair is completely reversible. Based on the projected flaw size below, the use of a hard patch (welded to pipe) is being considered. See Section B for details.

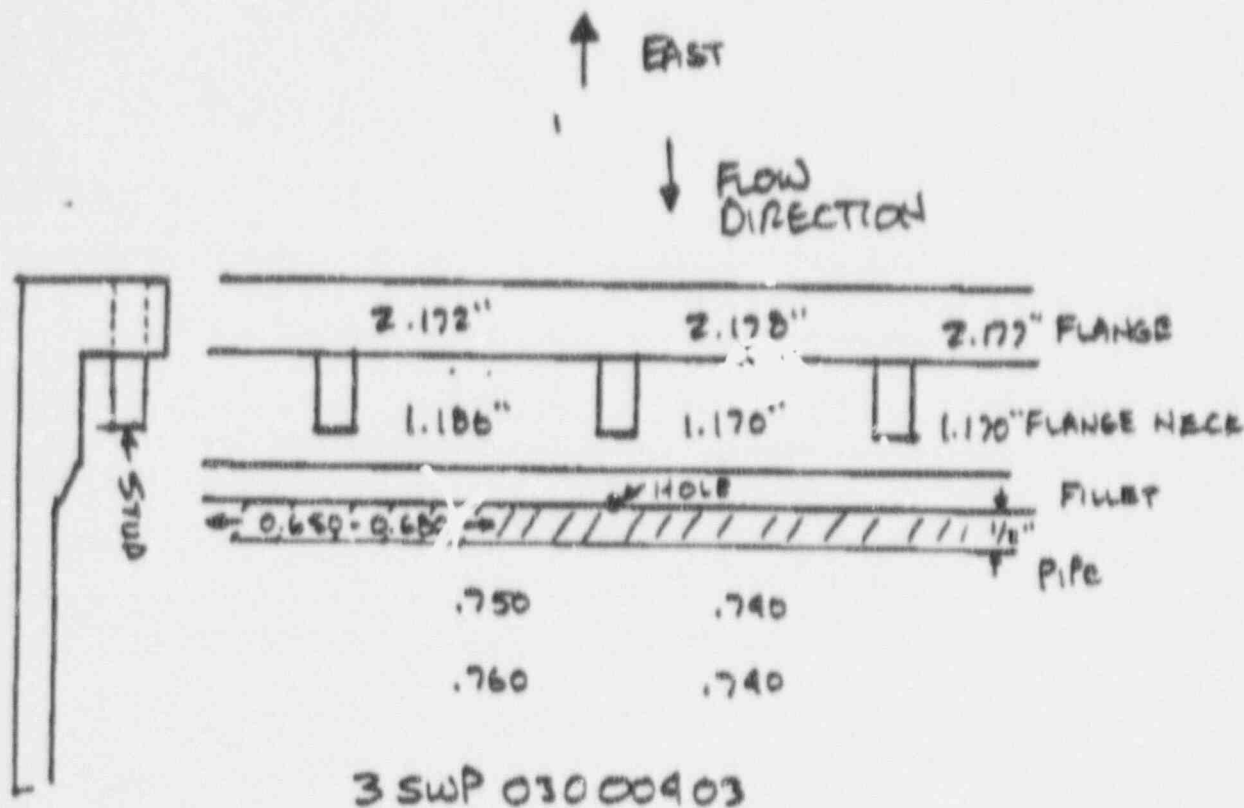
See the attached drawing. The leak from a single 1/8" hole was discovered on June 6, 1991. An area approximately 1 square foot was examined by UT, including portions of an adjacent slip-on flange. As no degradation was found outside the immediate vicinity of the leak hole, a grid was not used, just the average pipe wall thickness for the areas shown.

The hole is located adjacent (at the "toe of the weld") to the flanged connection between a long straight run of pipe and an elbow. The hole is on the elbow side of the flange connection with flow coming from the straight run of pipe and entering the elbow. There is no sign of degradation of the pipe wall excluding the through-wall hole, but it must be noted that the UT examination does not "see" the pipe under the slip-on flange. Past experience has shown that most likely the pipe under the flange is degraded to some degree. The thickness readings of the flange in the immediate area indicate the flange has not been affected.

Past inspections of large bore Service Water piping has shown sulfide attack in the areas adjacent to flange faces (heat affected zone caused by the installation of the slip-on flange). The literature on the subject is mixed as to the rate at which this attack takes place and the severity of the attack. Inspections to date have not indicated that this attack is occurring at a rate to cause short term (6 to 12 months) concern. As the flange joint is downstream of a long straight run of pipe, and there are no causes of flow disturbance upstream of the leak, sulfide attack has to be considered.

The leak is at the "toe" of the slip-on flange weld (also a heat affected zone caused by the installation of the slip-on flange), where a small flaw or holiday in the copper-nickel cladding during construction could have gone undetected. Localized erosion/corrosion of the cladding in time would expose the carbon steel base metal to service water, i.e. sea water. Once sea water came in contact with the carbon steel base metal, a through-wall leak would follow.

NOTE - FOR AREA 1/2" FROM TOE OF WELD AN AREA ALL AROUND THE PIPE WAS STEPPED DOWN FROM ≈ 0.750 " TO $0.650-0.680$ ". STEP WAS VERY PROMOUNCED.

The hole has been covered by an approximately 4" by 8" soft patch (rubber with a contoured wooden block) held in place by nylon strapping bands (circumferentially around pipe) and a clamp to hold the patch against the backside of the flange. This temporary repair is completely reversible. Based on the projected flaw size below, the use of a hard patch (welded to pipe/flange) is being considered. See Section H for details.
