**Wisconsin Electric** POWER COMPANY

August 18, 1983

DOCKET NO. 50-301  
CONTROL ROD WEAR  
POINT BEACH NUCLEAR PLANT, UNIT 2

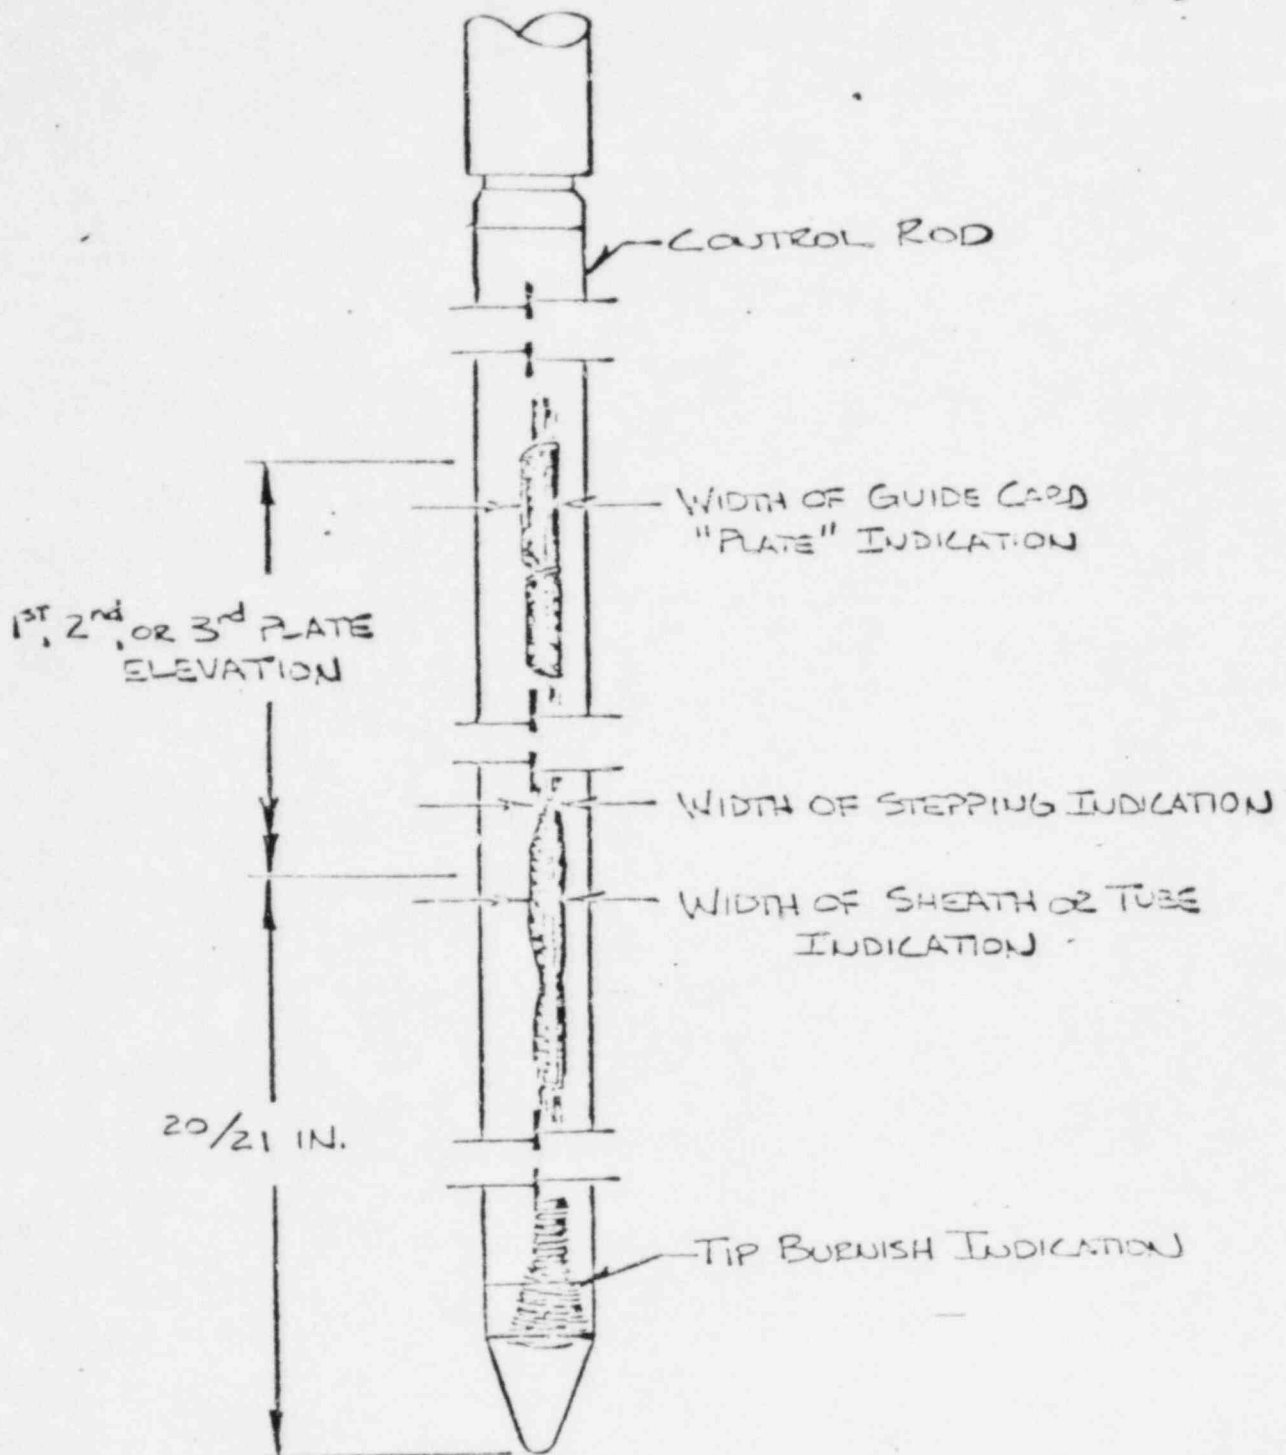
FIGURE 1

The clad wear is postulated to be a combination of two types. One is wear occurring as a result of RCCA stepping and trip insertion. The other is wear occurring as a result of vibratory interaction between rodlets and control rod guide tube cards and sheaths during long periods of steady-state power operation with all the rods essentially out of the core. (See Figures 1 and 2.)

"TYPICAL CONTROL ROD WEAR PATTERN"

- (1) R52 should be replaced prior to Cycle 10 operation.
- (2) R71 should be replaced or repaired prior to Cycle 10 operation.
- (3) R51 and R58 should be located in a shutdown bank away from the reactor vessel outlet nozzles.

- (4) All RCCA's other than those in control bank "D" should be positioned at 225-226 steps instead of the normal fully withdrawn position of 228 steps during full power operation. An RCCA which is withdrawn at or above 225 steps is fully withdrawn from the core and has no reduction in available shutdown margin or effect on plant operation. Bank "D" should be positioned 2-3 steps either above or below the 215 steps it has been positioned at for long periods of time during the past several cycles. This is to change the wear points on the RCCA's.

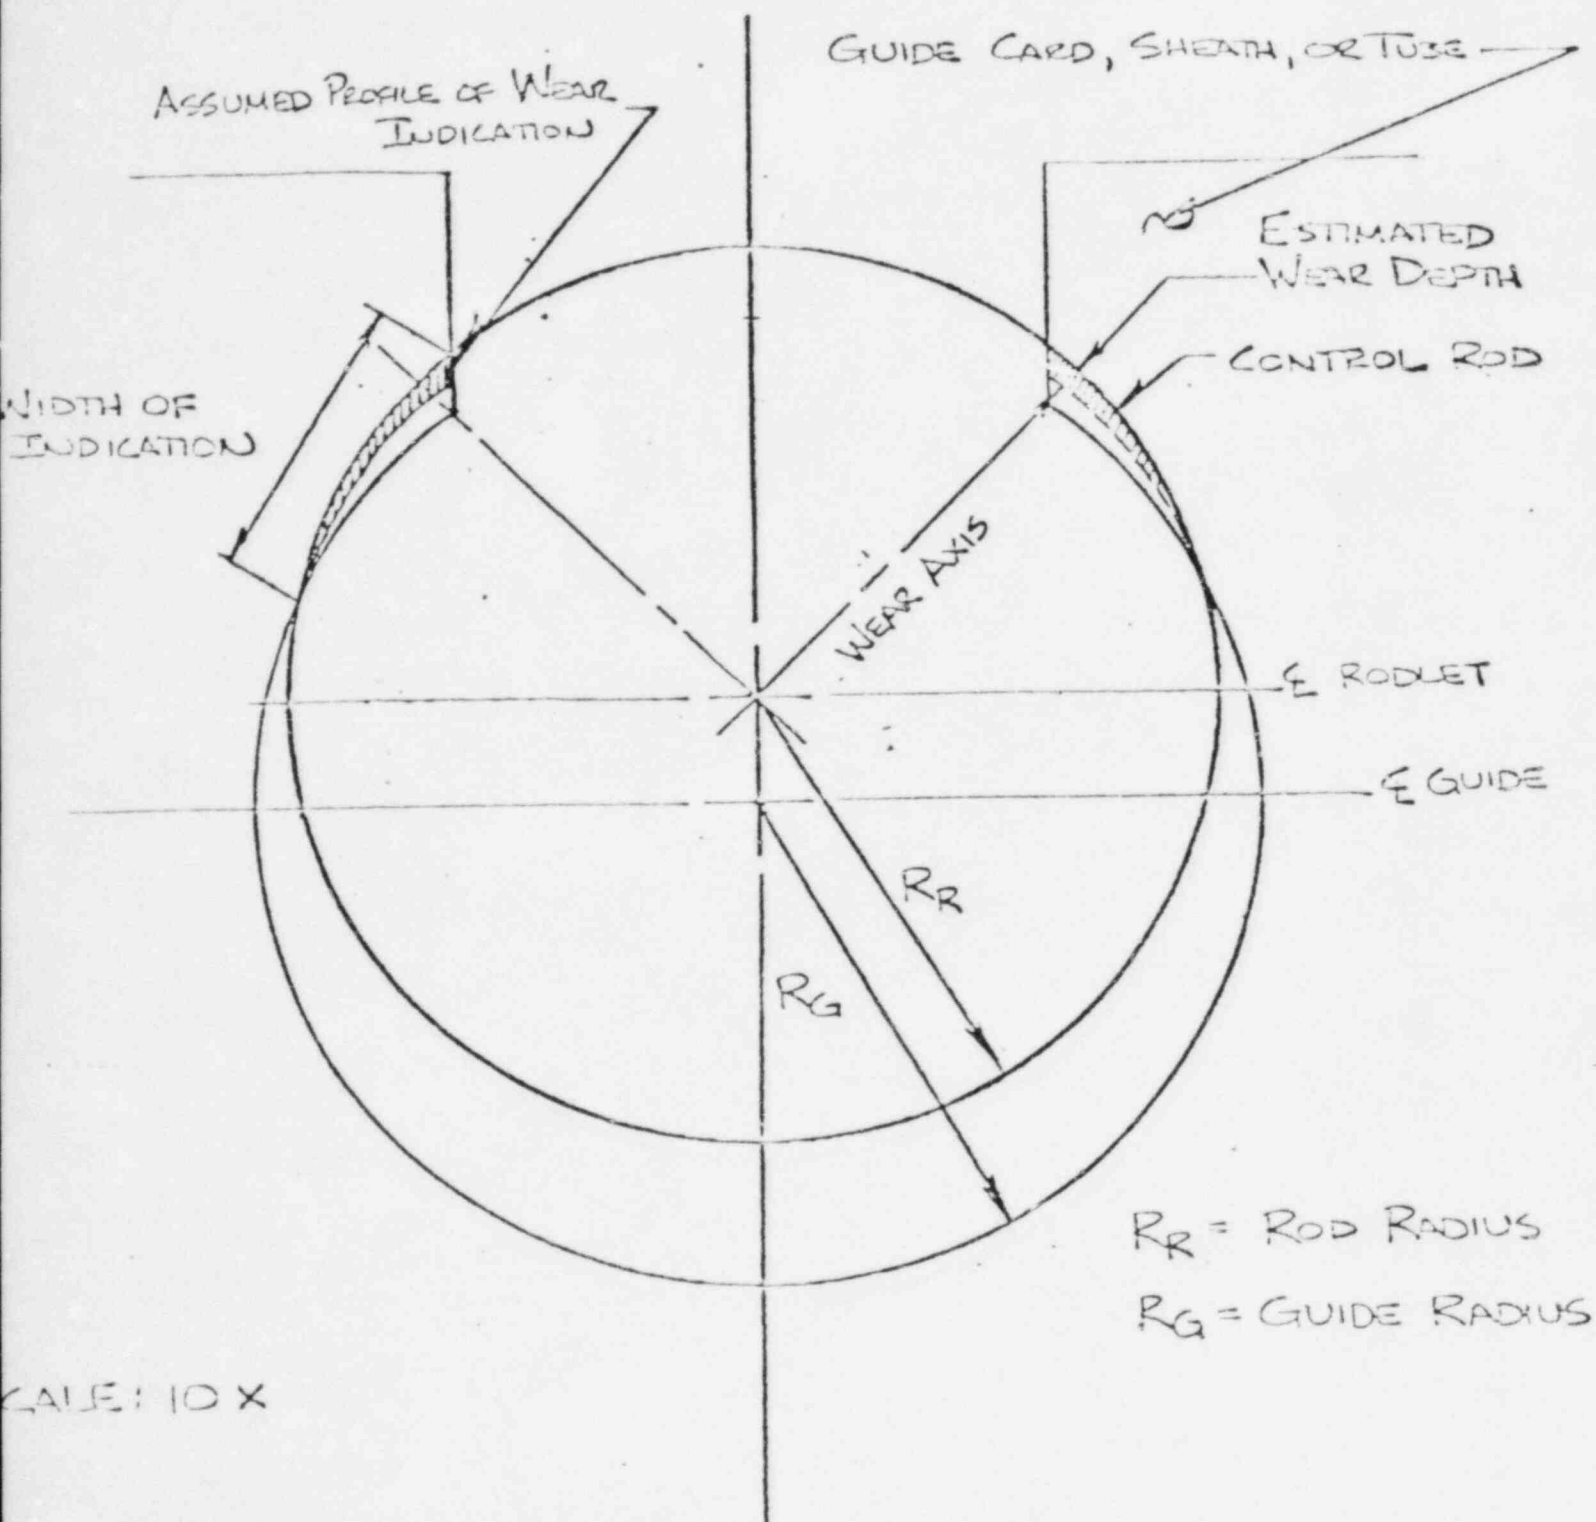
FIGURE 2

"CONTROL RODLET/GUIDE TUBE INTERFACE"
