FERMI 2 TURBINE FAILURE

POST EVENT EARTHQUAKE PASSIVE INSTRUMENTATION DATA EVALUATION

Prepared for: Detroit Edison Company
Enrico Fermi 2 Job Site
6400 North Dixie Highway
Newport, MI 48166

August 1994

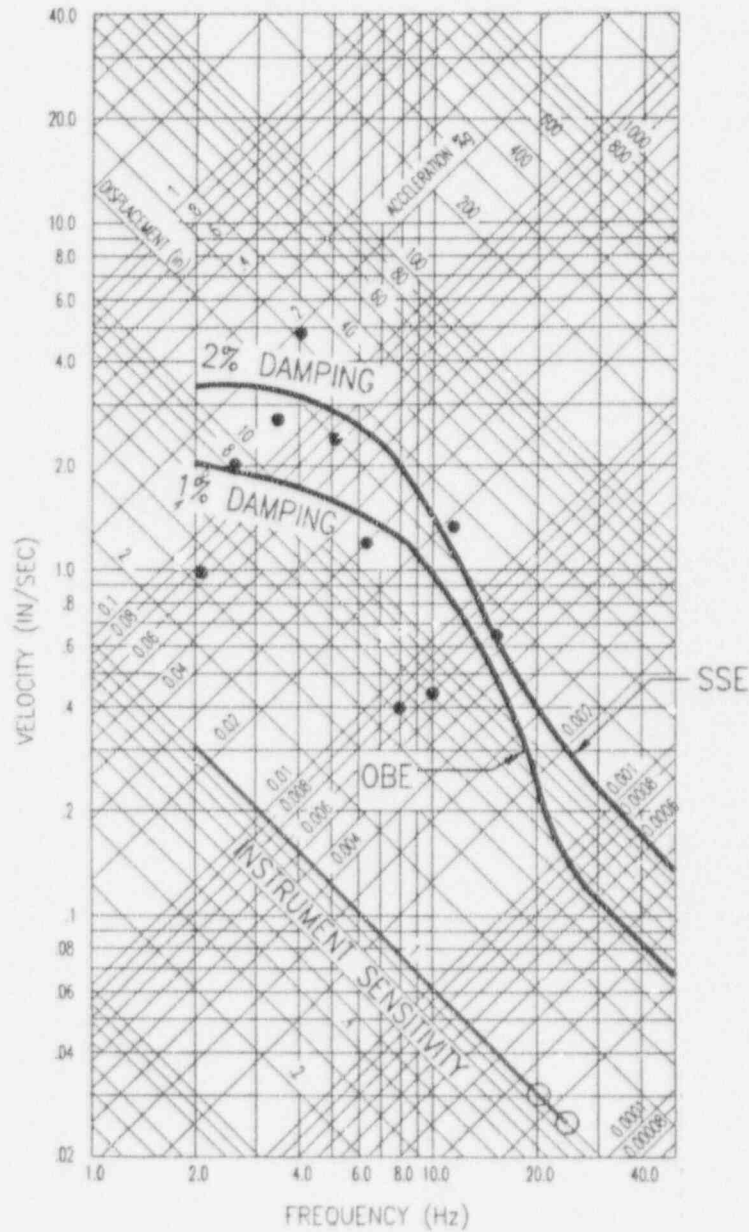
Figure 3.2.1.1

Below the second floor, the passive instrumentation exhibits OBE exceedences in the HPCI room. However, no anomalies were observed during the event, and inspections of both building and equipment after the event indicates there to be no apparent problems. Artificial time-histories developed to result in the passive instrumentation recorded response spectra exhibit those characteristics that would be anticipated from a surface wave system emanating from an impact at an adjacent surface location. These waves locally pass through the structural foundation with the path of the particle motion theoretically describing a single retrograde ellipse. They possess none of the energy characteristics of tectonic earthquake waves and do not result in the global structural excitation experienced during a traditional seismic event.

D30-N005 Passive Instrumentation, Vertical Response Spectra - HPCI Room

Below the second floor in the foundation, the building and equipment experienced local OBE and SSE exceedences recorded by the passive sensors located at the HPCI room sub-basement.

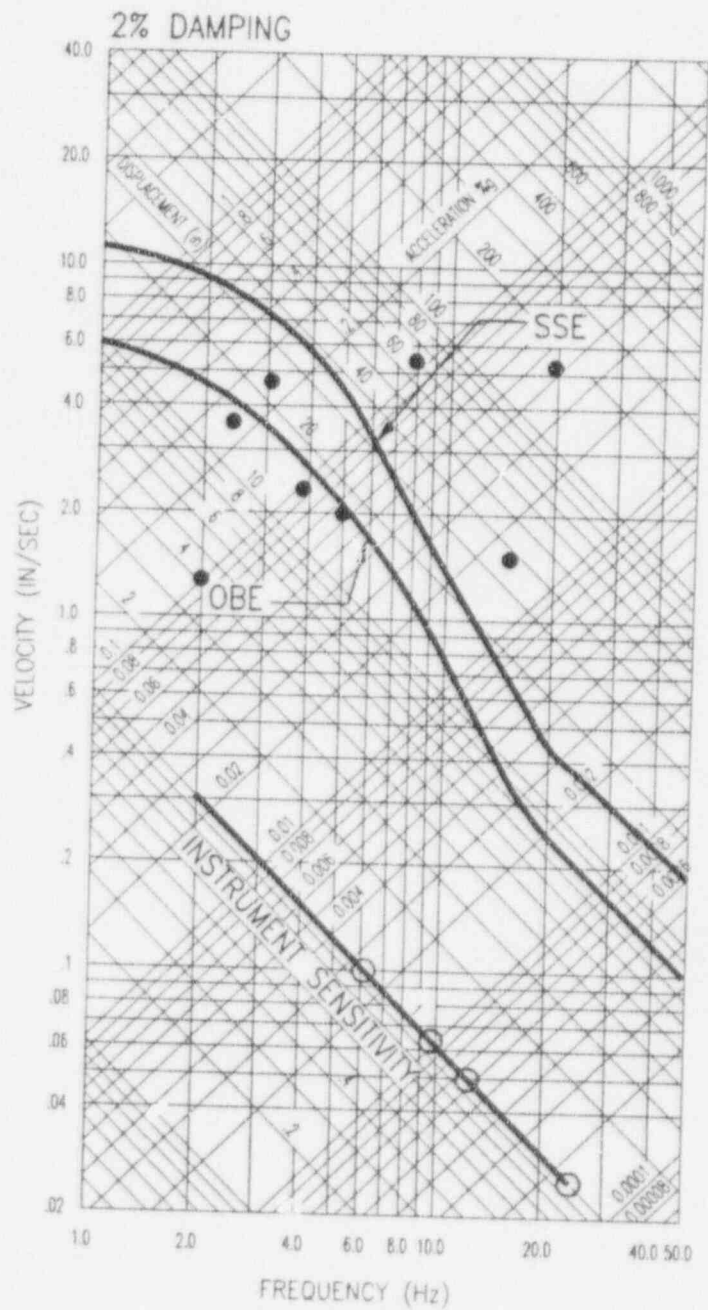
Figure 3.2.1.3

D30-N005 Passive Instrumentation, East/West Response Spectra - HPCI Room

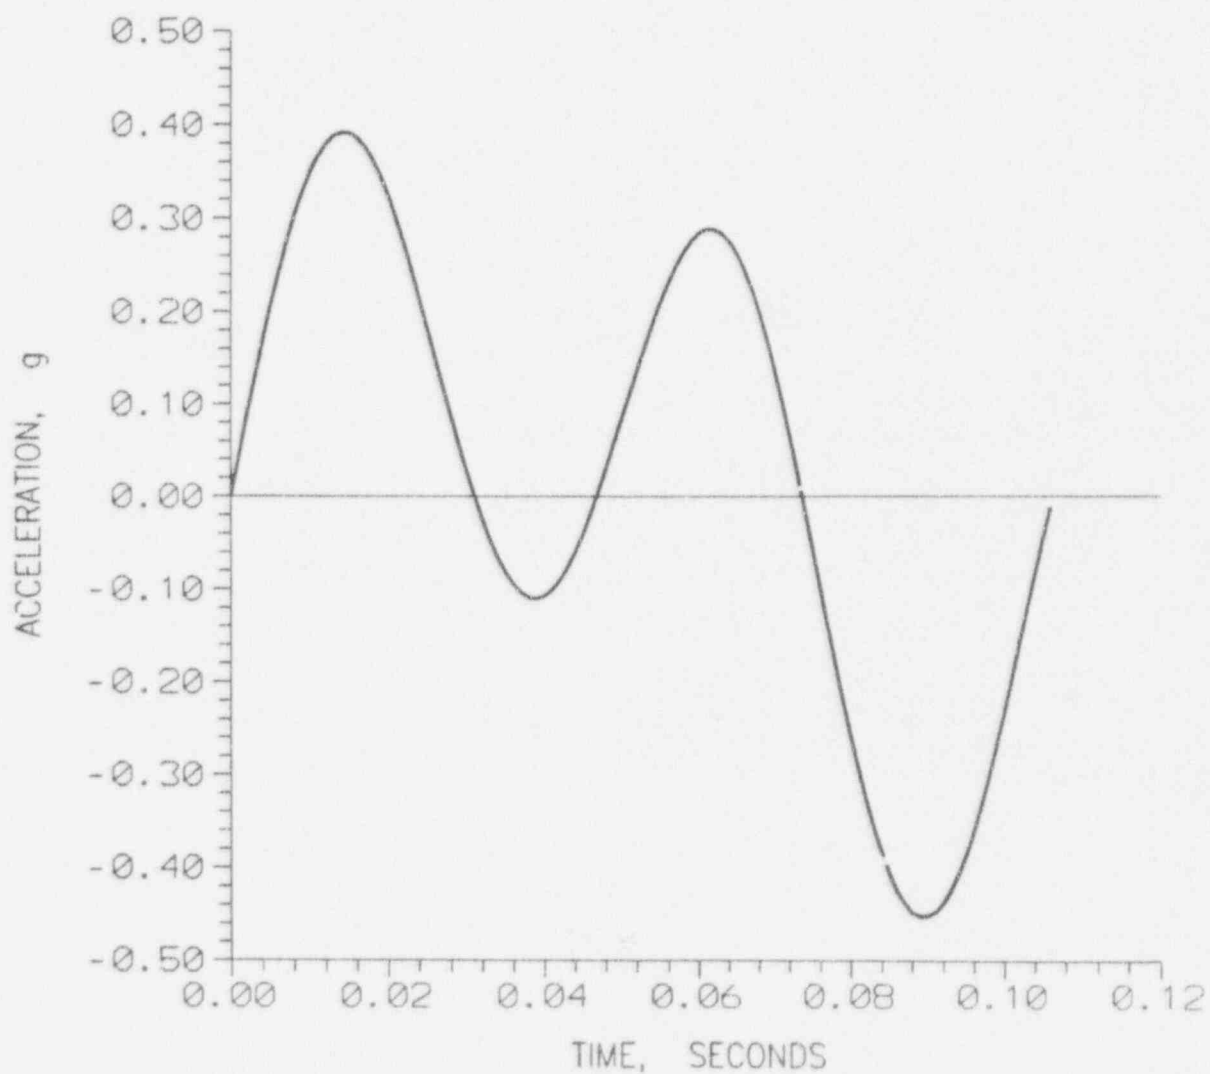
Figure 3.2.2.1

The horizontal east/west direction response spectra produced a time-history which is representative of an impulse excitation. This time-history is shown in Figure 3.2.2.1. Figure 3.2.2.2 shows the measured and artificial response spectra.

The artificial time-histories are similar to shock incident time-histories, as evidenced by the short duration and high accelerations. The time-histories, in conjunction with the event observations, research, and subsequent walkdowns, suggest the turbine failure event was an impulse type shock incident with low energy and short duration, unlike an earthquake which imparts high energy into the structures and is of relatively long duration.

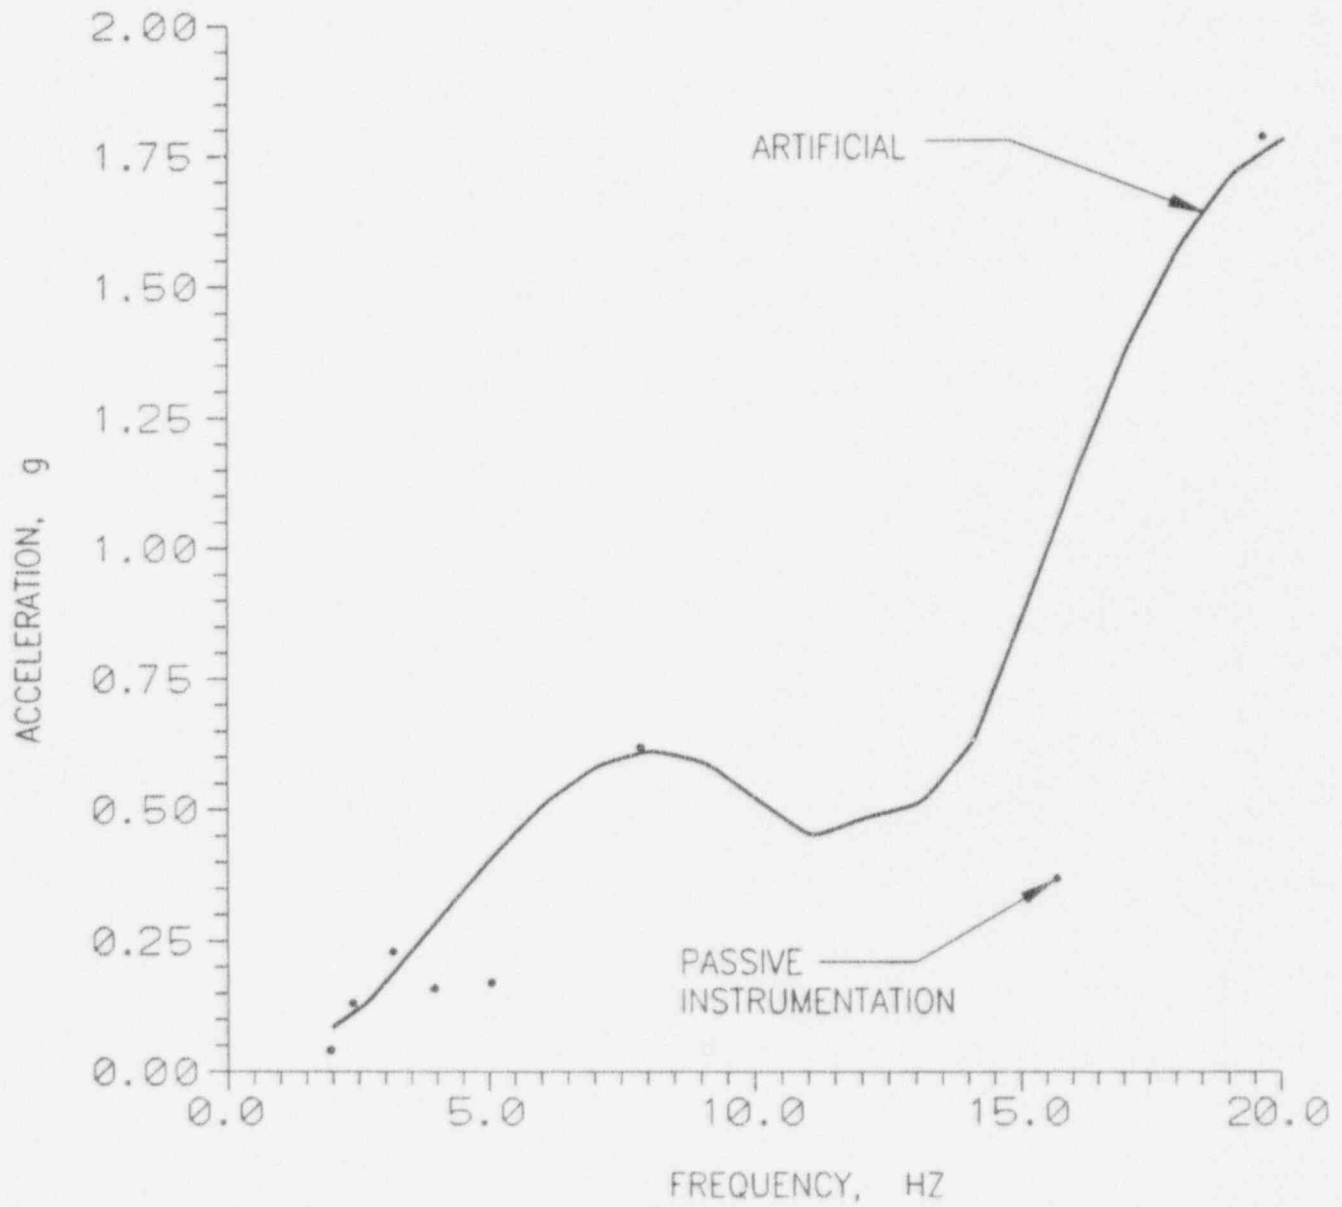
Figure 3.2.2.2

The measured and artificial response spectra compare favorably. The artificial response spectra for the east/west direction very nearly matches the measured response spectra, while the artificial response spectra for the vertical direction essentially envelopes the measured response. The data point at 4 cps falls outside the artificial response spectra, and may be attributed to the rumbling felt throughout the buildings.

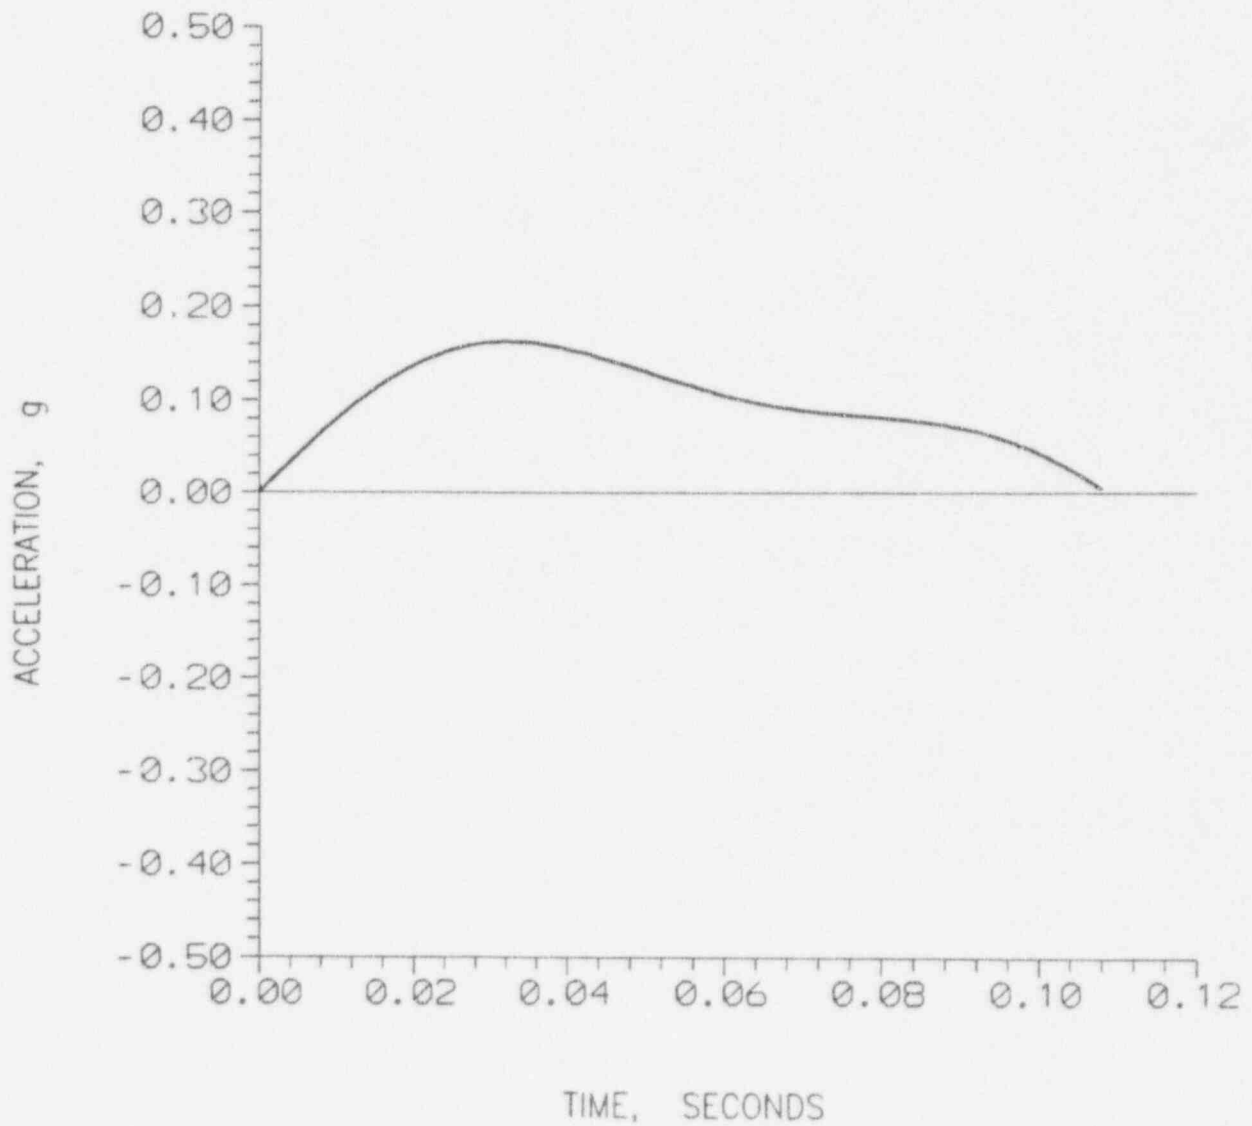
Figure 3.2.2.3

From the east/west artificial time-history, the vertical artificial time-history was generated based on typical Rayleigh wave characteristics and theory. The time-history is shown in Figure 3.2.2.3. Figure 3.2.2.4 shows the measured and artificial response spectra.

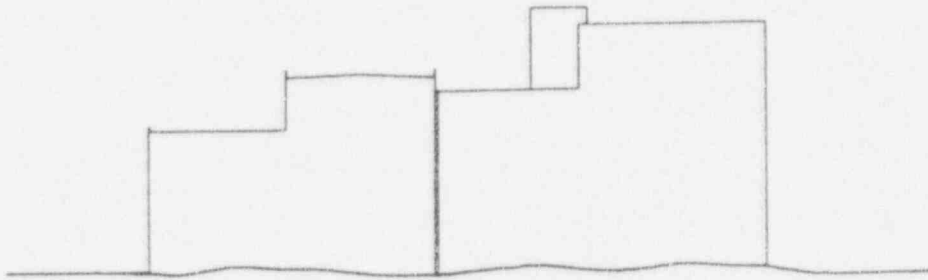
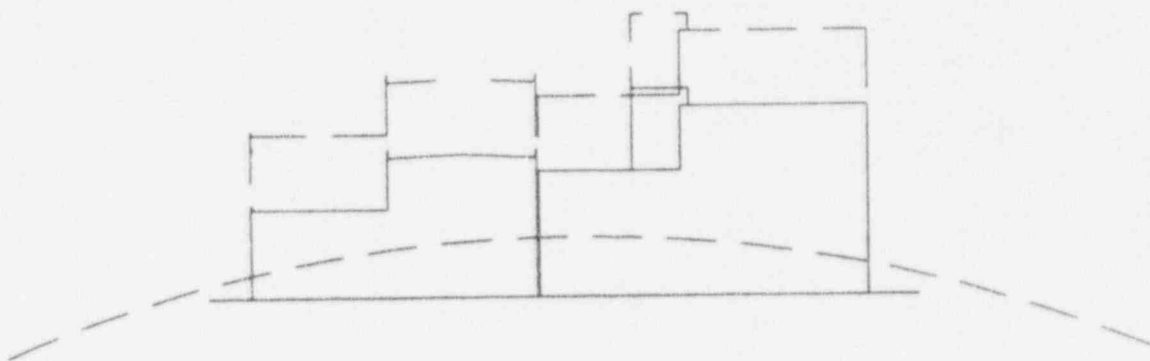
Figure 4.0.1

The turbine failure at Fermi 2 on December 25, 1993, should not be compared with a tectonic earthquake, and globally, the Reactor/Auxiliary building did not experience OBE excitation levels. The turbine failure was a shock incident, resulting in dynamic response phenomena of a wave propagating through the building foundation without exciting the structure above.

The ratio of the shock wave length resulting from the turbine event at Fermi 2 and the building length is much less than the corresponding ratio of an earthquake wave length and the building wave length (Figure 4.0.1). While the shock incident produced local high accelerations, the short duration, low energy, and small deformations associated with these high frequency accelerations did not compromise the structural integrity of the Reactor/Auxiliary building or the equipment therein.
