NUCLEAR GENERATION MEMORANDUM

Subject: Final Report-Structural Walkdown

STRUCTURAL WALKDOWN

FINAL REPORT

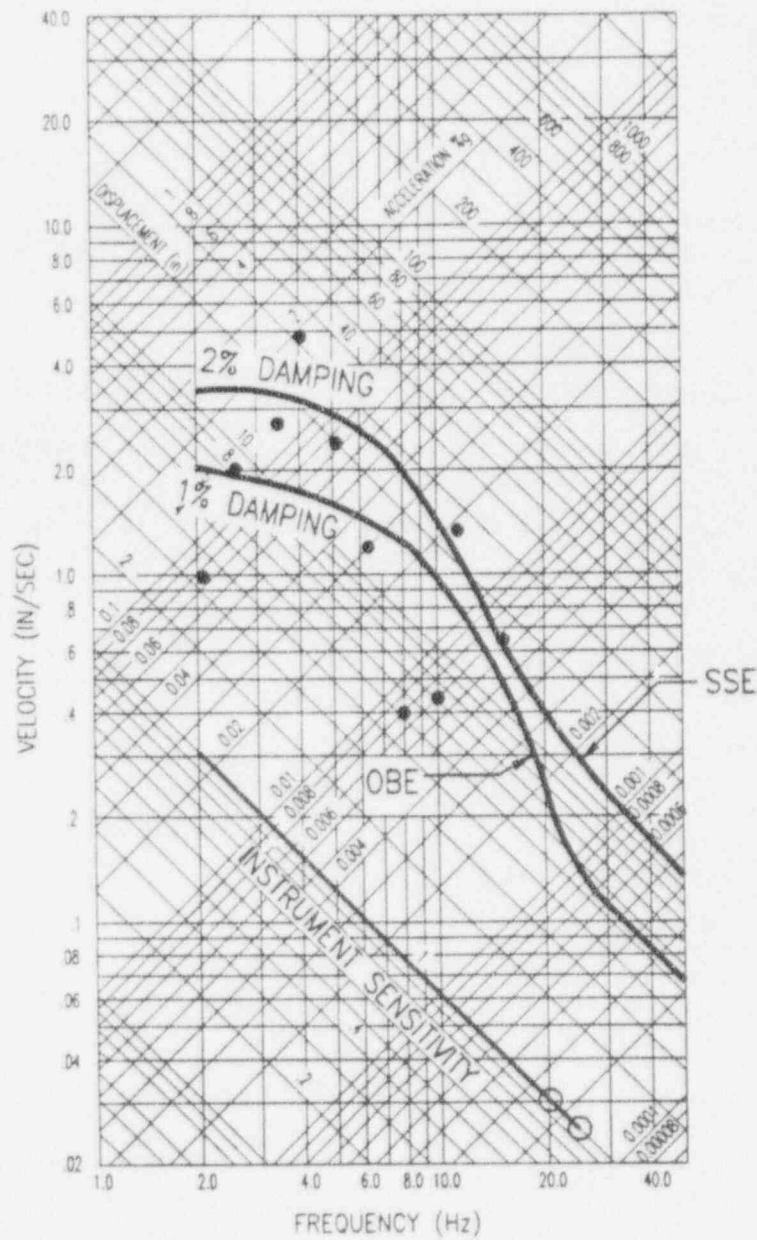
Figure 3.2.1.1

D30-N005 Passive Instrumentation, Vertical Response Spectra - HPCI Room

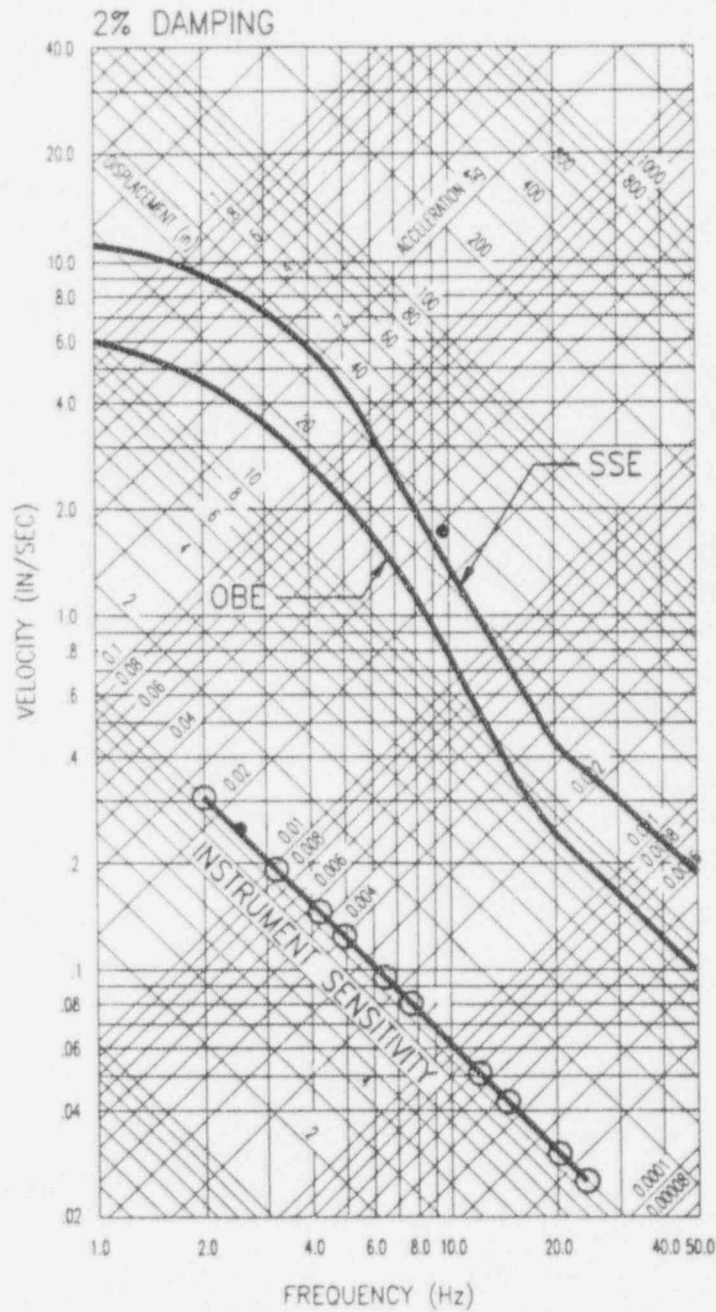
Figure 3.2.1.2

D30-N005 Passive Instrumentation, North/South Response Spectra - HPCI Room

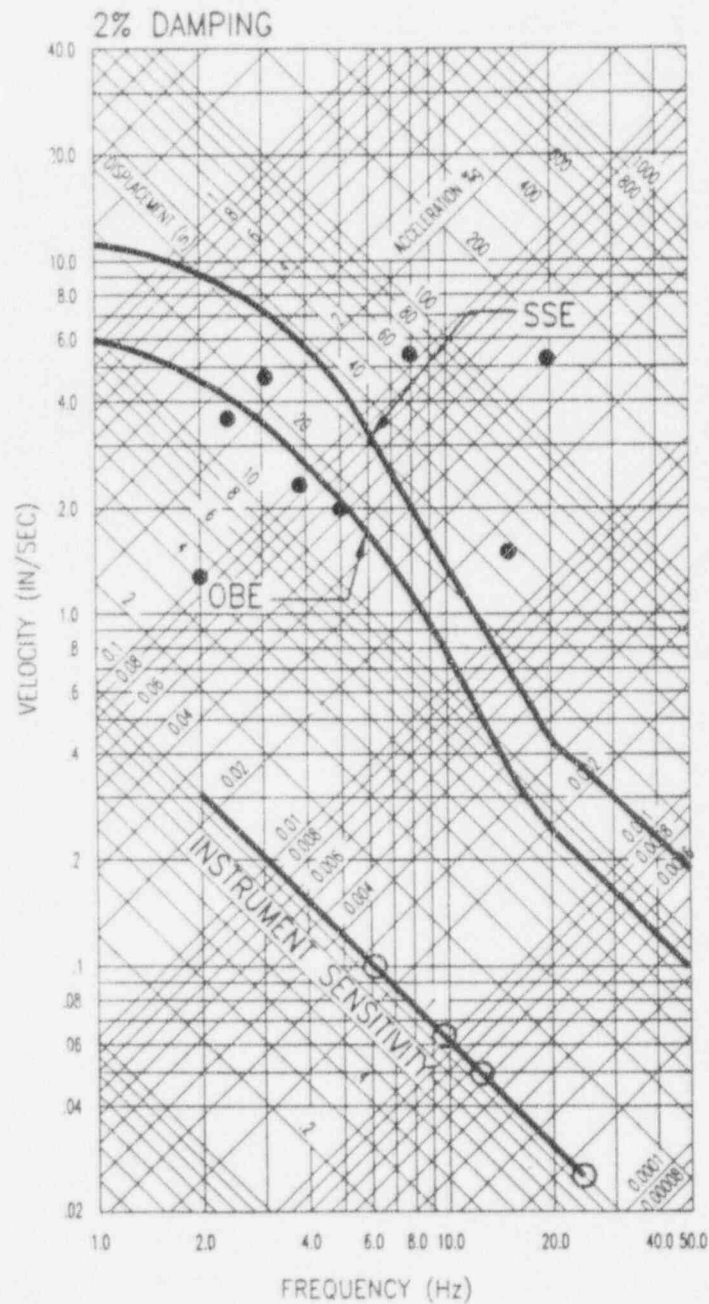
Figure 3.2.1.3

D30-N005 Passive Instrumentation, East/West Response Spectra - HPCI Room

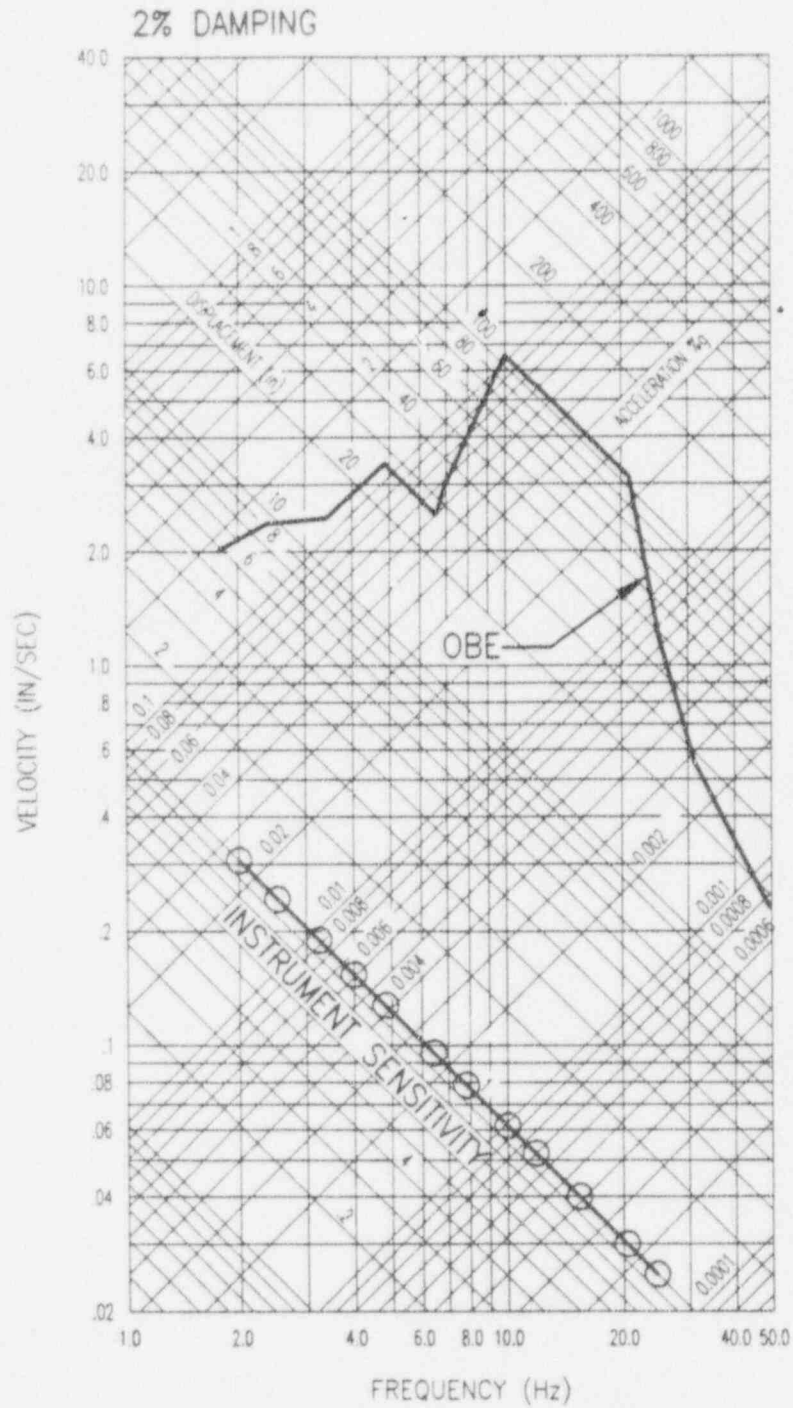
Figure 3.2.1.4

D30-N601 Passive instrumentation, Vertical Response Spectra - Second Floor

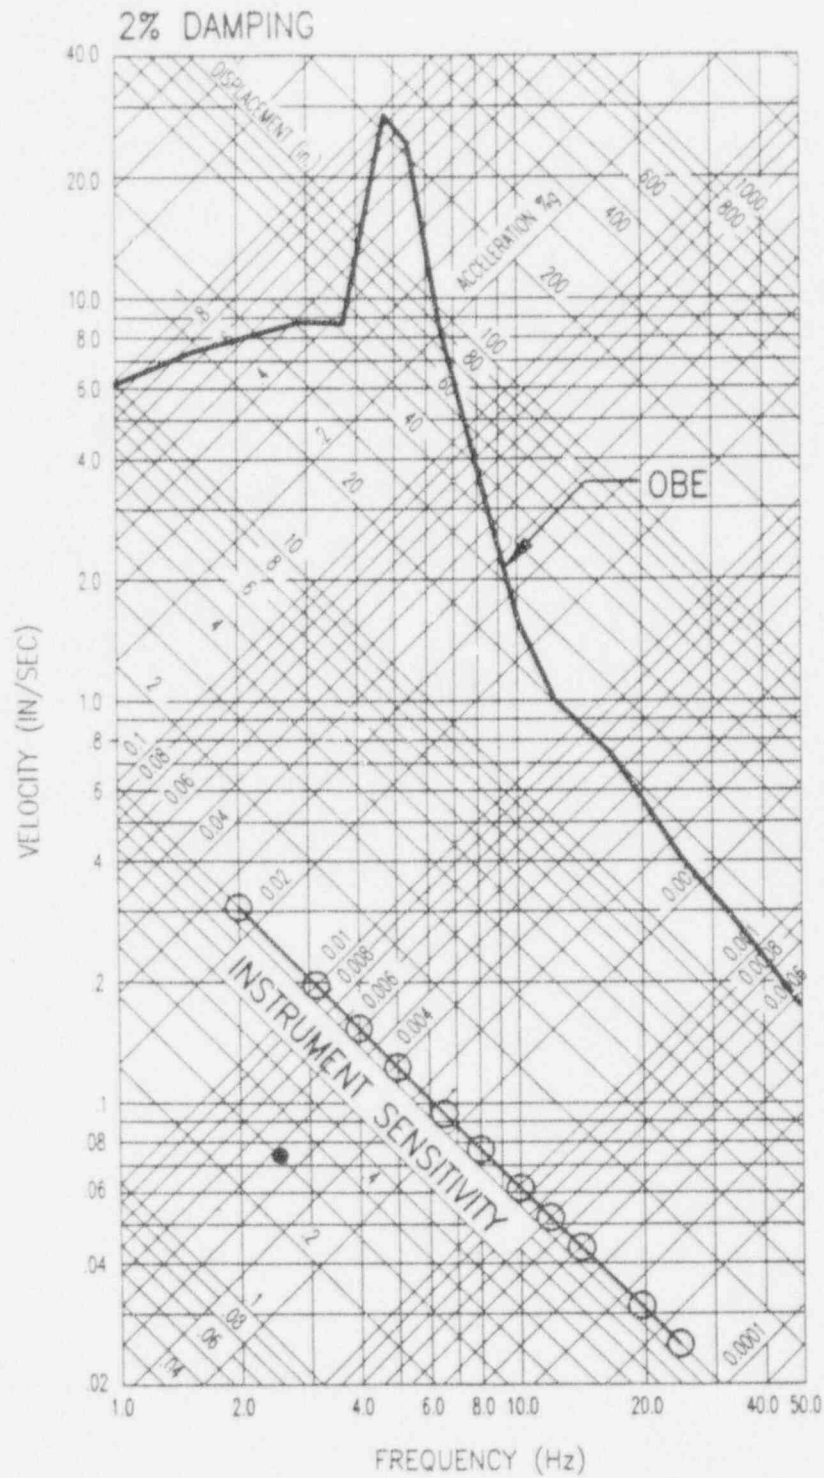
Figure 3.2.1.5

D30-N601 Passive Instrumentation, North/South Response Spectra - Second Floor

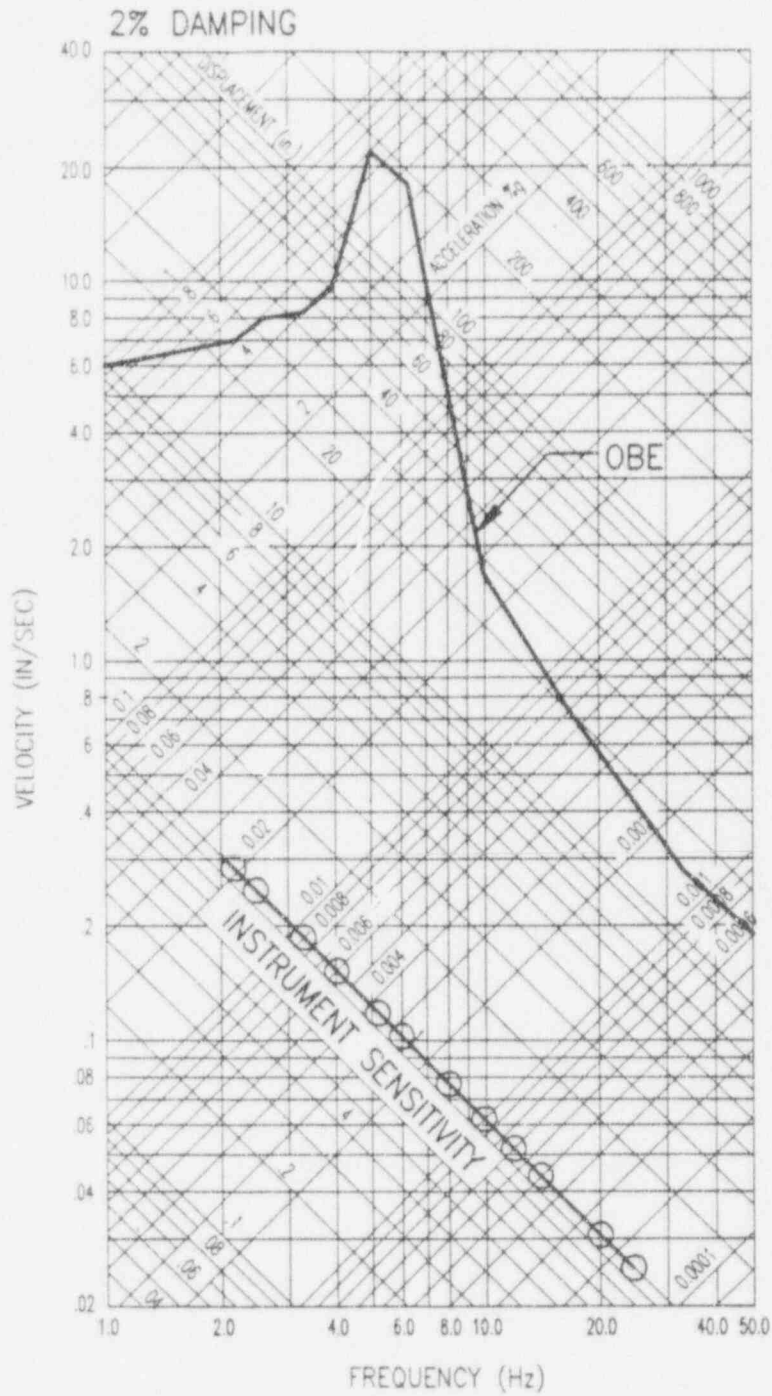
Figure 3.2.1.6

D30-N601 Passive Instrumentation, East/West Response Spectra - Second Floor

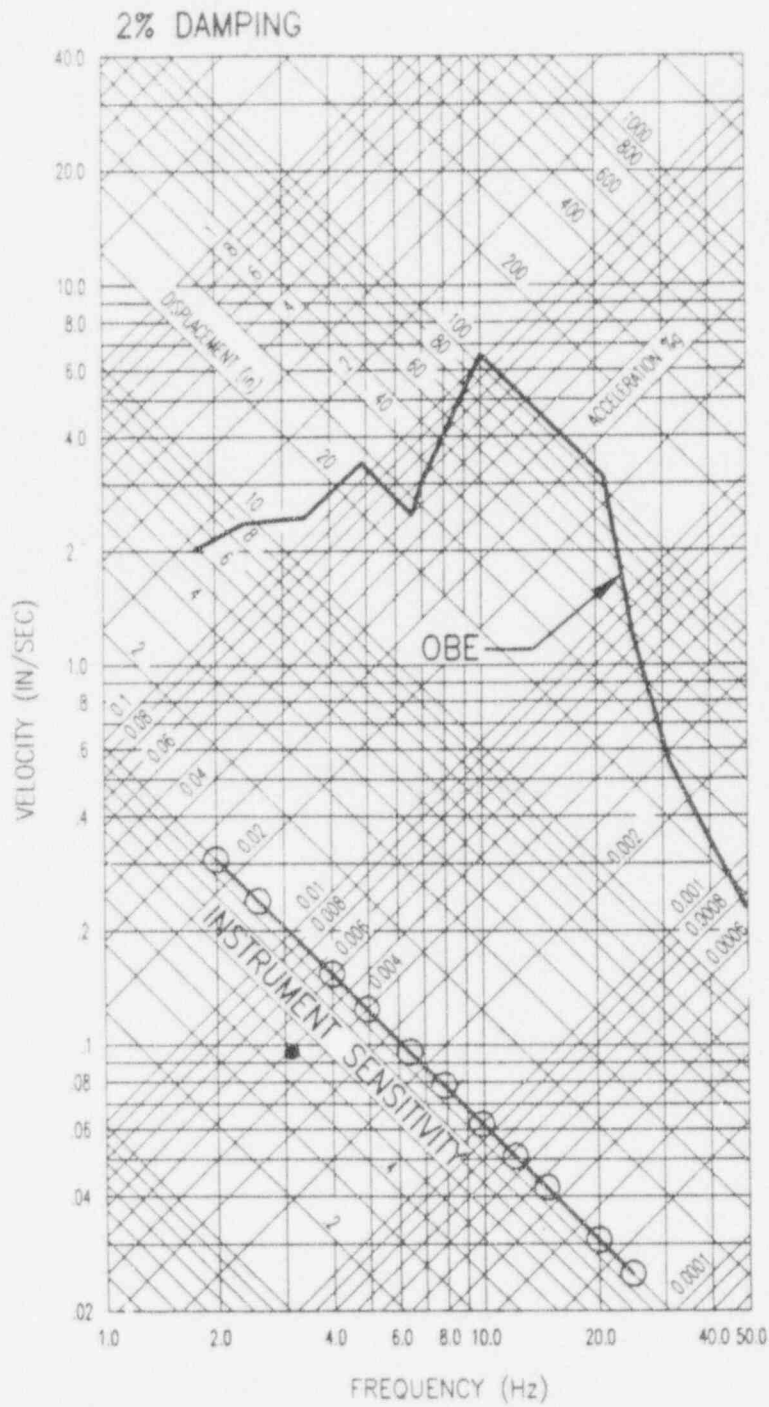
Figure 3.2.1.7

D30-N006 Passive Instrumentation, Vertical Response Spectra - Fifth Floor

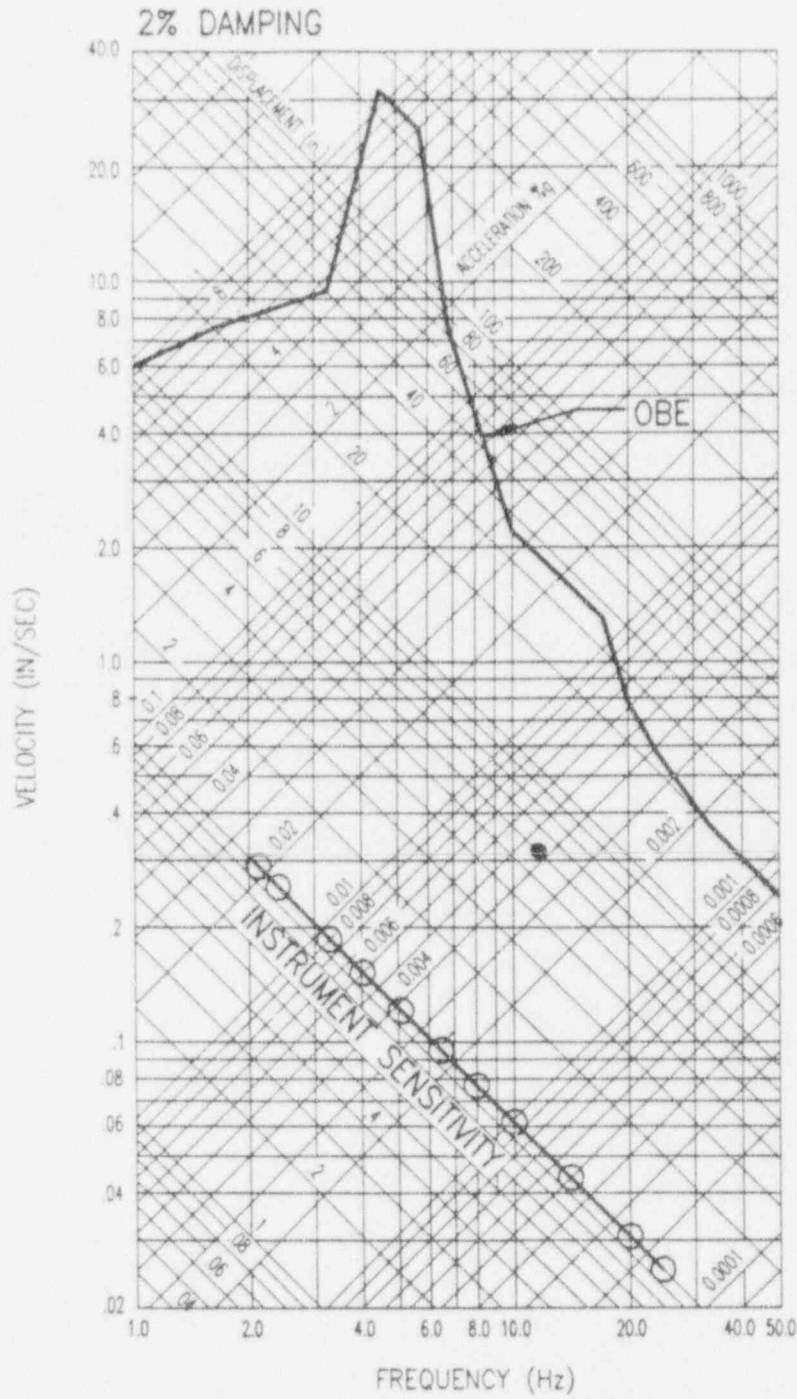
Figure 3.2.1.8

D30-N006 Passive Instrumentation, North/South Response Spectra - Fifth Floor

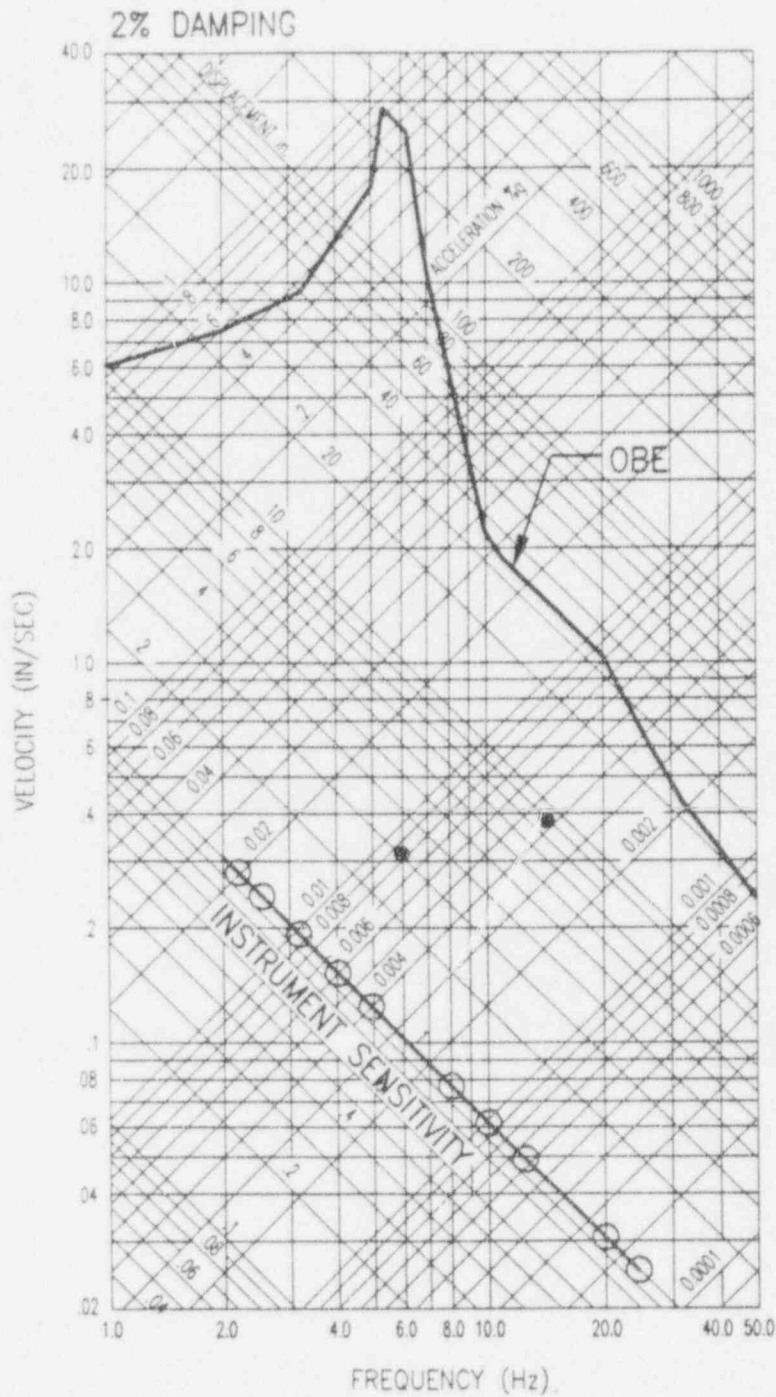
Figure 3.2.1.9

D30-N006 Passive Instrumentation, East/West Response Spectra - Fifth Floor

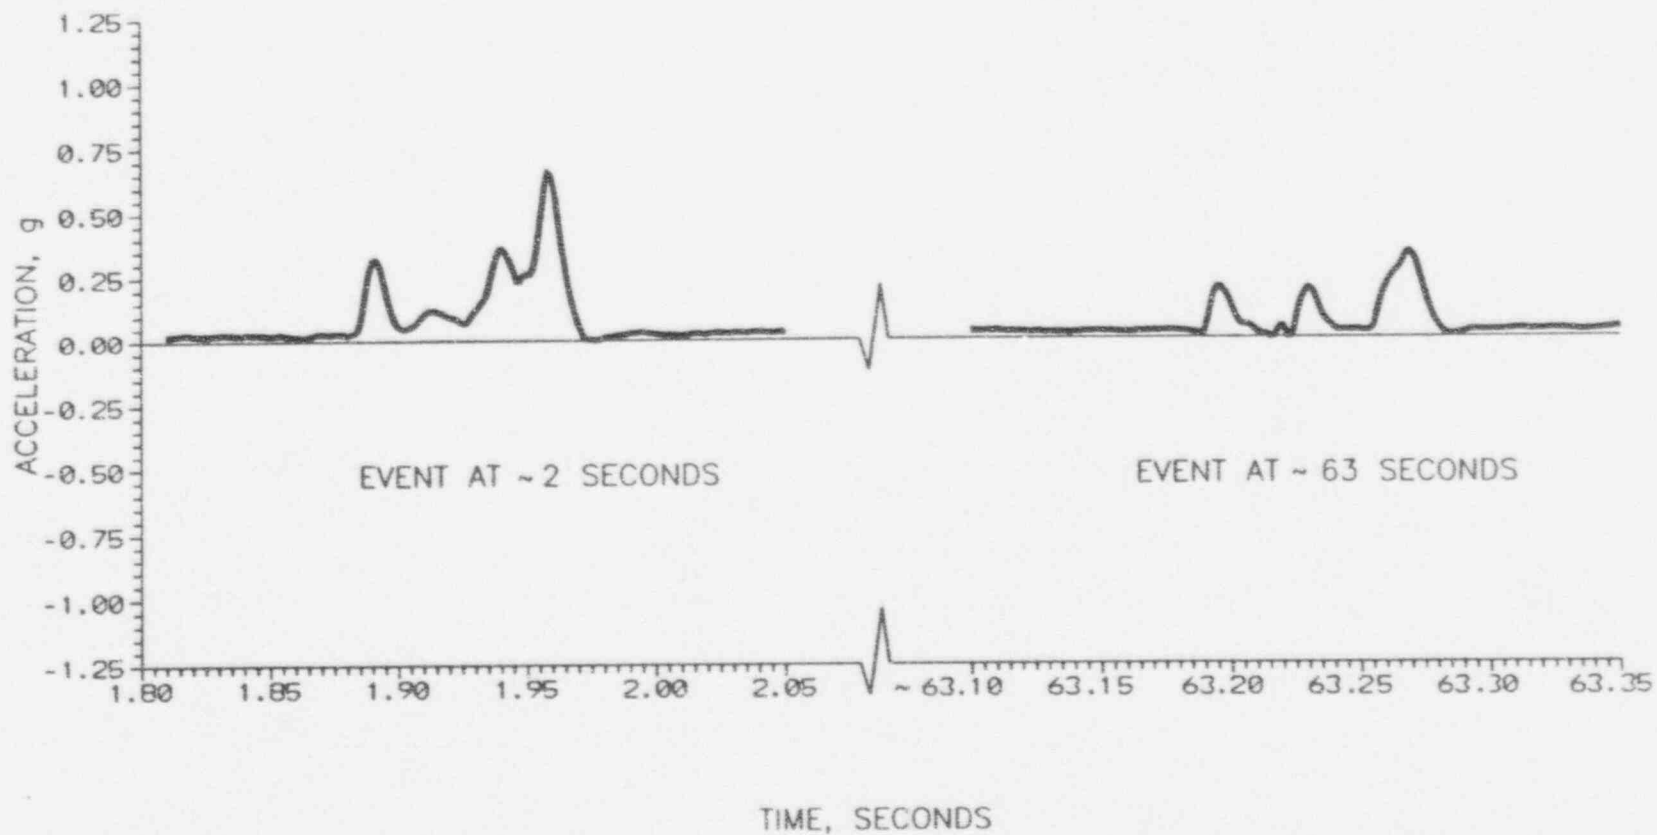
Figure 3.2.2.1

D30-N003 Accelerometer, Vertical Direction Time History - HPCI Room

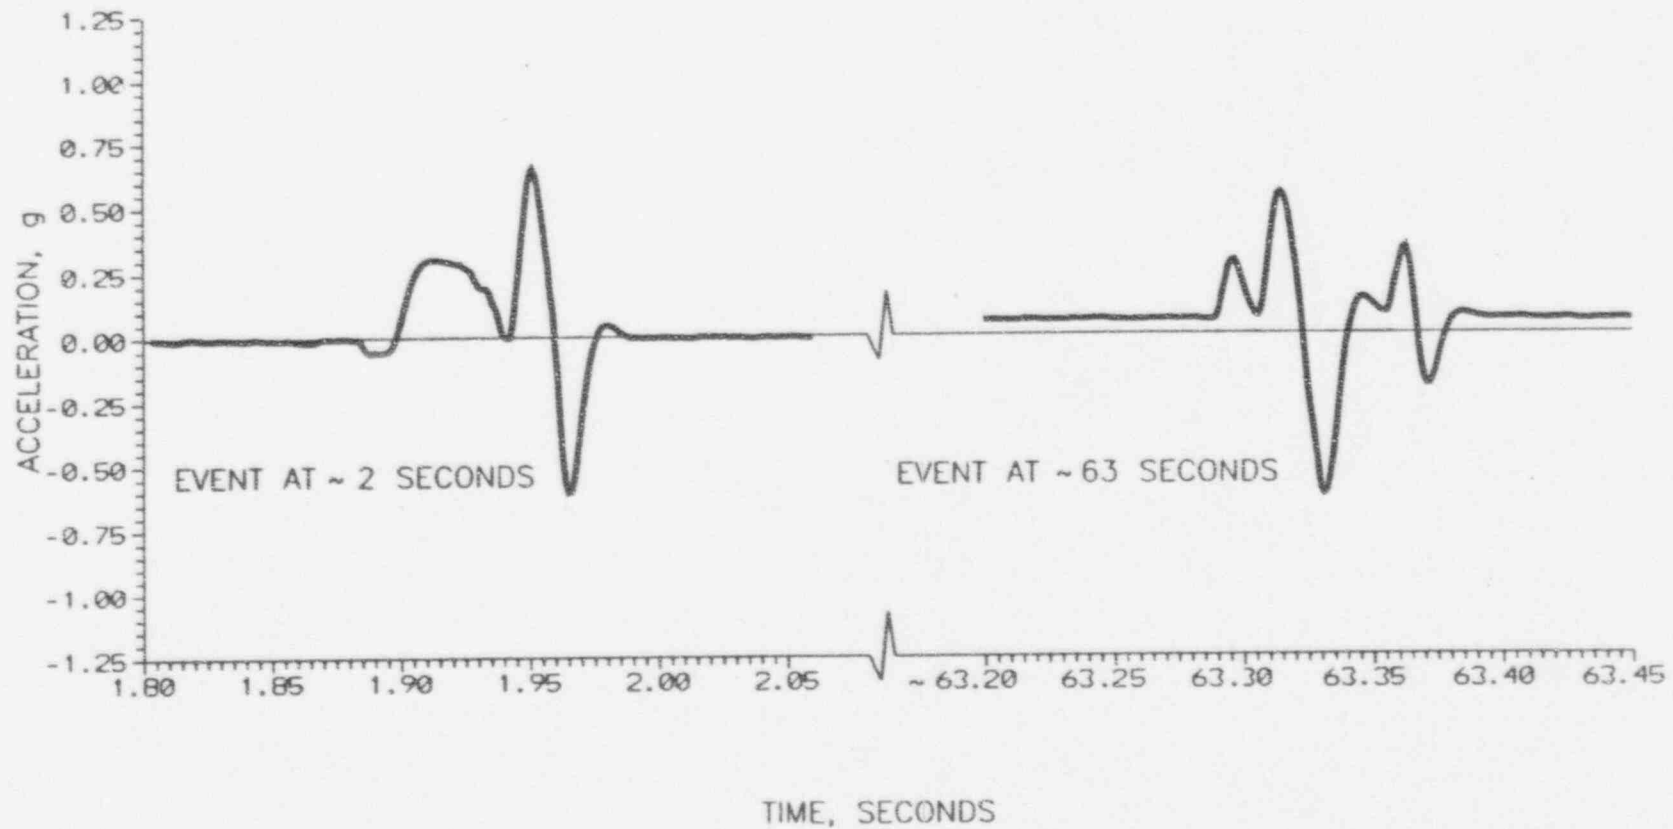
Figure 3.2.2.2

D30-N003 Accelerometer, North/South Direction Time History - HPCI Room

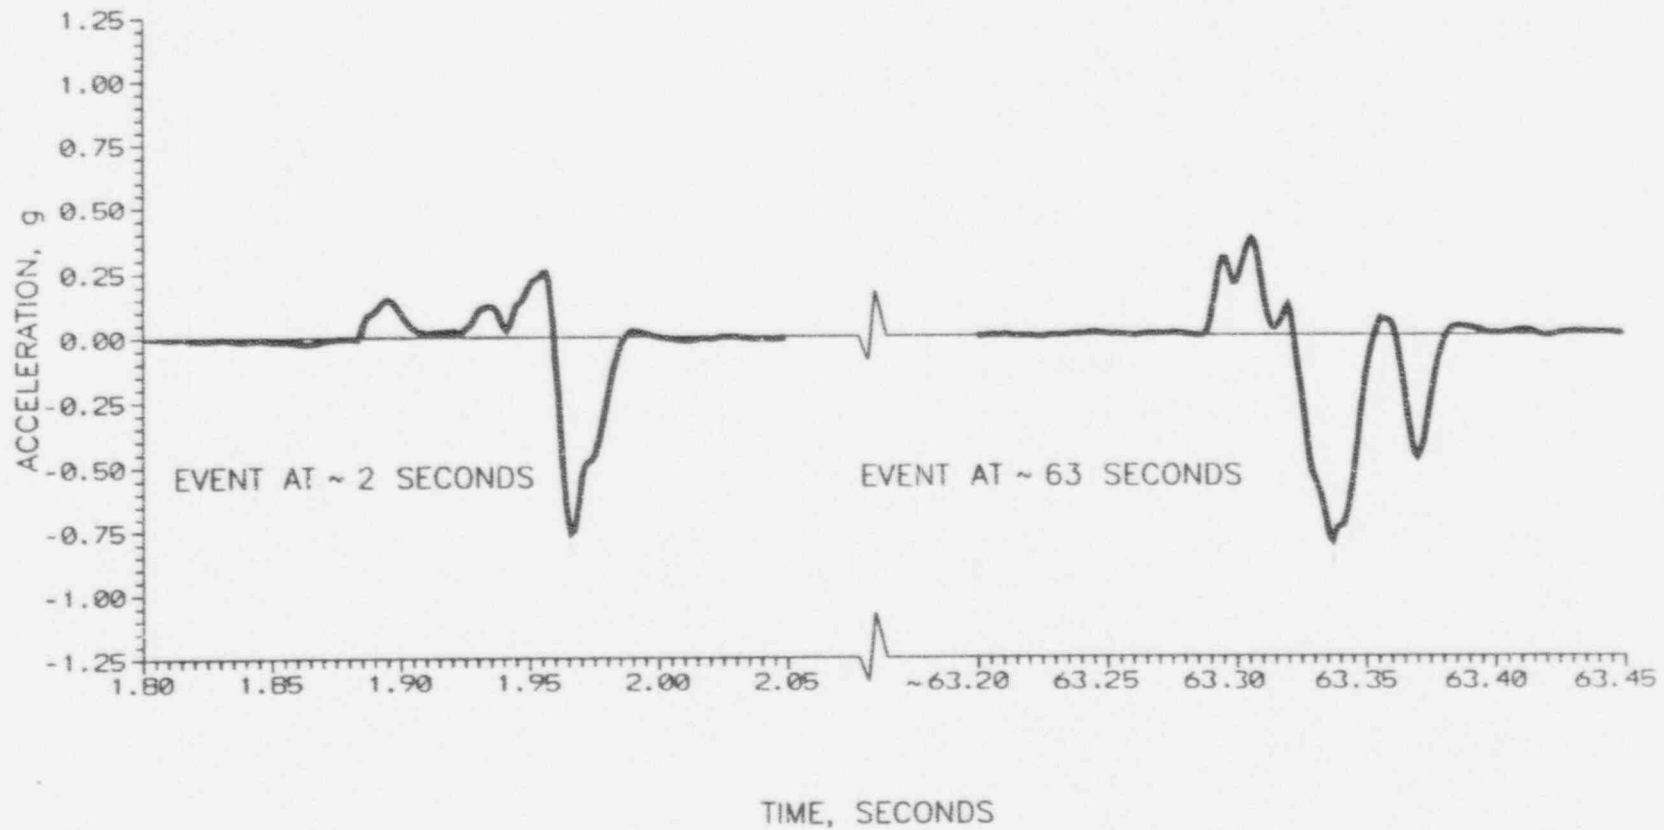
Figure 3.2.2.3

D30-N003 Accelerometer, East/West Direction Time History - HPCI Room

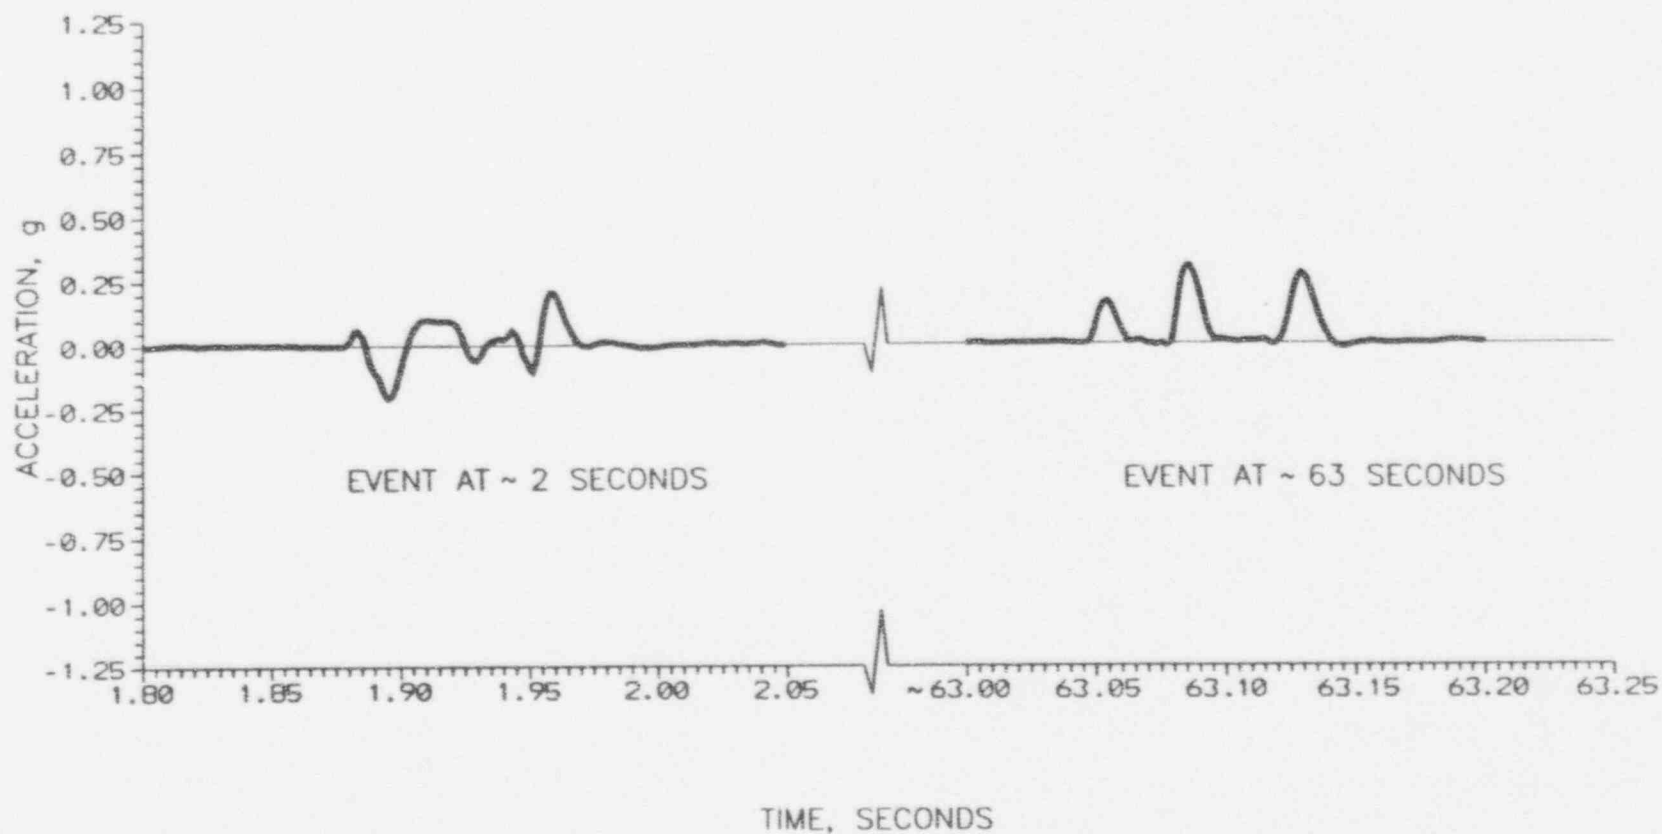
Figure 3.2.2.4

D30-N002 Accelerometer, Vertical Direction Time History - RPV Pedestal

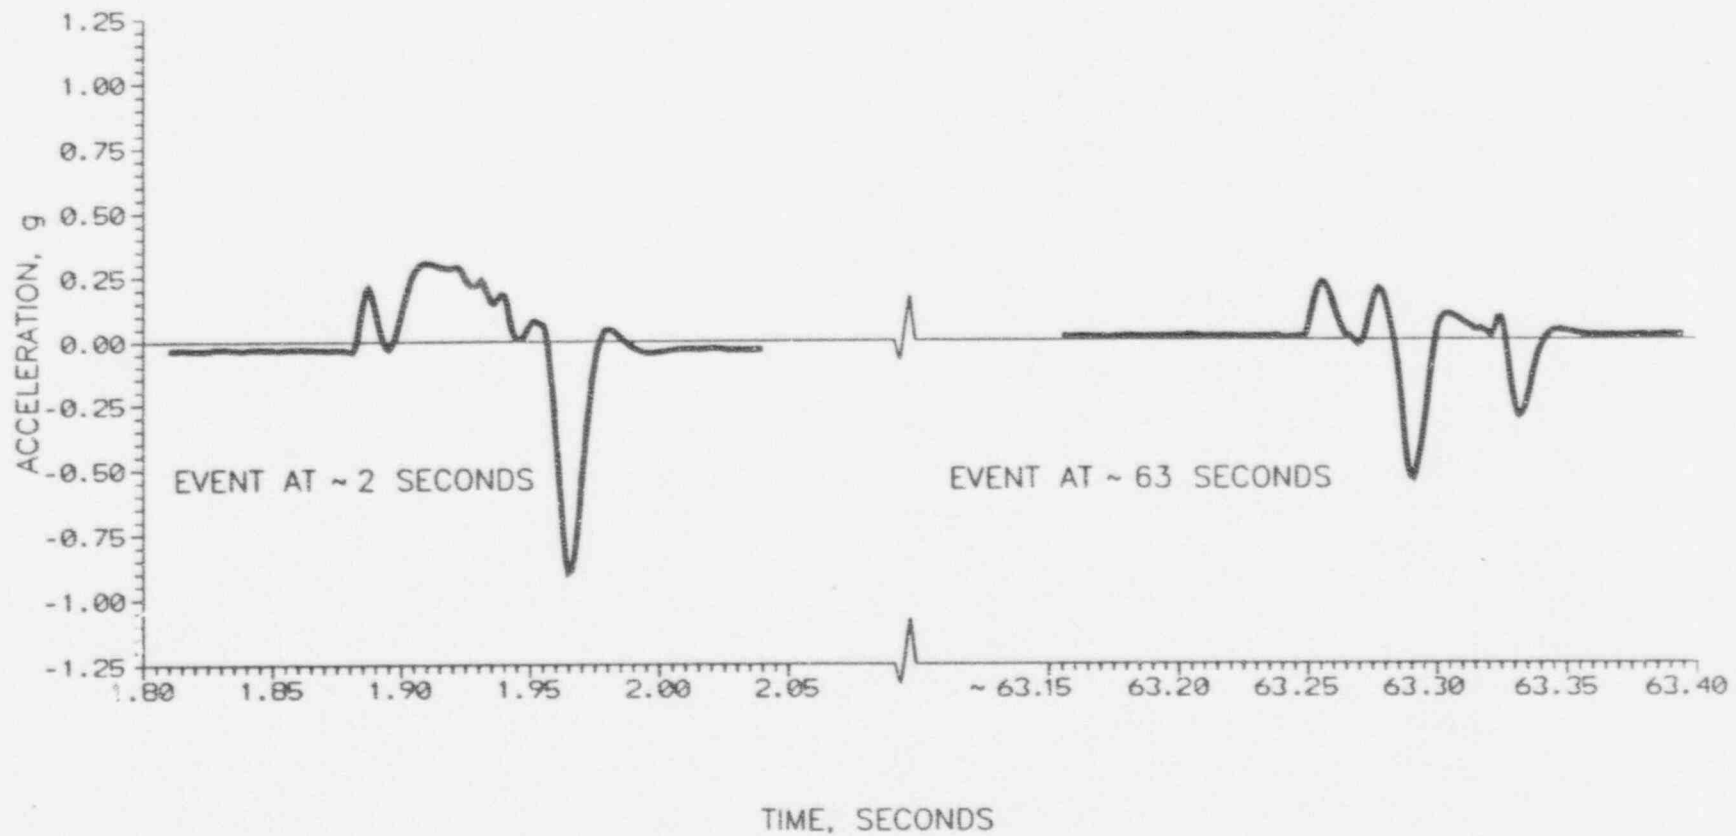
Figure 3.2.2.5

D30-N002 Accelerometer, North/South Direction Time History - RPV Pedestal

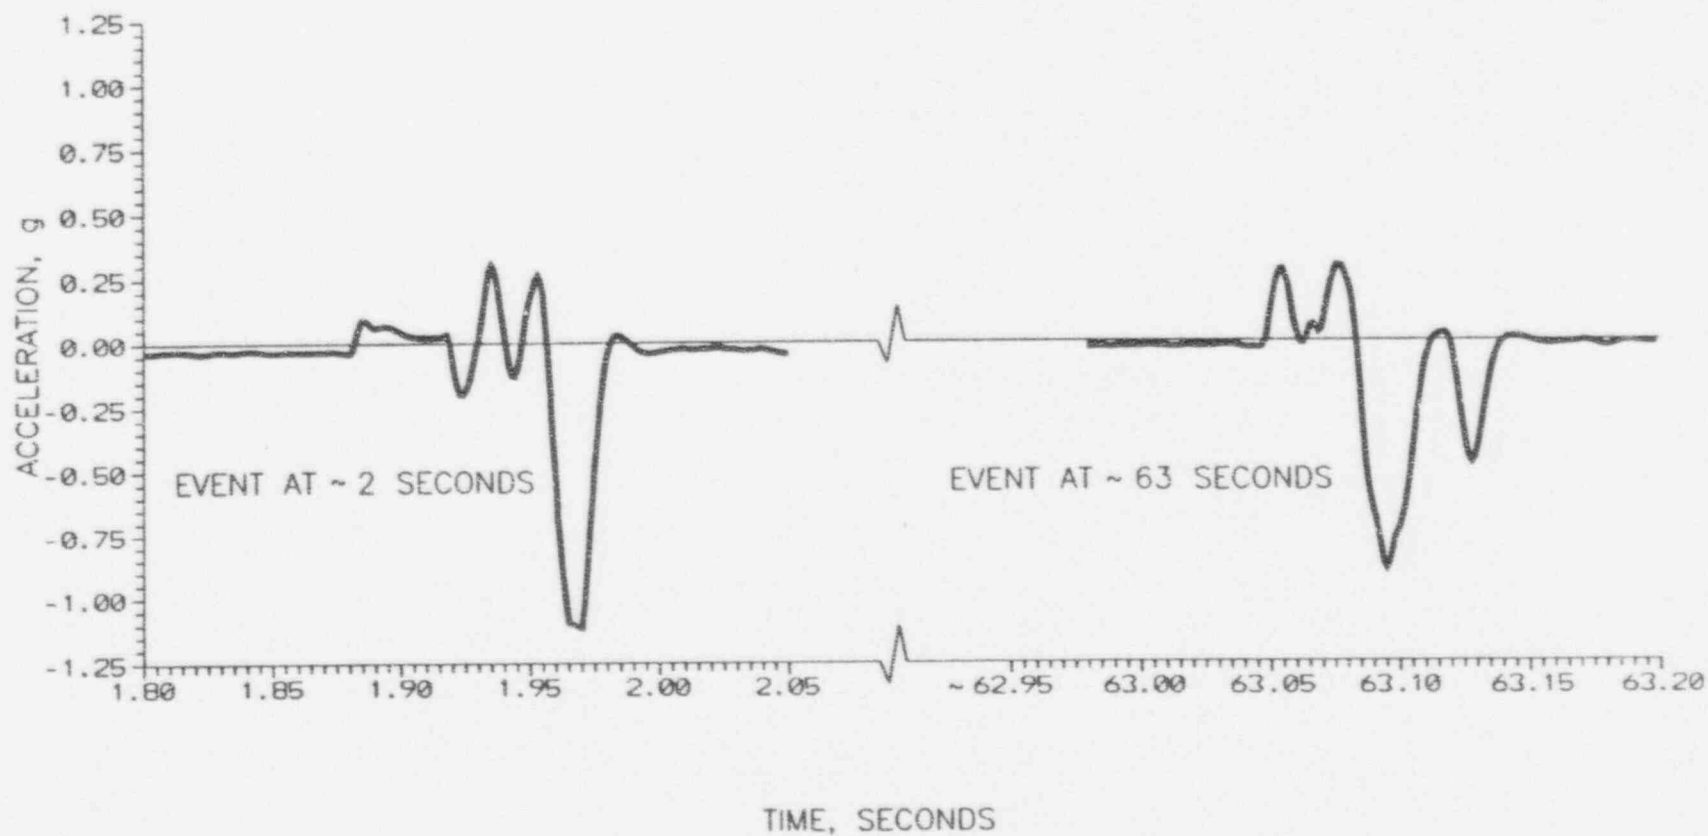
Figure 3.2.2.6

D30-N002 Accelerometer, East/West Direction Time History - RPV Pedestal

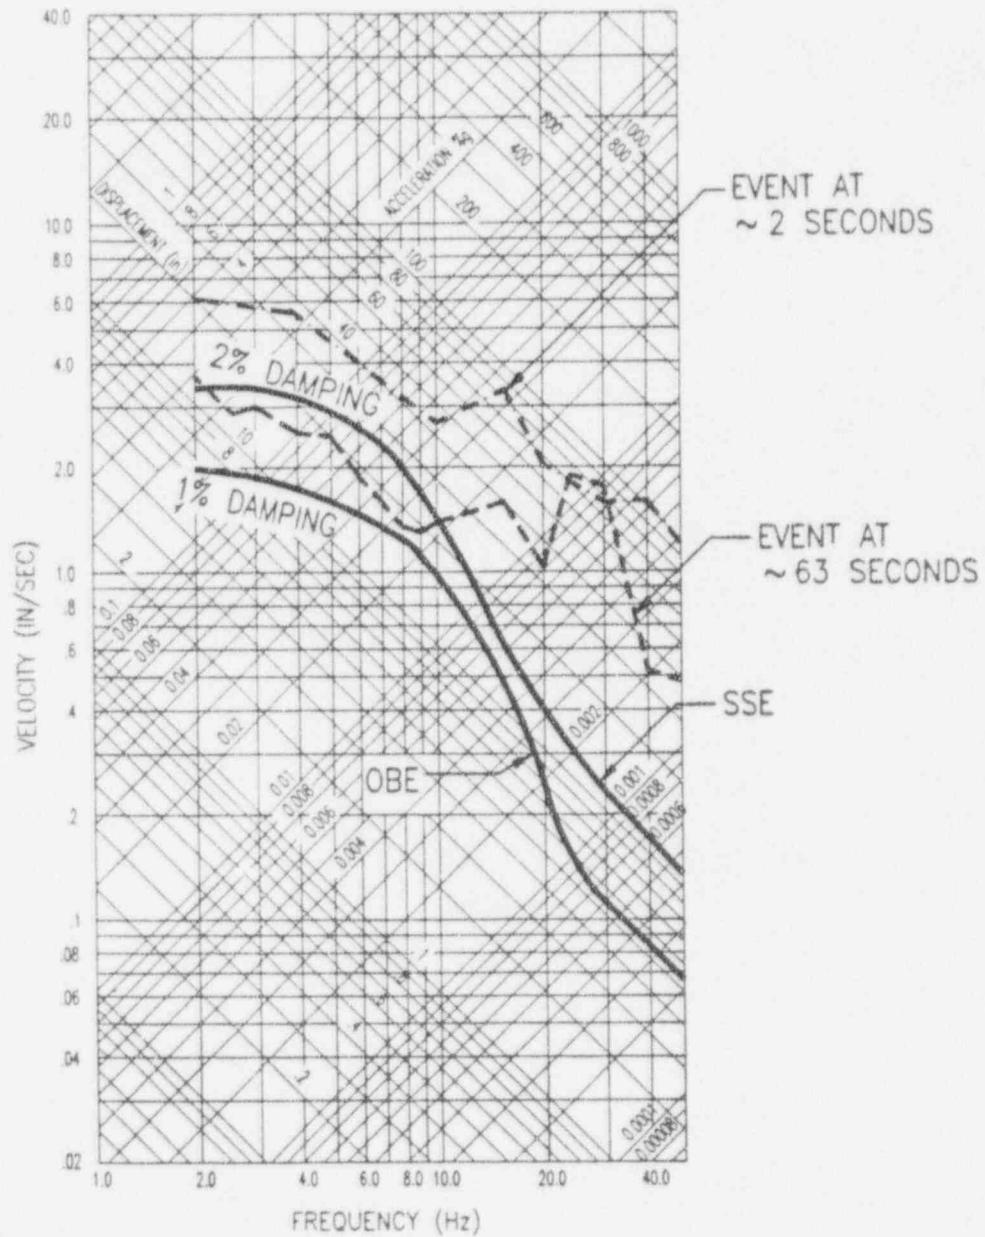
Figure 3.2.2.7

D30-N003 Accelerometer, Vertical Response Spectra - HPCI Room

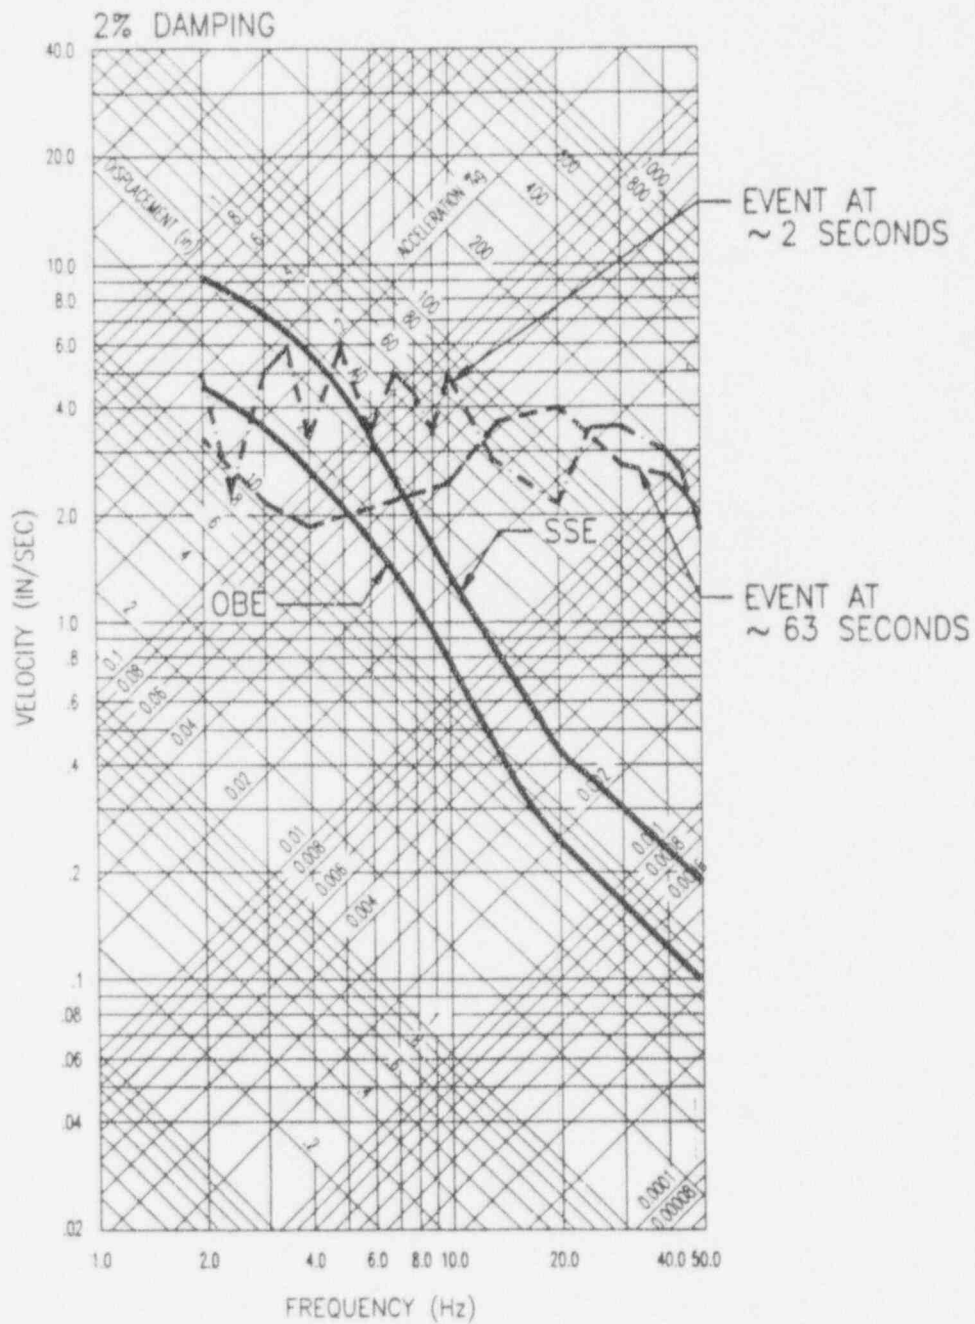
Figure 3.2.2.8

D30-N003 Accelerometer, North/South Response Spectra - HPCI Room

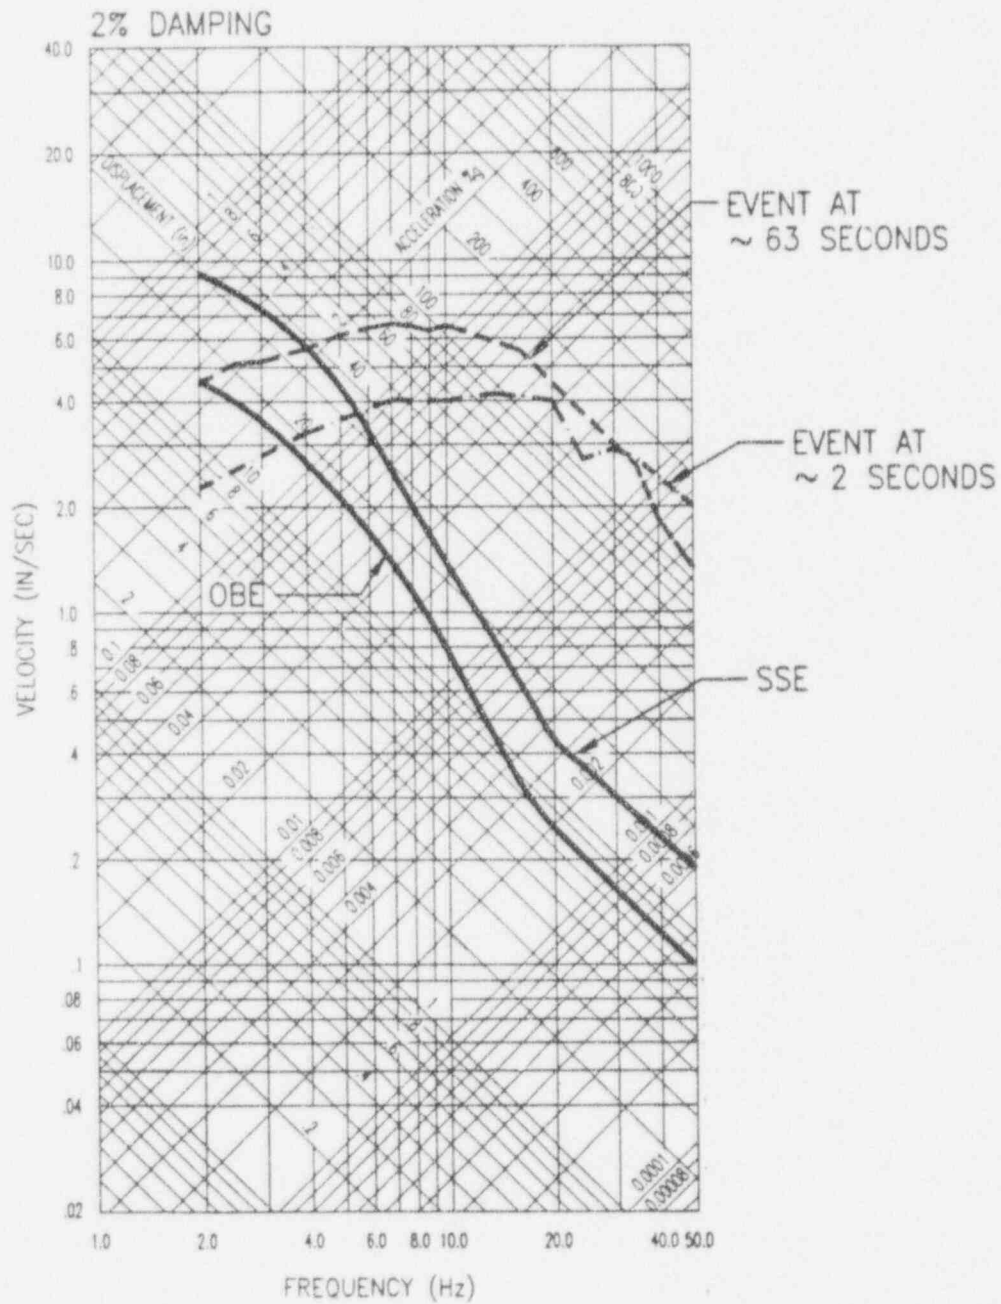
Figure 3.2.2.9

D30-N003 Accelerometer, East/West Response Spectra - HPCI Room
