NUCLEAR GENERATION MEMORANDUM

Subject: Final Report-Structural Walkdown

STRUCTURAL WALKDOWN

FINAL REPORT

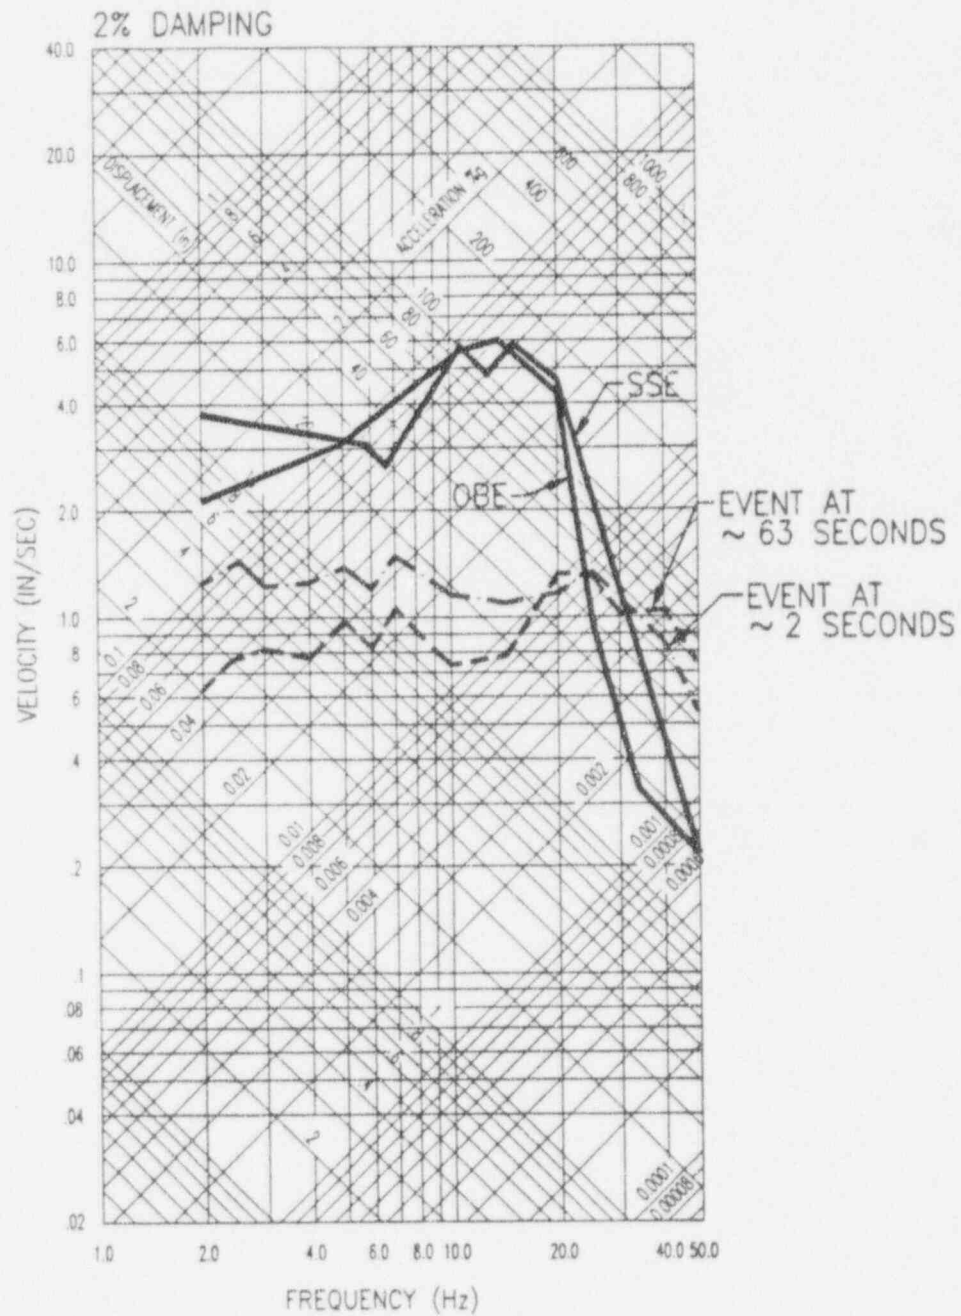
**Figure 3.2.2.10**

**D30-N002 Accelerometer, Vertical Response Spectra - RPV Pedestal**

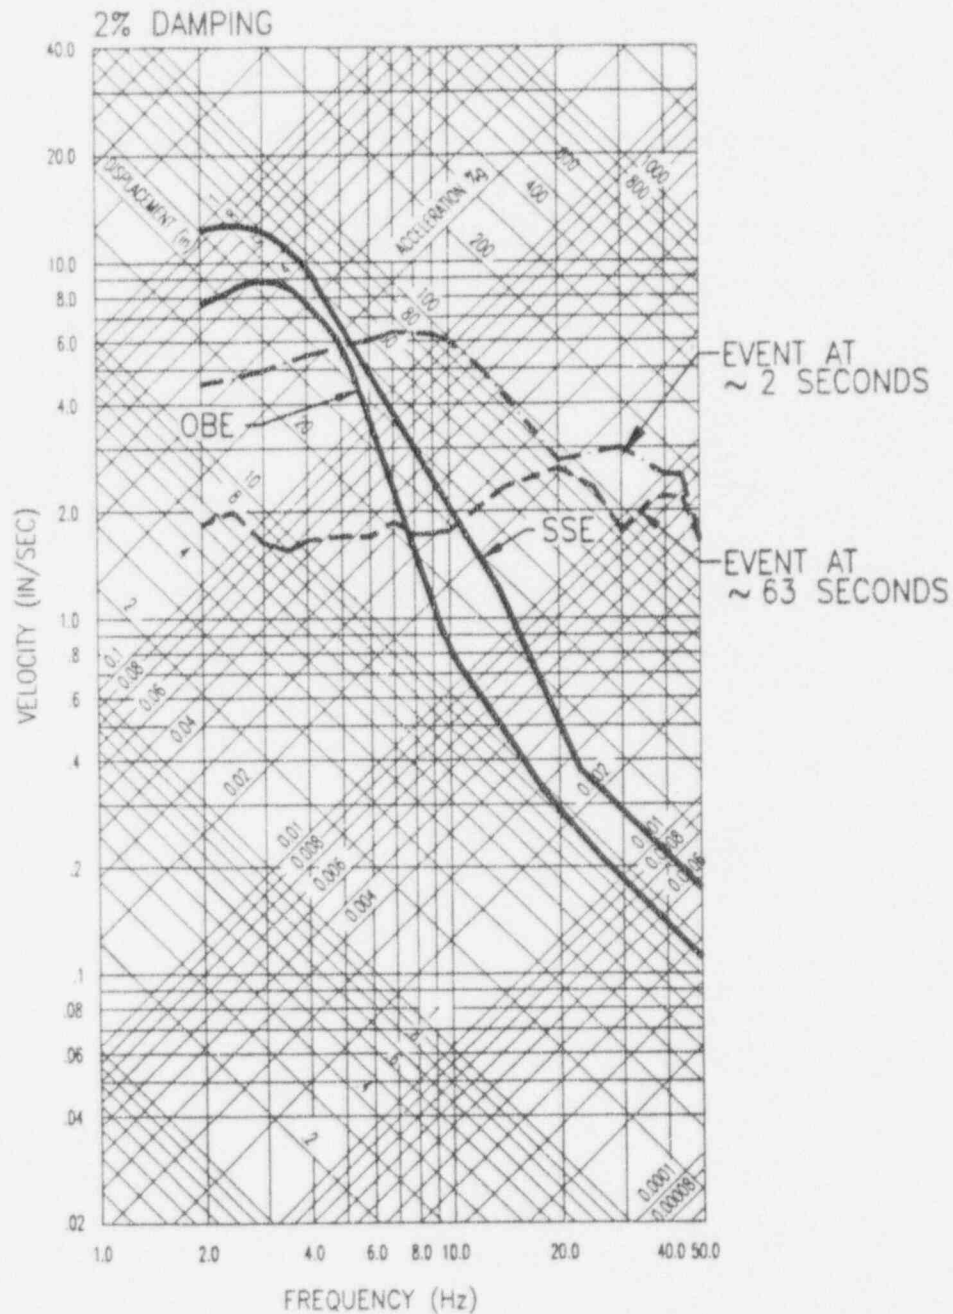
Figure 3.2.2.11

D30-N002 Accelerometer, North/South Response Spectra - RPV Pedestal

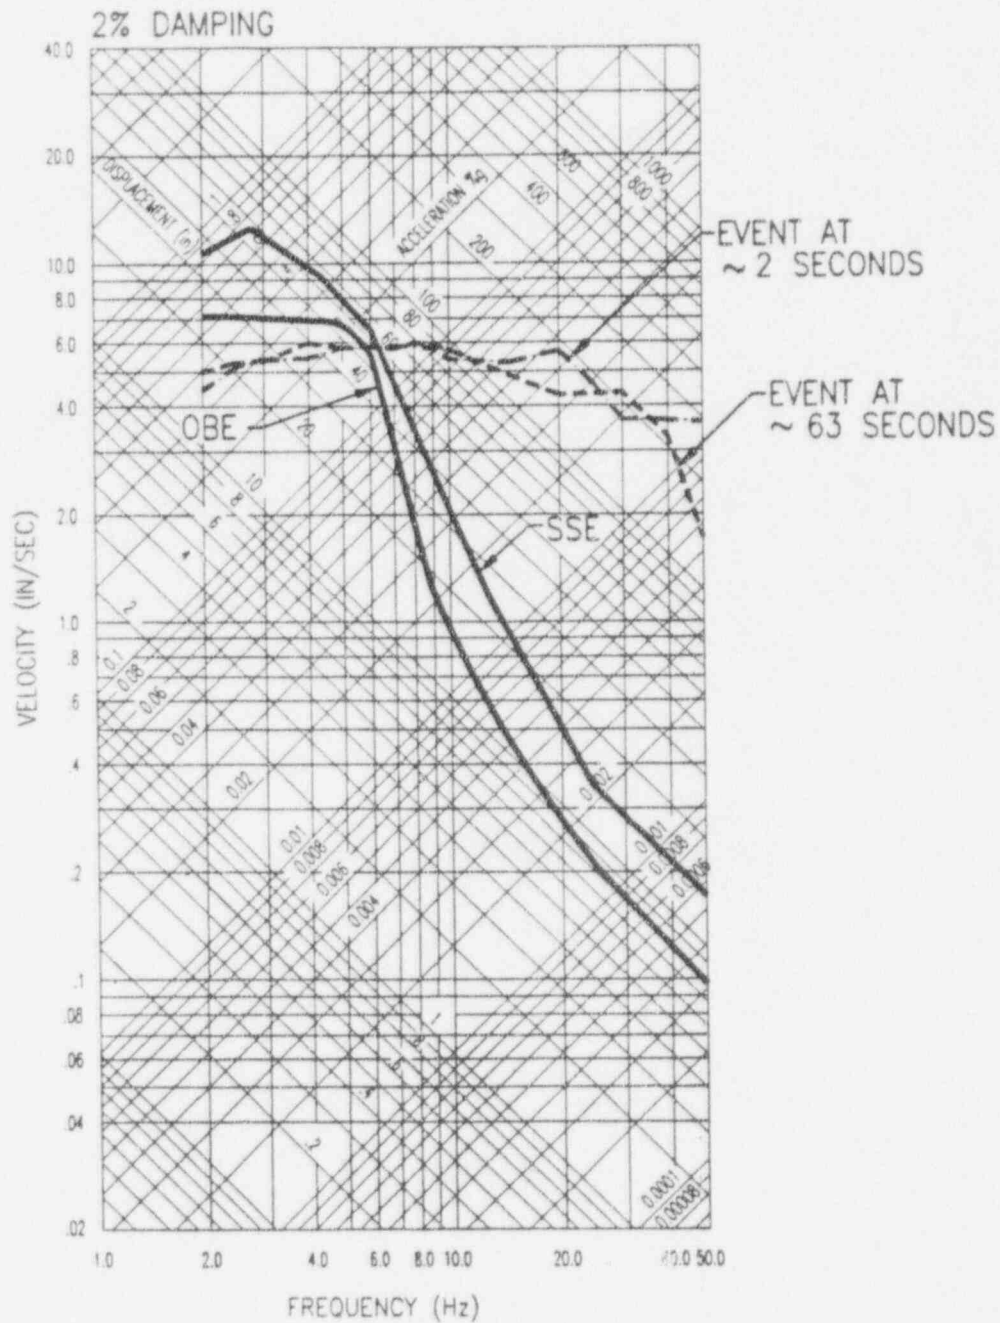
Figure 3.2.2.12

D30-N002 Accelerometer, East/West Response Spectra - RPV Pedestal

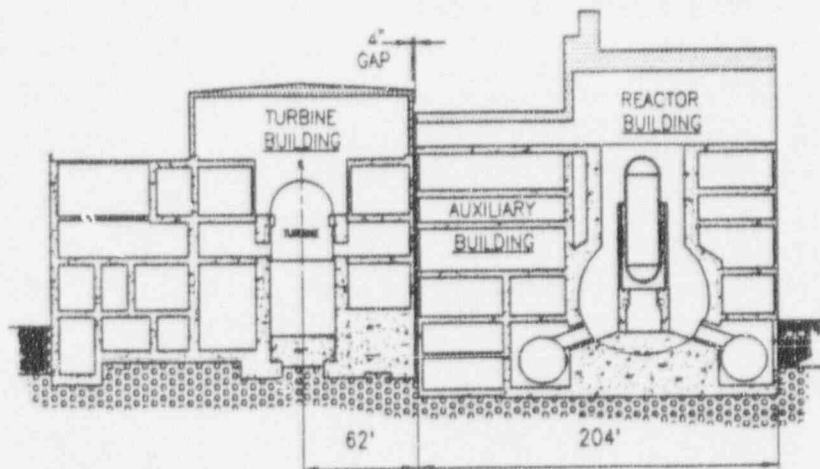
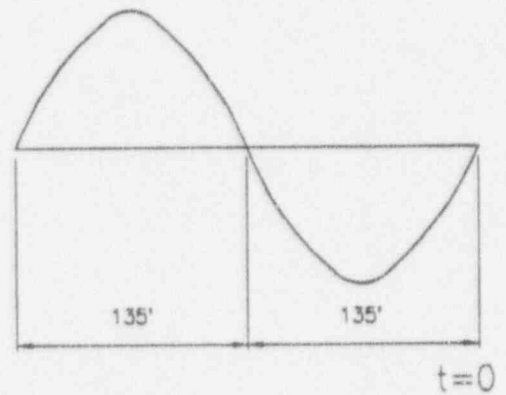
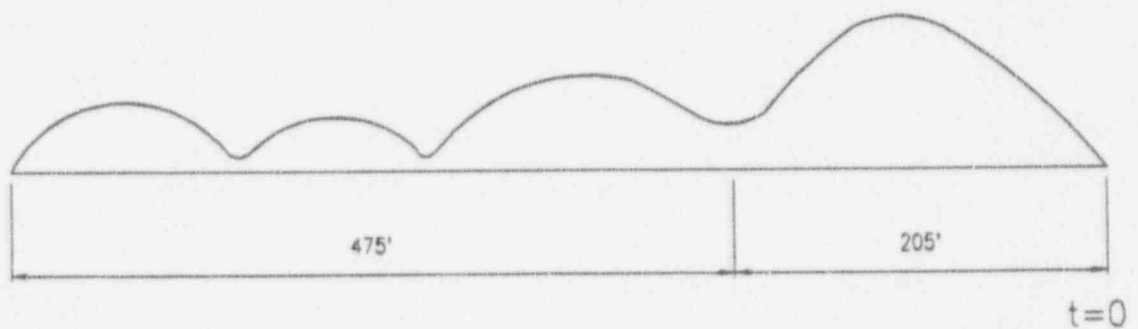
**Figure 4.0.1**

The shock wave length resulting from the turbine event at Fermi 2 was small compared to the building, and therefore produced local high accelerations, but the short duration, low energy, and small deformations associated with these high frequency accelerations did not compromise the structural integrity of the Reactor/Auxiliary building or the equipment therein.

**Schematic Representation of Shock Impulse Wave Length  
Compared to Building Dimension**

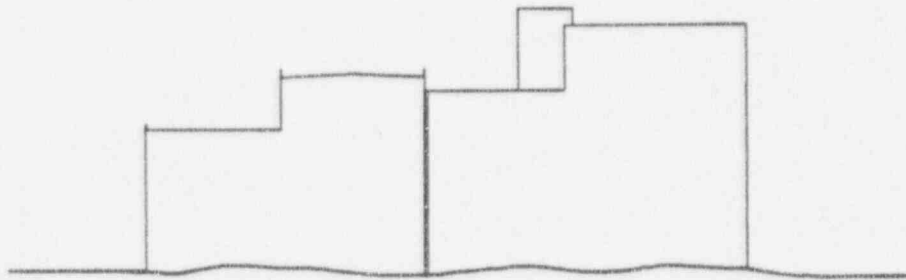
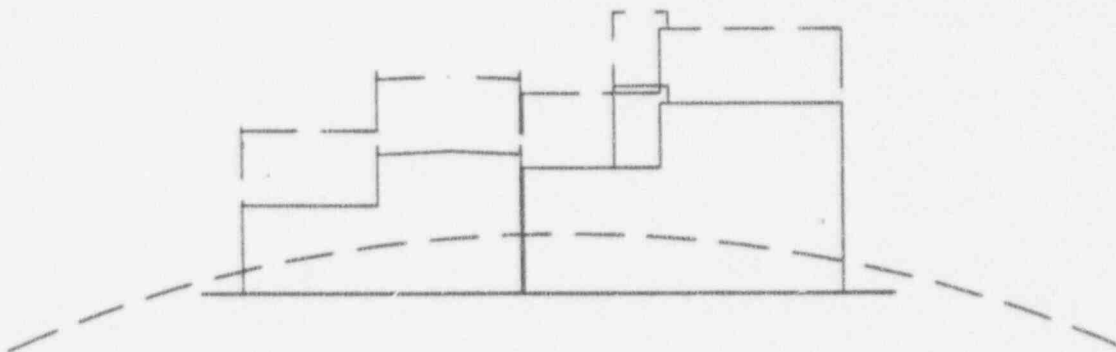
**Schematic Representation of Impulse Tremor Versus  
Earthquake Wave - Vertical Direction**
