| J) Title <i>Verification of Turbine Building East side Overhead</i> | | |

A) Title (Subject): TURBINE BEARING BEAM REPAIRS

Assessment of Turbine Bearing Beam Cracking

Date: June 21, 1994
To: A. S. Young
From: D. J. Connell *[Signature]*
Subject: Metallurgical Evaluation of Bearing Pedestal Box Beam Weld Cracking,
Fermi 2
Technical & Engineering Services Report 94V70-20

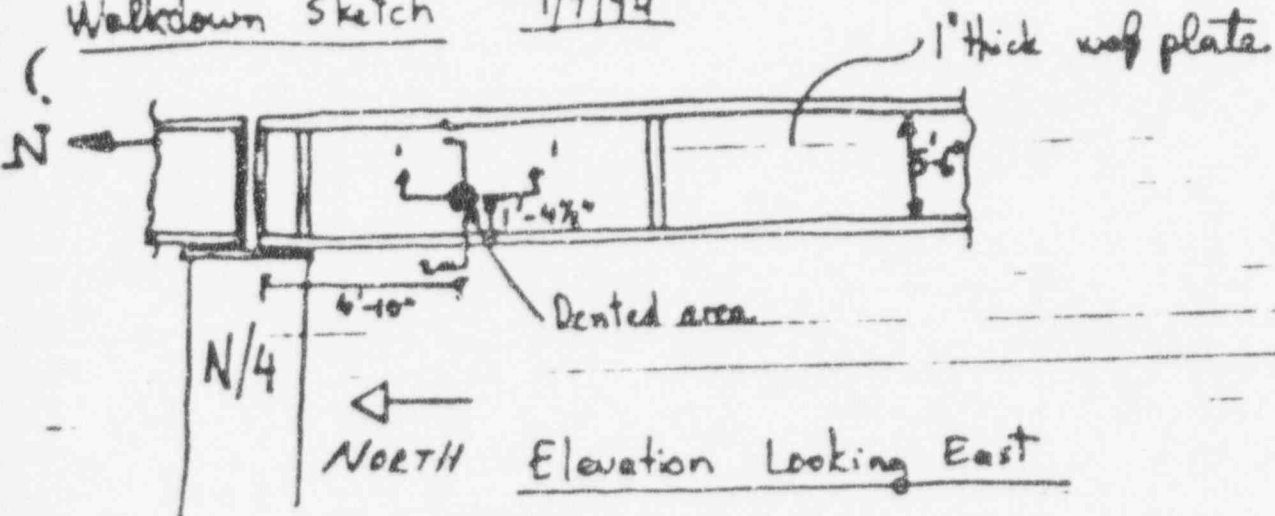
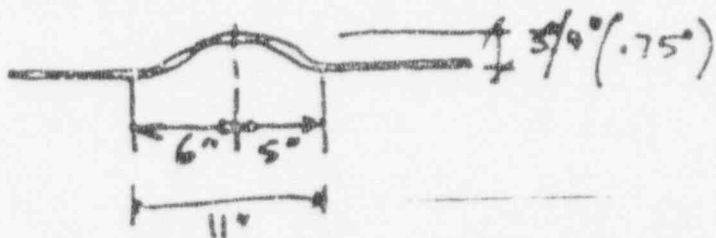
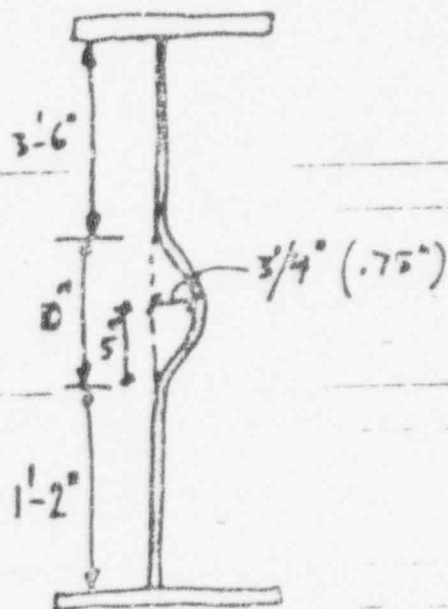
Walkdown sketch 1/7/94

The Turbine Building Overhead crane east girder, was found to have a web plate damage due to an impact from a suspected missile. The location of the damaged web and the details are shown on the walkdown sketch.

The damaged area was bowed in $3/4"$ deep, with no visual indication of any cracks on the surfaces. (Both front and back)

The walkdown team did not observe any other missile damage on the east girder. The visual inspection ~~from~~ of the west crane girder from the east walkway did not indicate any structural damage on the west girder.

In addition, the east girder connection to column N4 (nearest support to the missile hit location) was inspected. Girder to column connection bolts, which were painted, did not indicate that the impact had caused any movement at the connection. There was no indication of any overall girder displacement.

Conclusion: The walkdown team observations conclude that the missile impact was absorbed by the plastic deformation of the web plate which has acted as a diaphragm without any detrimental effect to the overall integrity of the crane girder structure. It was deemed to perform an evaluation (design calculation) by neglecting the damaged web area (1ft dia circle) and determine if any restrictions

are needed for crane use. If the calculation results show that the crane girder is adequate as-is, no immediate or future repair work are required from structural point of view. During the walkdown, the crane rails were not inspected as they were not accessible.

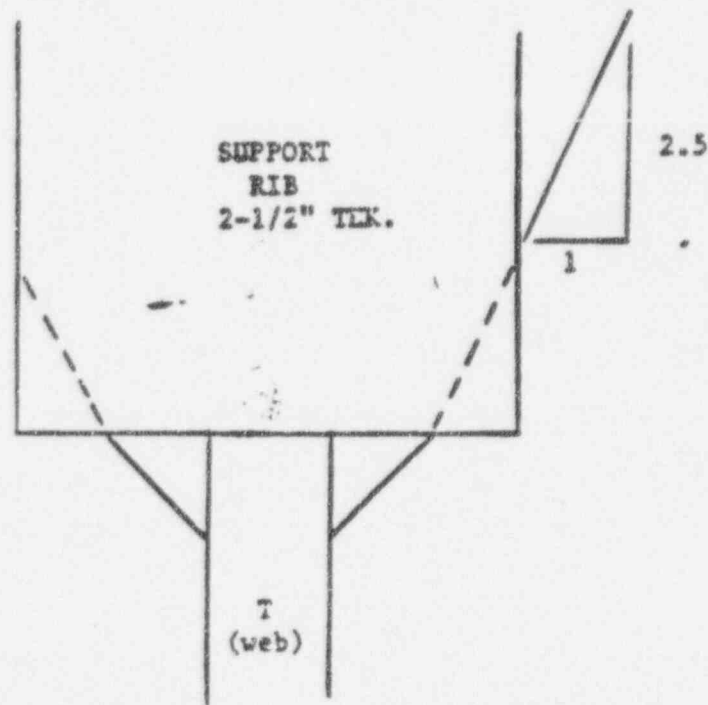
FIGURE 1 - Support Rib to T web Transition

Apart from the repair of cracks, a weld design change will be made during the repair. This weld design change will eliminate the wrap around welds between T section and 2 1/2" thick rib plates. The walkdown data indicates that this weld was completed as a fillet weld and indications point to this location as the starting point of the propagating cracks. This design change will be repeated at four locations per bearing beam, in total of 16 places. The revised drawings in this TSR reflect these weld changes. Reinforcement plates used in this repair process are detailed in Rev. A of this TSR. A

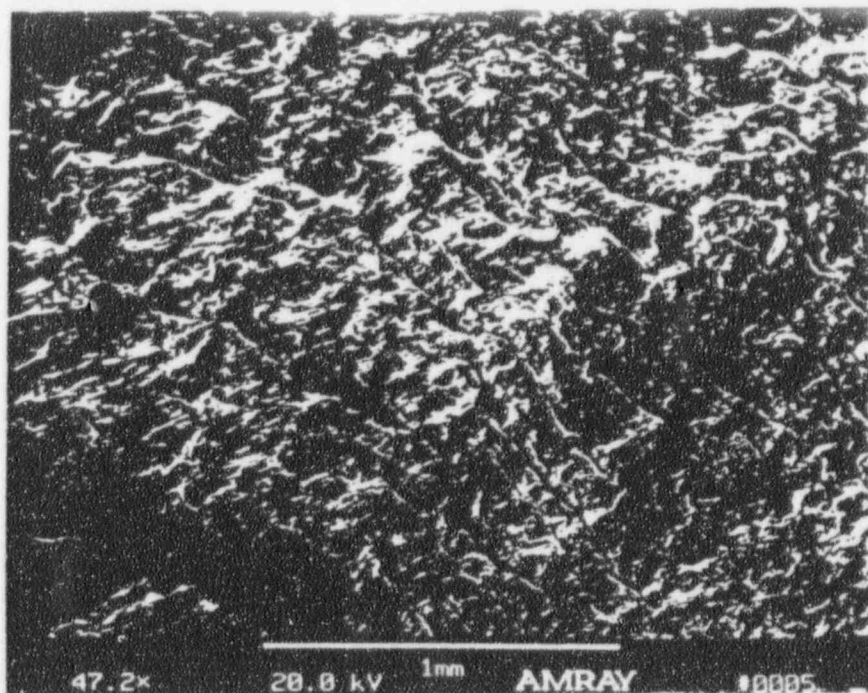
Examination of Sample 5 in the SEM was the first direct evidence of high stress-low cycle fatigue. Figure 1 shows the fracture surface at relatively low magnification, approximately 47X. At this magnification fatigue striations can be clearly observed. In figure 2 the boxed area is magnified 10X on the right. This shows that ductile tearing has occurred within each fatigue cycle. This magnitude of cyclic stress is rarely observed in engineered structures.

Figure 1 - SEM photo showing coarse fatigue striations

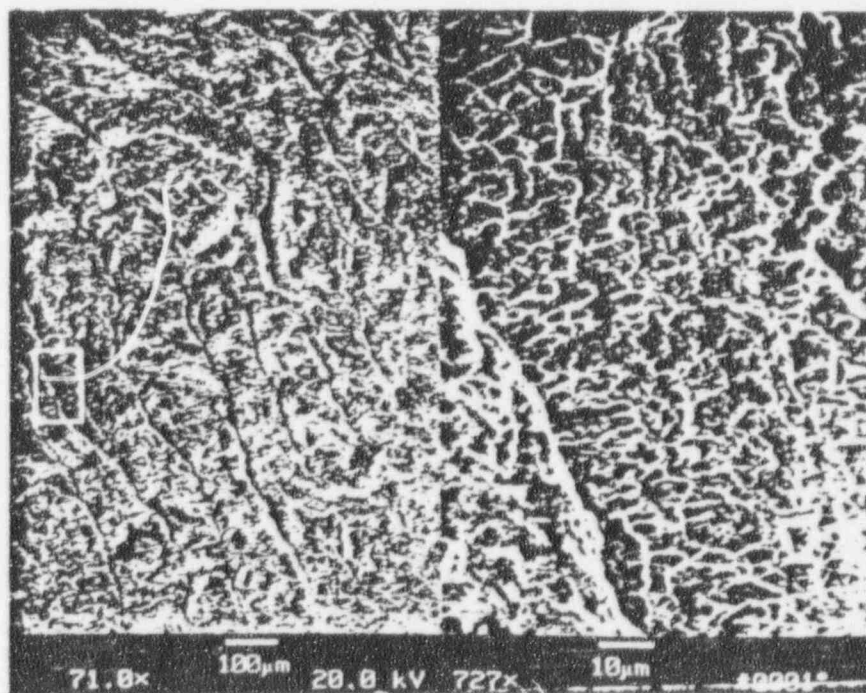
Figure 2 - SEM photo showing coarse fatigue striations and ductile tearing
