**Florida
Power**
CORPORATION
Crystal River Unit 3
Docket No. 80-302

Subject: Licensee Event Report (LER) 94-005-00

TITLE (4)
Personnel Error Leads to Failure to Perform Reactor Coolant Pump Motor Flywheel
Surveillance Resulting in Violation of Technical Specifications

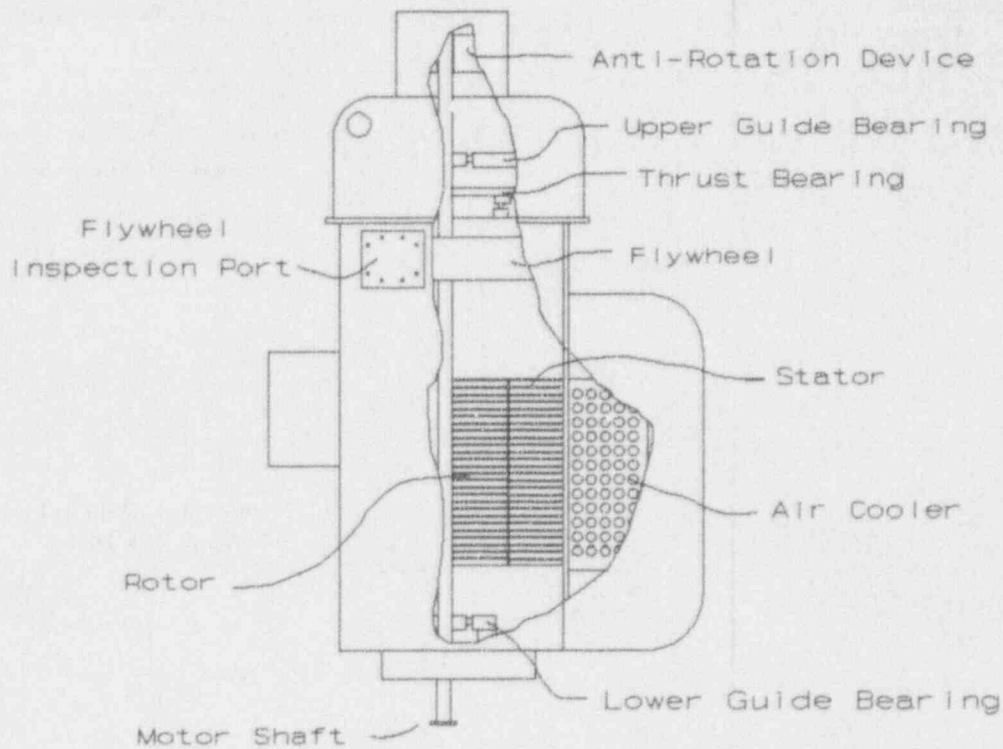
FIGURE 1

Prior to the expiration of the first ten year interval at CR-3 in 1987, FPC personnel recognized and understood the requirements of Reg. Guide 1.14, however, the RCP motor design prohibited performance of a complete surface examination of the RCP motor flywheel without substantial disassembly of the upper motor area. Removal of the flywheel inspection port (see Figure 1), exposing a segment of the circumferential area of the flywheel and RCP motor rotation would enable examination of the total circumferential area, however, examination of this small area, relative to the total surface area of the flywheel, would not have provided meaningful technical data and could have potentially resulted in introduction of foreign material into the RCP motor. Additionally, FPC personnel thought that the examination was not required since there was no exposed surface.

Figure 1 is a representation of the Reactor Coolant Pump Motor illustrating the complexity of RCP motor disassembly to expose all surfaces of the RCP motor flywheel.
