VERMONT YANKEE NUCLEAR POWER CORPORATION

November 02, 1994
BVY 94-106

REFERENCES: Operating License DPR-28
Docket No. 50-271
Reportable Occurrence No. LER 94-008

As defined by 10 CFR 50.73, we are reporting the attached Reportable Occurrence as LER 94-008.

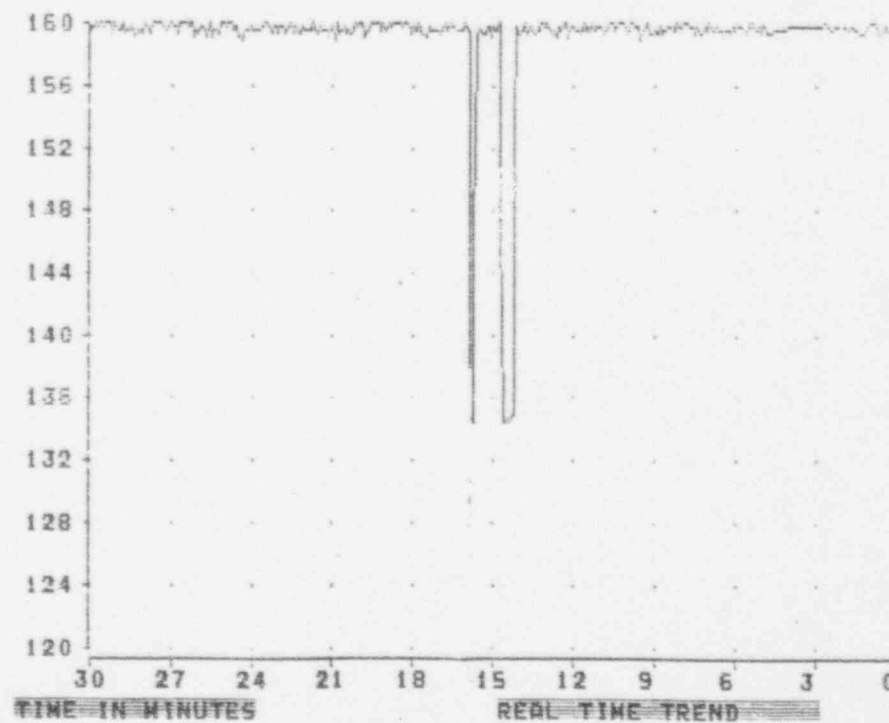
ATTACHMENT 1, - LER 94-008

On 10/03/94 at 1520 hours, with the reactor operating at 100% steady state power, and with the plant preparing for a scheduled maintenance shutdown, several down spikes occurred over a three minute period in the reactor water level instrument loop for LT-2-3-72B. The most significant spikes indicated a 25 inch drop in Reactor water level as recorded on the plant Emergency Response Facility Information System (ERFIS). The step change recorded on Attachment 1 shows a change from 160 inches to 135 inches which was not sufficient enough to generate an Engineered Safety Feature (ESF) system response.

FLIGHT MODE	ERFIS
RUN	10/03/94
EVL 72B LEVEL	15:09:32

REACTOR WATER LEVEL 72B
