LIMERICK GENERATING STATION

SUBJECT: Licensee Event Report  
Limerick Generating Station - Units 1 and 2

Reference: Docket Nos. 50-352  
50-353  
Report Number: 1-91-006  
Revision Number: 00  
Event Date: February 18, 1991  
Report Date: March 18, 1991  
Facility: Limerick Generating Station  
P.O. Box A, Sanatoga, PA 19464

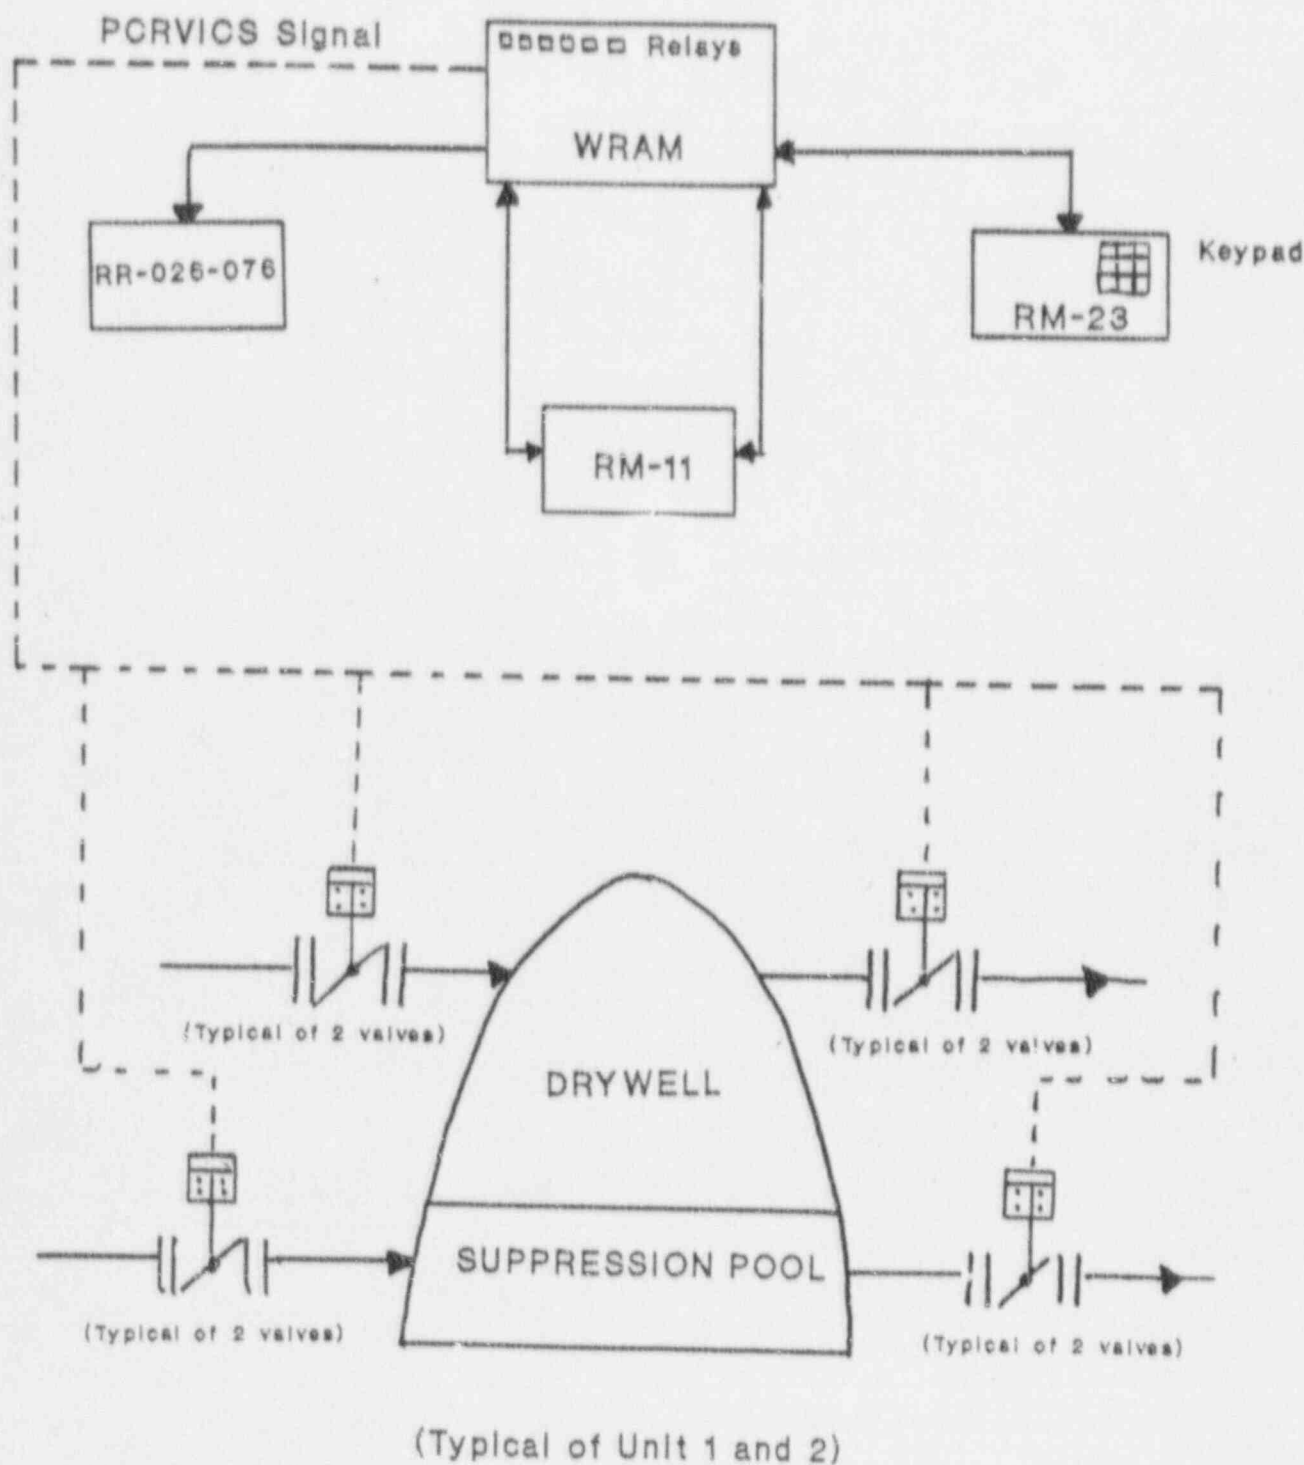
- o RM-80; Wide Range Accident Monitor (WRAM),
- o RM-23; Safety-Related Data Access Panel,
- o RM-11; Remote Terminal, and
- o RR-026-076; Recorder.

See Figure 1 for the single line system schematic.
