J A Mooney
Executive Manager
Midland Project Office

July 15, 1983

MIDLAND ENERGY CENTER GWO 7020
RESPONSE TO NRC REGION III QUESTIONS
OF JULY 14, 1983 MEETING
File: 0485.16 UFI: 42*05*22*04 Serial: CSC-6792
12*32

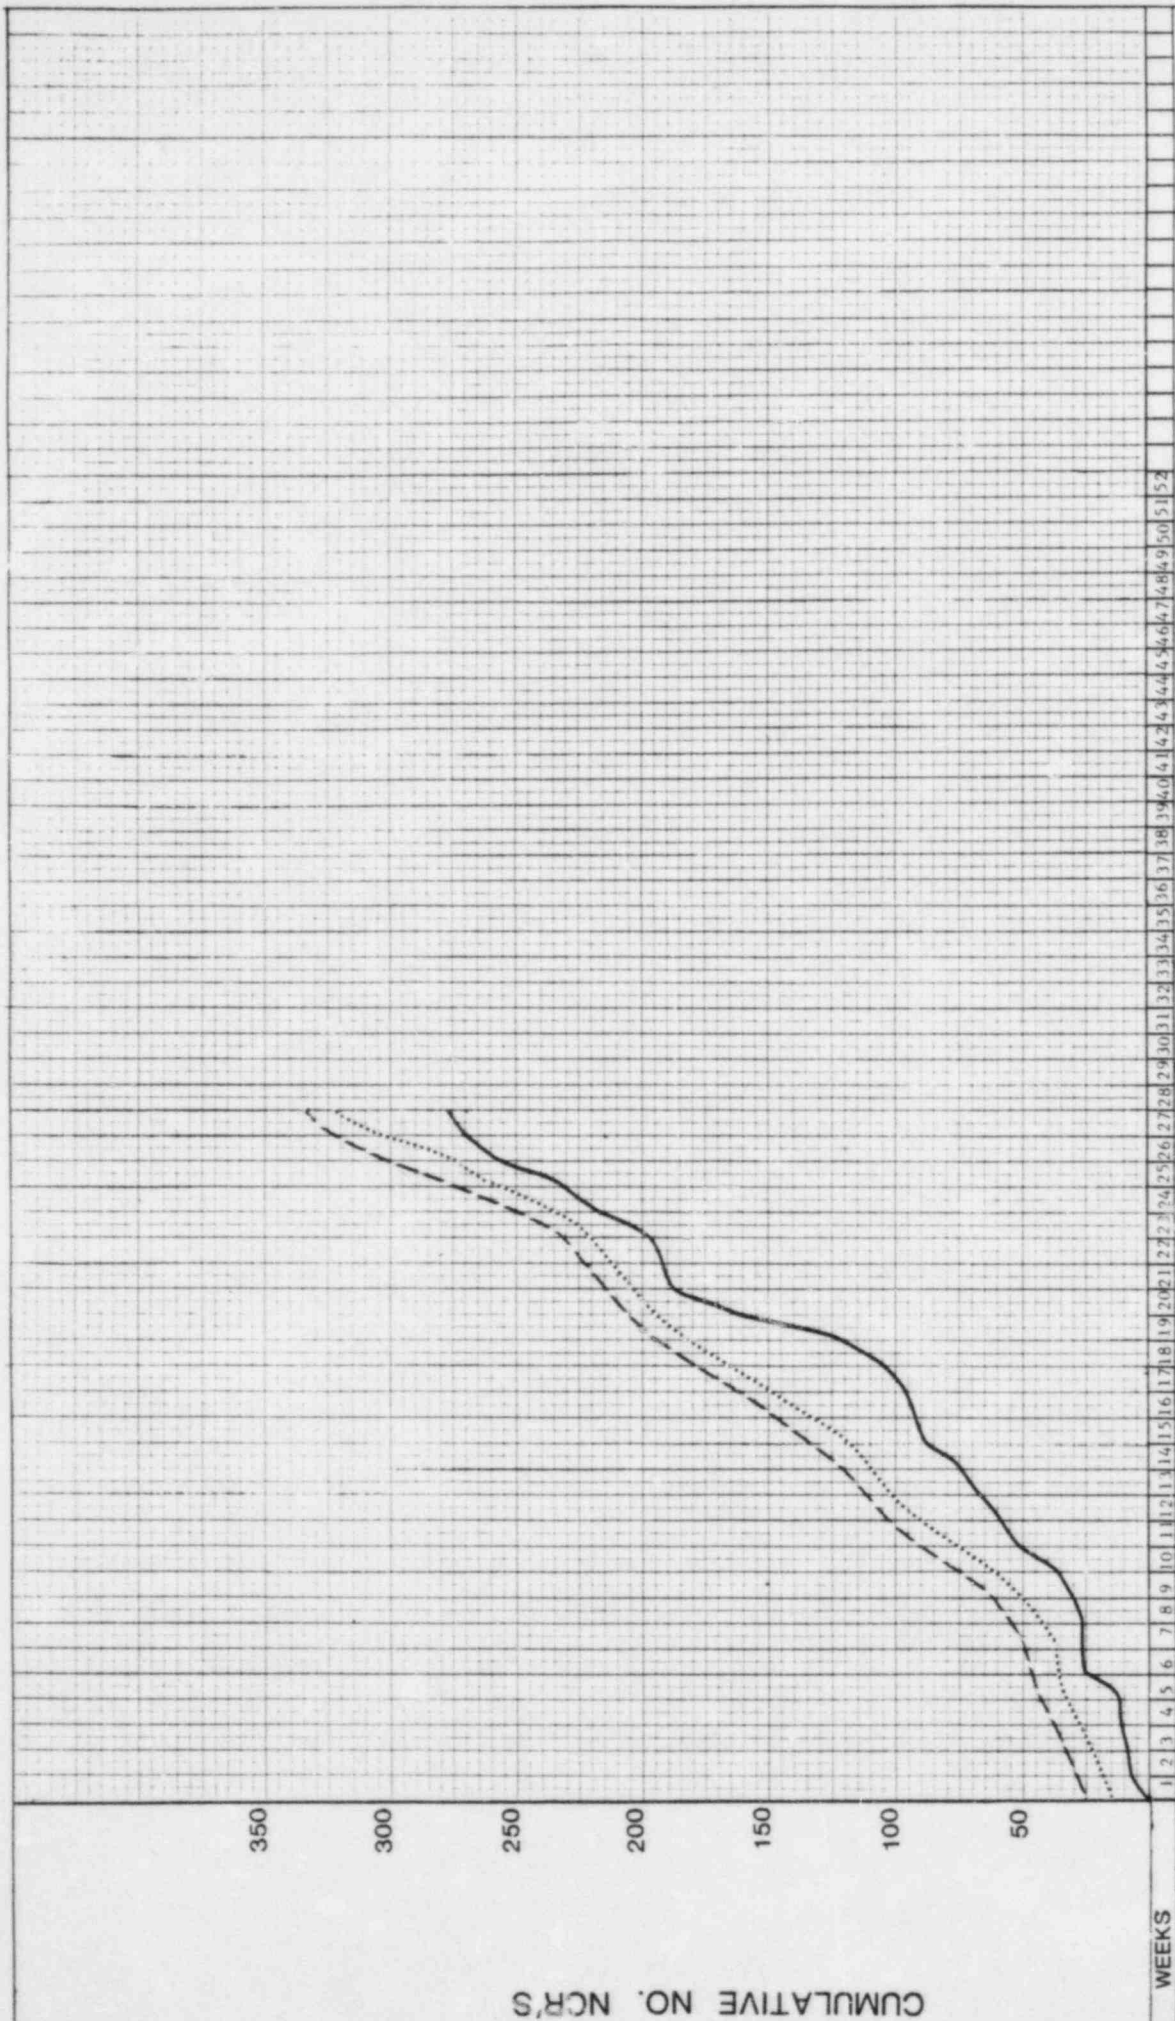
Graph 1: The cumulative number of NCR's is plotted for each week. The broken/slashed line represents all FSO NCR's written. The dotted line represents FSO NCR's written and corrected for those NCR's inherited from the Balance of Plant. These "inherited" NCR's predate the FSO organization and represent long term Non-"Q" soil replacement. The solid line represents the number of NCR's closed.

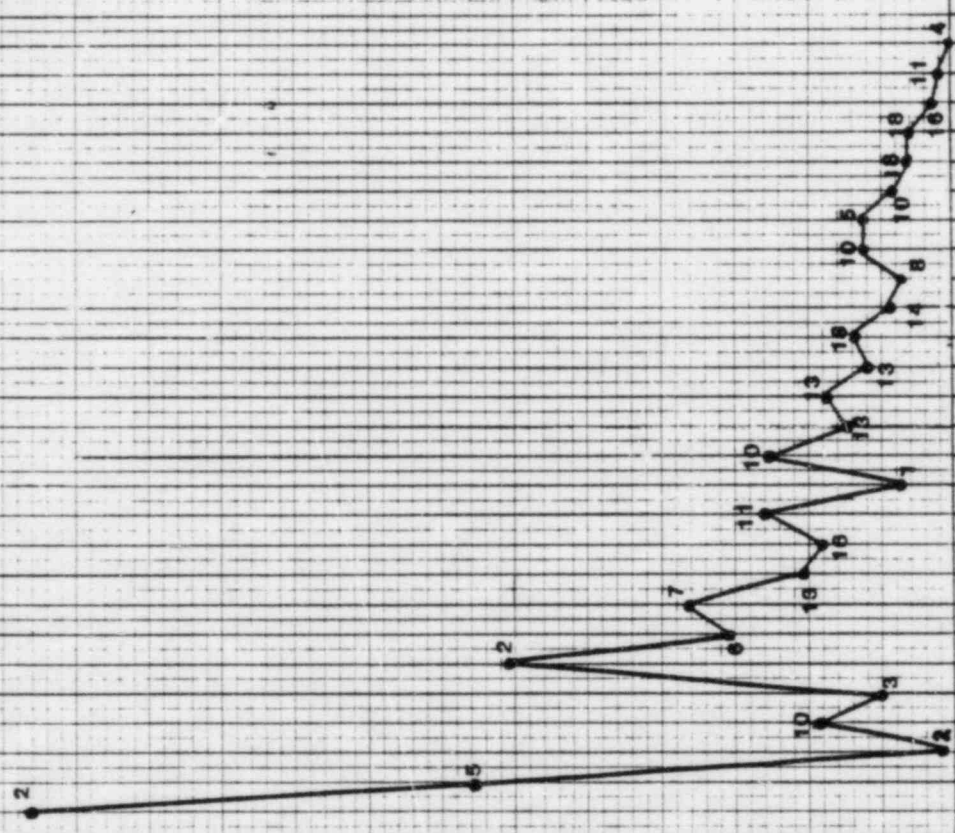
GRAPH 2

Graph 2: The average time to close an NCR for a given week is plotted for each week. The number shown beside each point is the number of NCR's used that week to determine the average.

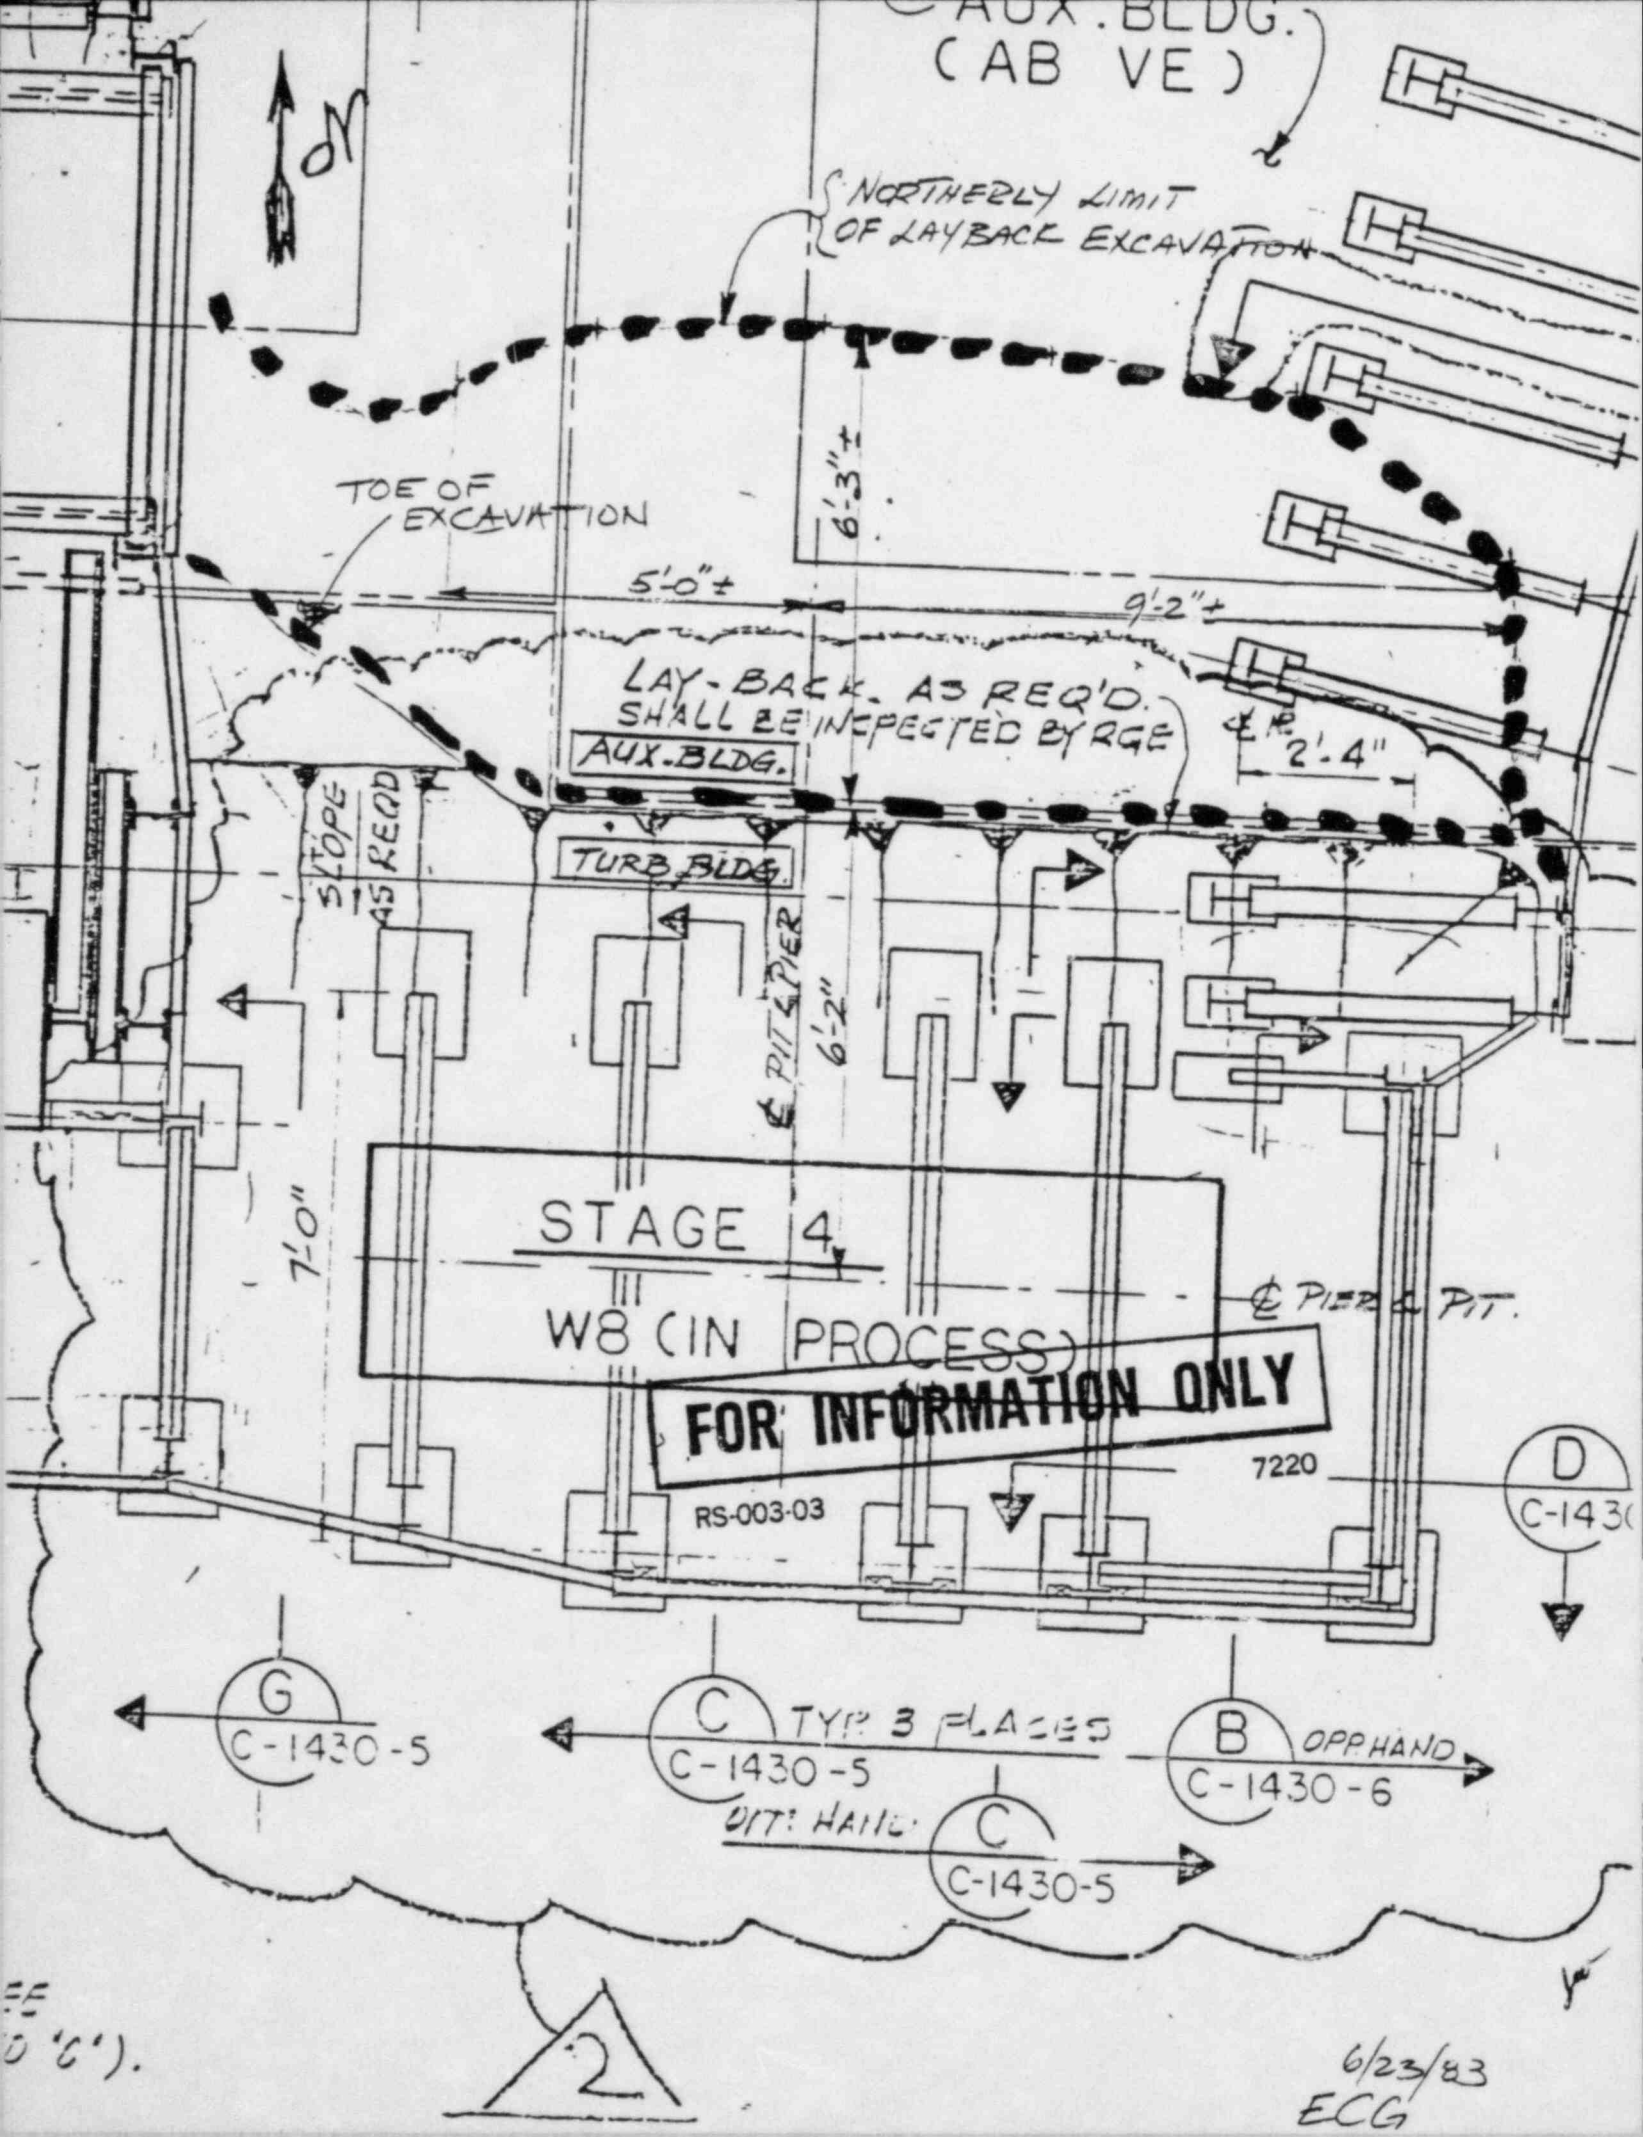
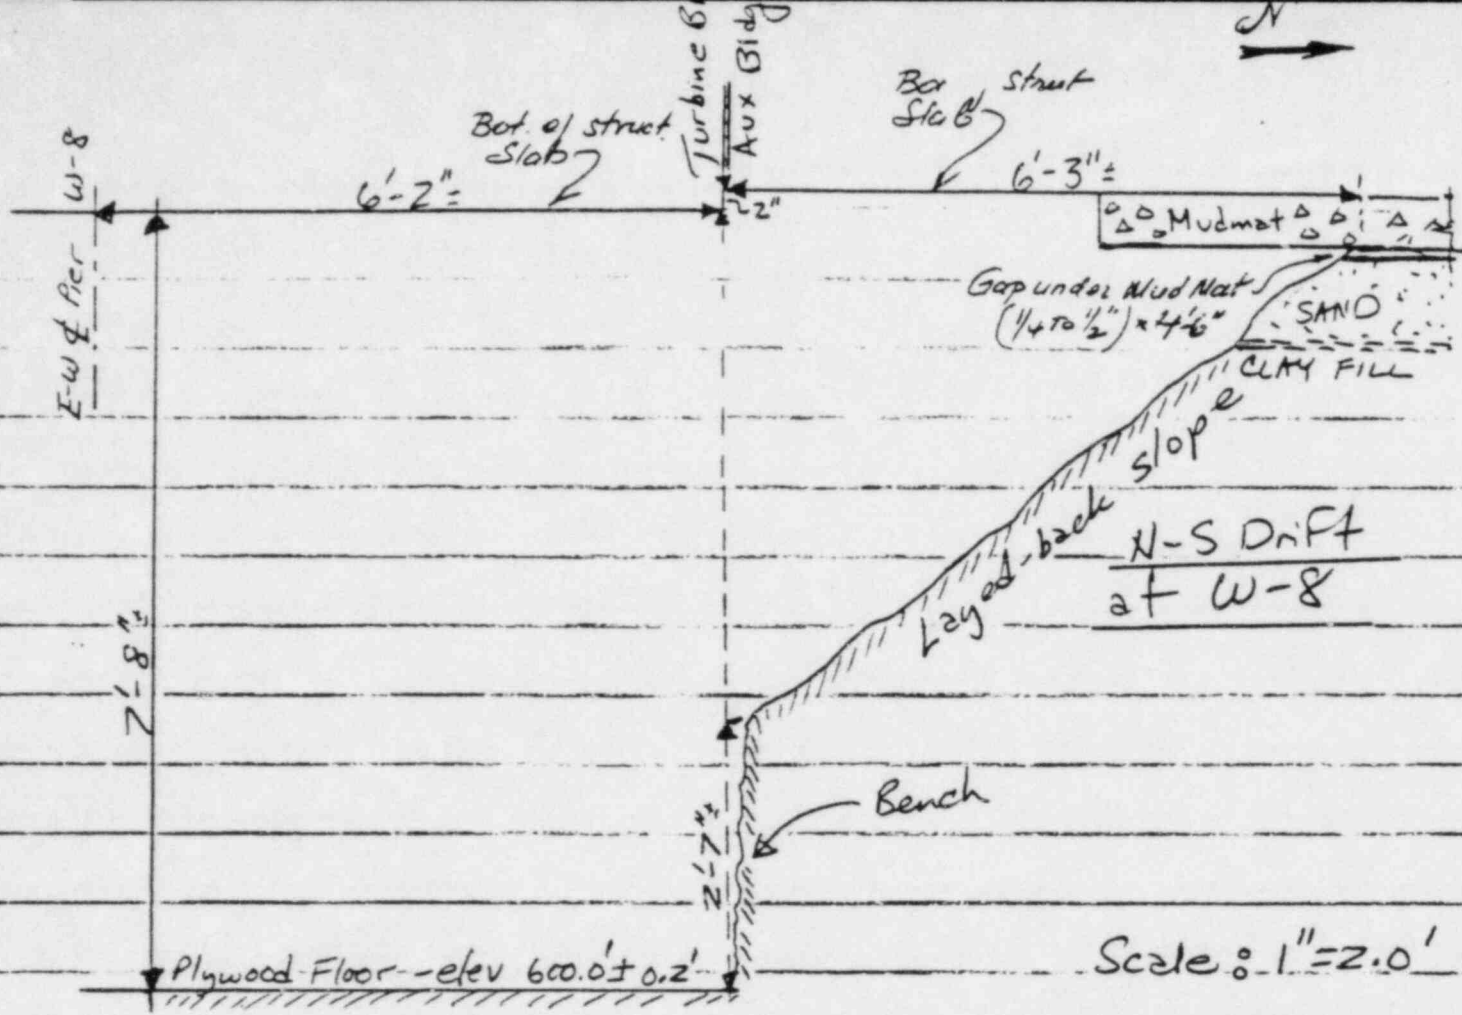
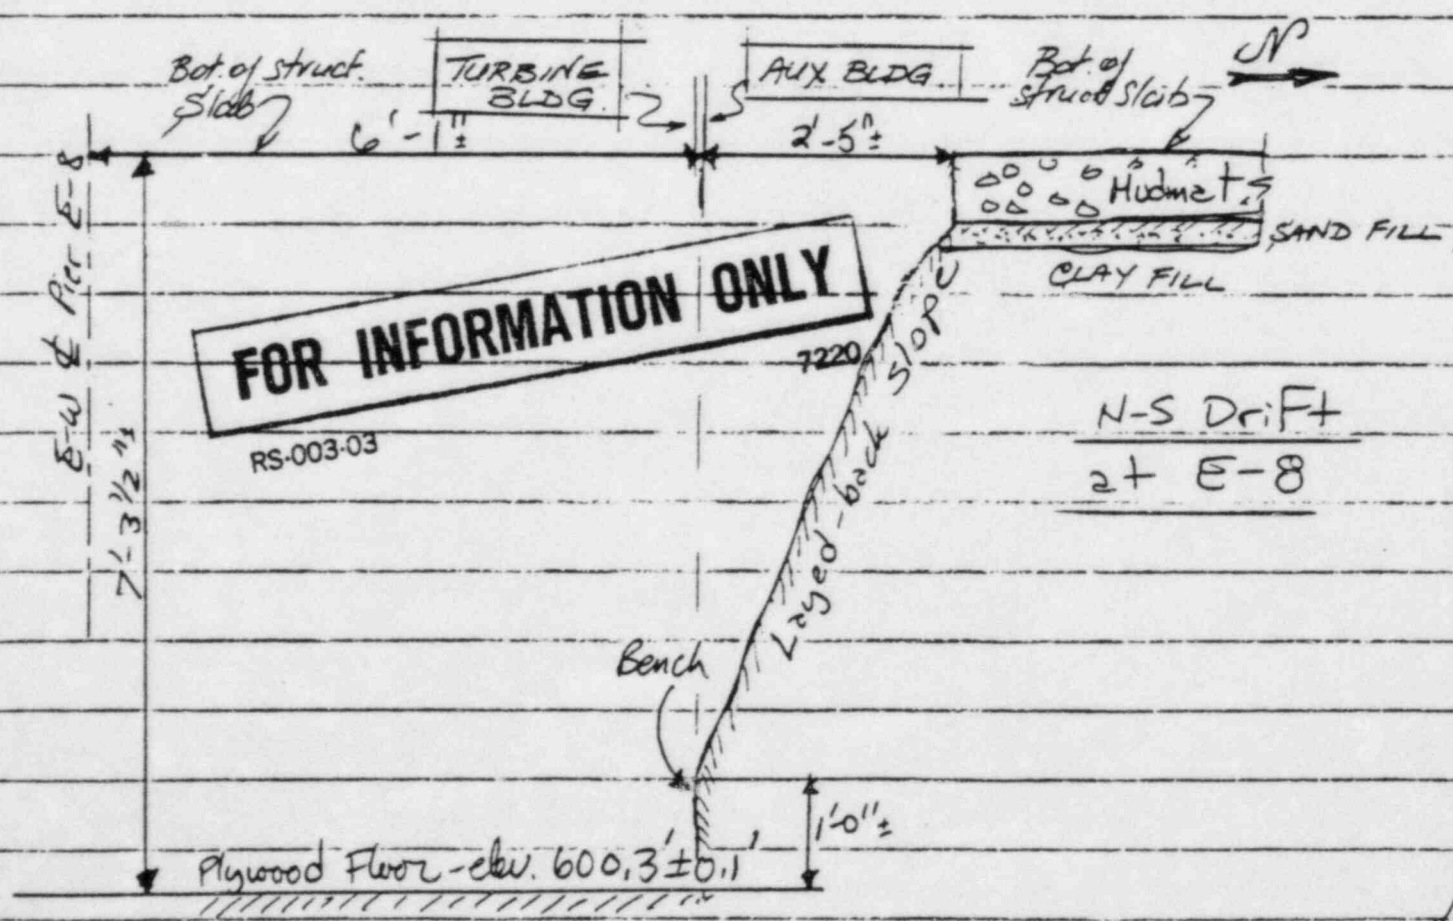
(3) SHEETS OF SKETCHES
ATTACHED TO THIS REPORT

NOTE: REG. NORTH SIDE OF ACCESS DRIFT (PIER PIT W-8) RSGFE CHECKED EXTENT OF THE 1/4" TO 1/2" GAPS UNDER THE MUD MAT ALONG NORTH LIMIT OF LAYBACK EXCAV. WITH 1/4" x 1" LATH PROBE 4'-6" MAX DEPTH OF THE GAPS WAS NOTED. STEEL TAPE/12' PENETRATED UP TO 12' INTO THE GAPS IN PROX. OF EXCAV. (N-S) OF THE PIT W-8

- 14) CURING OF THE UPPER TELL - TALE P_2 DRYFACE CONTINUED
- 15) RGE (R COSBY & E GRAY) COMPLETED PREPARATION
OF "AS BUILT" EXTENT OF EXCAVATIONS UNDER AUX
BIDG. ALONG THE NORTH SIDE OF ACCESS DRIFTS
TO PIERS E-B & W-9. TODAY SKETCHES WERE
PREPARED
