OYSTER CREEK CORE SPRAY SYSTEM
INSPECTION PROGRAM - 15R OUTAGE

TOPICAL REPORT NO. TR-098

Project No. 328352

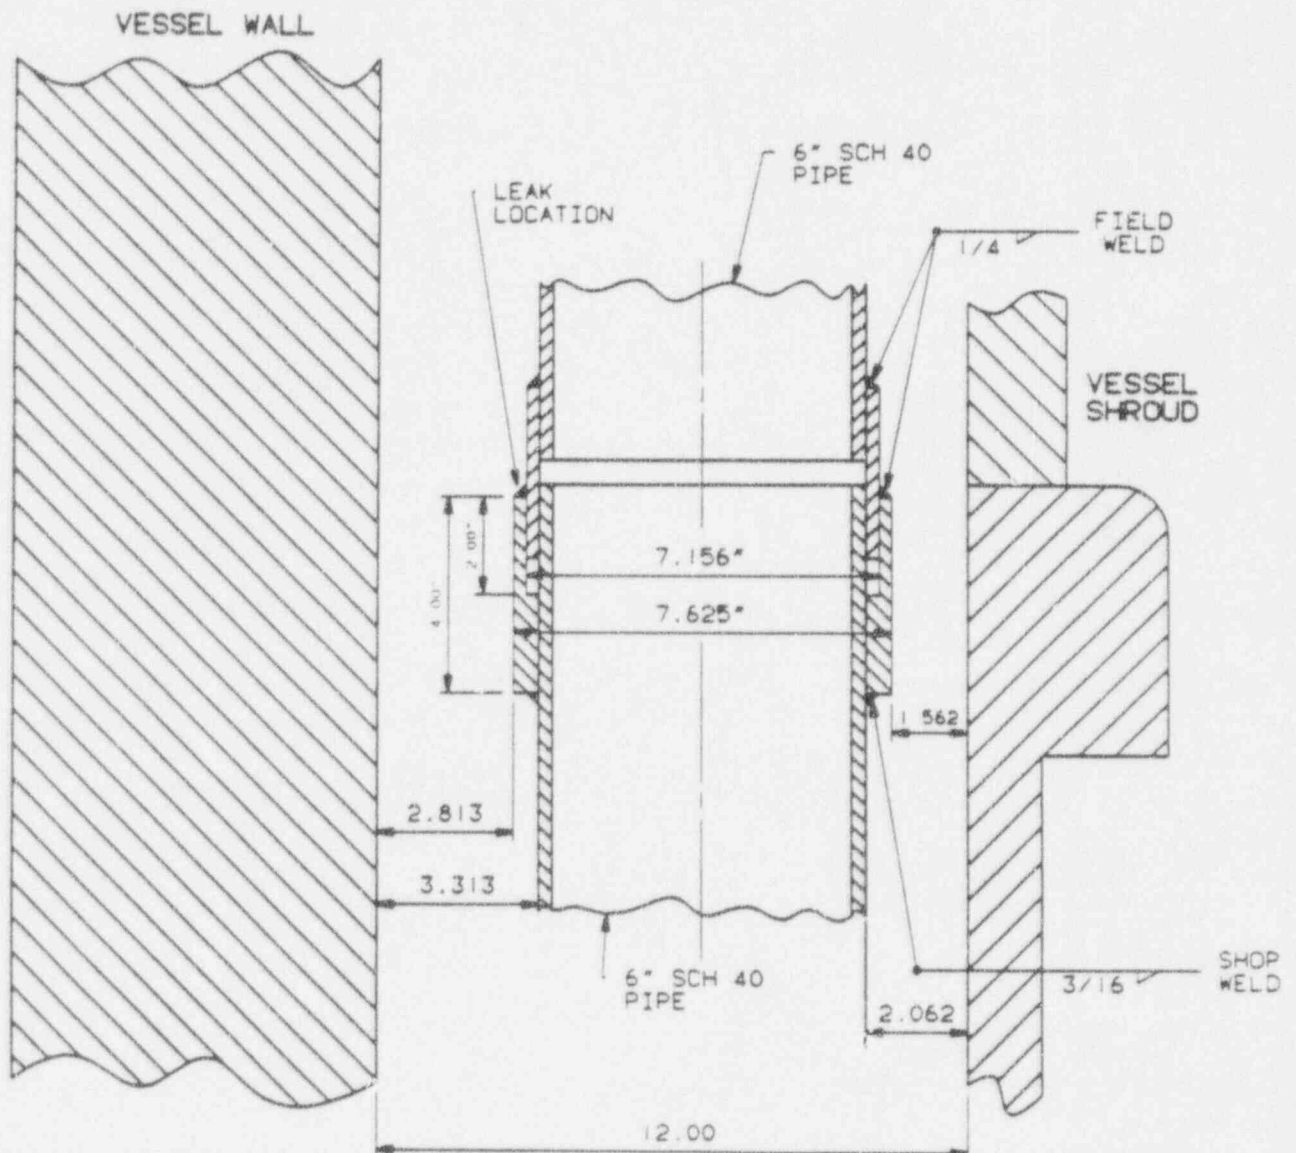
FIGURE 5

Prior to the initial inspection of the System I (Lower Spargers) air bubbles were observed coming from the annulus area as noted in previous air test during refueling Outage 14R. These bubbles as noted in the referenced TR were leaking out of the fillet weld designated L-3A, 240° azimuth (see Figure 5 for joint configuration and weld type). The location of the leak was at the point along the circumference of the weld nearest the vessel wall. A direct straight on view of the weld was attained utilizing a water proof Elmo chip video camera. The video revealed three rounded indications at the lower toe of the weld. These rounded indications originated from initial fabrication. One of the three rounded indications emitted air bubbles while the System was under pressure. Once the pressure was reduced the air bubbles subsided. Further inspection of the balance of the annulus piping revealed no additional air leaks.

- One rounded, through wall, indication was observed at the toe of the weld designated as L-3A. This weld is in System I of the annulus piping. The rounded indication was discovered during the air test perform in outage 14R and was determined to originate from initial fabrication of the component.

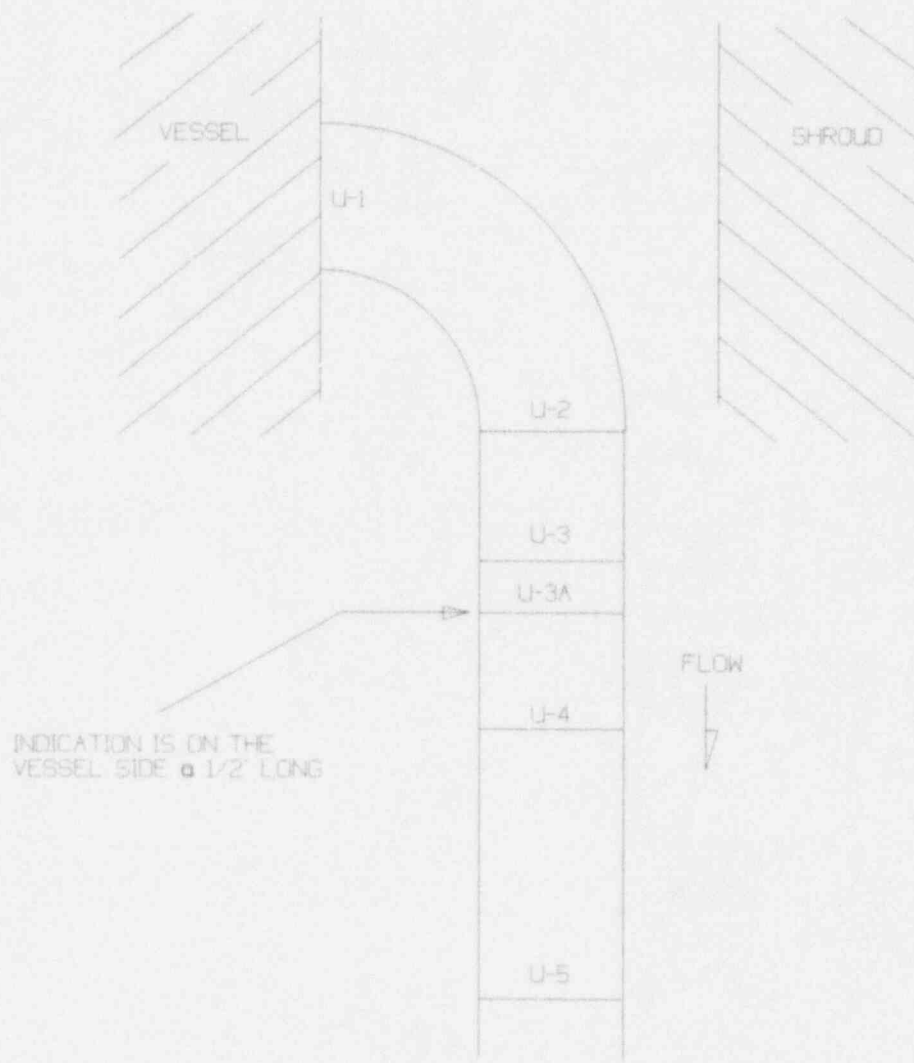
FIGURE 6

- Two linear indications originally observed during Outage 14R in the annulus piping in System II Weld U-3A (reference TR-093). These indications were revisited this outage (15R) and there appears to be no change and no air bubbles were observed emitting from this location during the air test.

CORE SPRAY PIPING WELD I.D.'S
INDICATION AT WELD U-3A
