Houston Lighting & Power South Texas Project Electric Generating Station P. O. Box 289 Wadsworth, Texas 77485

May 01, 1991
ST-HL-AE-3758
File No.: G26
10CFR50.73

South Texas Project Electric Generating Station
Unit 1
Docket No. STN 50-498
Revision 1 to Licensee Event Report 90-025
Regarding Reactor Trip Due to a
Generator Ground Fault Relay
Actuation Caused by a Stator Coil End Turn Failure

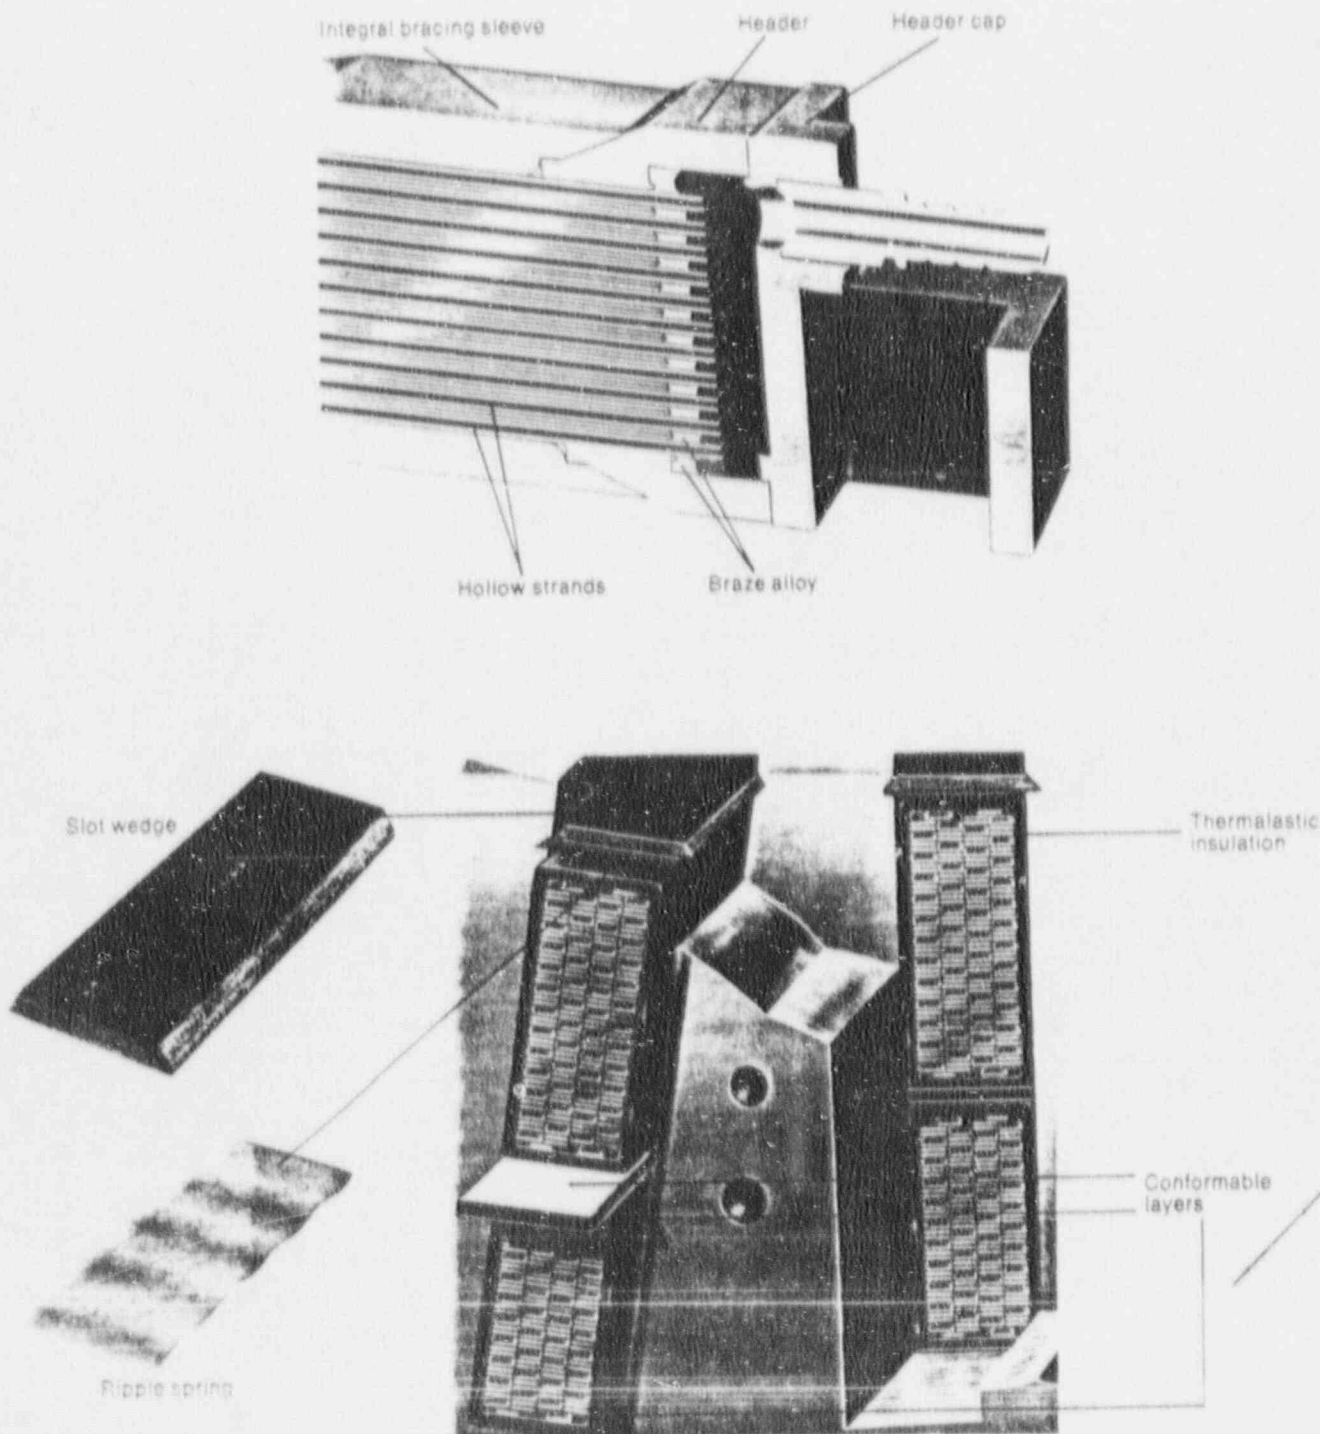
FIGURE 1

Initial internal inspection of the generator revealed a damaged area at the end turn of bottom stator coil #23, which is located between the nine and ten o'clock positions when viewed from the turbine end.

- A significant amount of the copper header box material was missing, presumably vaporized or melted by electrical arcing.
- The teflon hose which connects the stator cooling water distribution header to the damaged coil was damaged.

- The cooling water manifold nipple associated with the failed stator coil was eroded away from the inside, presumably by an electrical arc.
- There was no damage on the adjacent manifold nipples on either side of the eroded nipple.

- c) A fatigue crack developed in one of the current-carrying stator coil header caps; first in the solder bond between the series connection strands and header cap ferrule; then progressing into the copper header cap ferrule itself. The increasing vibratory stresses were the primary cause of the crack initiation and propagation.

- d) The fatigue crack propagated along the ferrule-to-header cap interface, parallel to the series connection strands, effectively reducing the stator coil current-carrying cross section, until the ferrule either fractured or melted off. This opened the electrical circuit and resulted in an electrical arc.

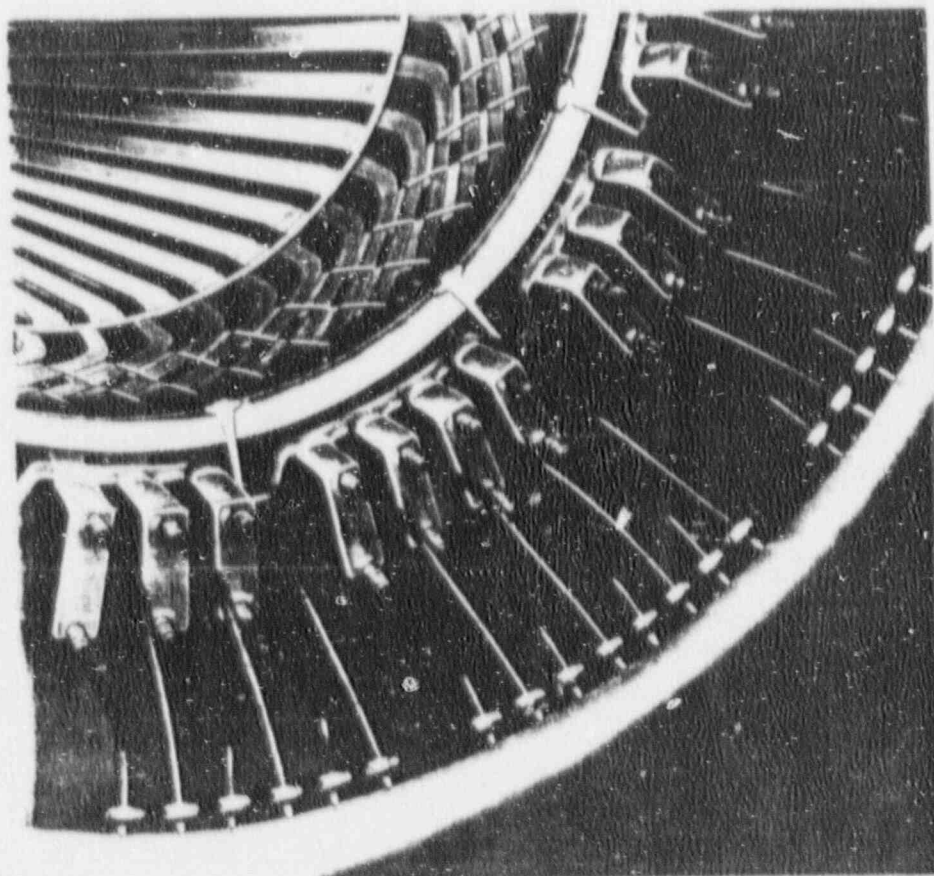
FIGURE 2

- The structural damage to the end turn winding blocking and lacing was severe on the turbine end of the generator. The exciter end blocking and lacing was essentially intact.

- e) A significant portion of the ferrule, series connection strands and header cap were melted/vaporized by the electrical arc. When the arc broke through into the water chamber, the resultant pressure of the steam, arc products and hydrogen rotor cooling gas forced the molten/vaporized metal back through the teflon cooling hose into the stator cooling water manifold. The arcing was of extremely short duration and would essentially resemble an explosion.

- f) A ground current developed in the partially ionized copper vapor flowing through the teflon hose, which resulted in the ground fault relay actuation. The pressures generated during the arc, in combination with the hydrogen pressure in the generator, would have forced the cooling water out of the local fault area during the fault condition.

The ground fault relay actuation was due to electrical arcing from the failed stator coil end turn to the stator cooling water system manifold. The stator coil end turn failure was due to vibration-induced fatigue cracking of the coil end turn series connection. The excessive end turn vibration which initiated the fatigue failure mechanism resulted from structural degradation of the end turn blocking and bracing. The specific cause of the blocking and bracing structural degradation cannot be determined with certainty. The generator internals are not accessible for frequent inspections, and the degraded condition of the turbine end stator windings following the failure was too widespread to isolate a single root cause. However, the most probable cause of the failure was latent damage resulting from the January 20, 1989 generator hydrogen cooling transient (refer to LER 89-005). This conclusion was reached independently by Westinghouse and a consultant employed by HL&P. It is important to note that the end turn structural damage occurred almost exclusively on the turbine end of the generator and not the exciter end, as this fact is significant with regard to root cause determination. The following is justification for this conclusion:
