NORTHEAST UTILITIES

MP-91-365

Reference: Facility Operating License No. NPF-49
Docket No. 50-423
Licensee Event Report 90-030-01

FACILITY NAME (1)										DOCKET NUMBER (2)										PAGE (3)									
Millstone Nuclear Power Station Unit 3										0 5 0 0 0 4 2 3										1 OF 0 6									
TITLE (4)																													
Manual Reactor Trip Due to Moisture Separator Reheater Piping Line Breaks																													
EVENT DATE (5)					LER NUMBER (6)					REPORT DATE (7)					OTHER FACILITIES INVOLVED (8)														
MONTH	DAY	YEAR	YEAR		SEQUENTIAL NUMBER		REVISION NUMBER		MONTH	DAY	YEAR	FACILITY NAMES																	
												0 5 0 0 0 0																	
1	2	3	1	9	0	9	0	0	0	3	0	0	1	0	5	0	1	9	1	0 5 0 0 0 0									
OPERATING MODE (9)					THIS REPORT IS BEING SUBMITTED PURSUANT TO THE REQUIREMENTS OF 10 CFR § (Check one or more of the following) (11)																								
1					20.402(b)					20.402(c)					<input checked="" type="checkbox"/> 50.73(a)(2)(iv)					73.71(b)									
POWER LEVEL (10)					20.405(a)(1)(i)					50.36(c)(1)					50.73(a)(2)(v)					73.71(c)

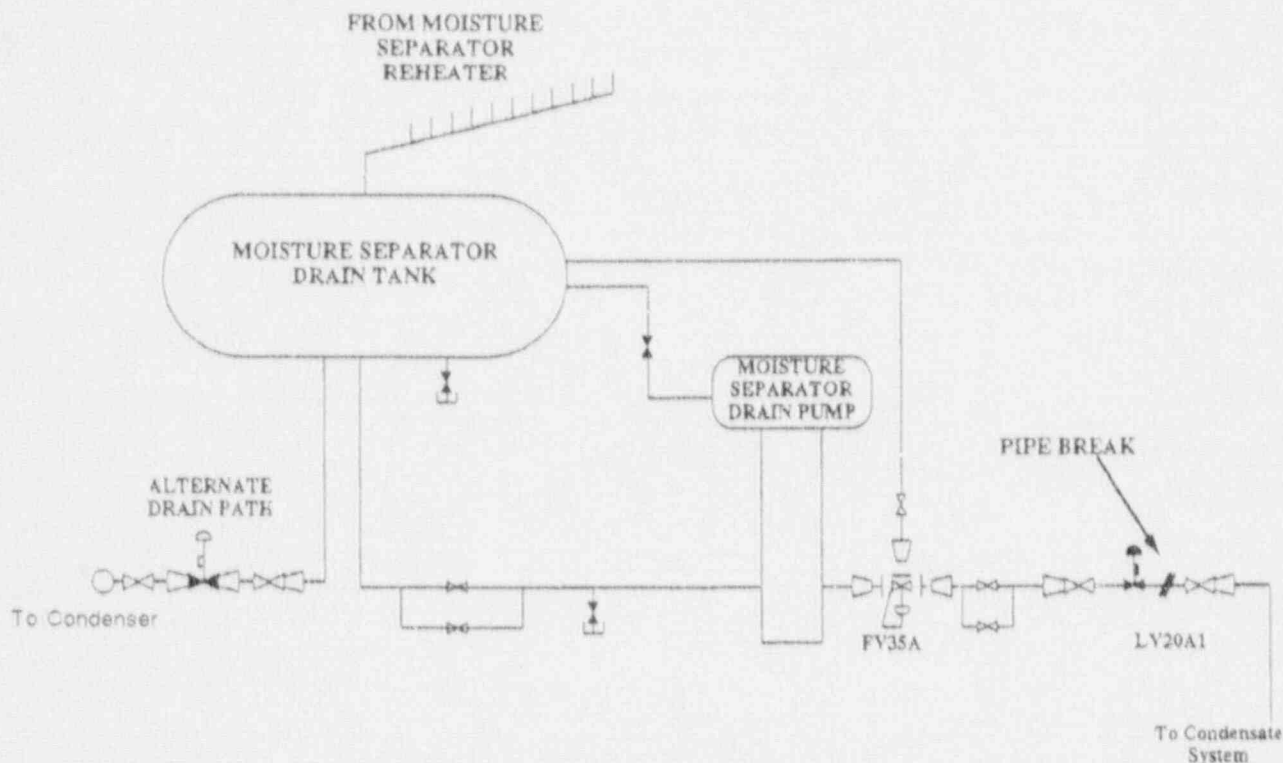
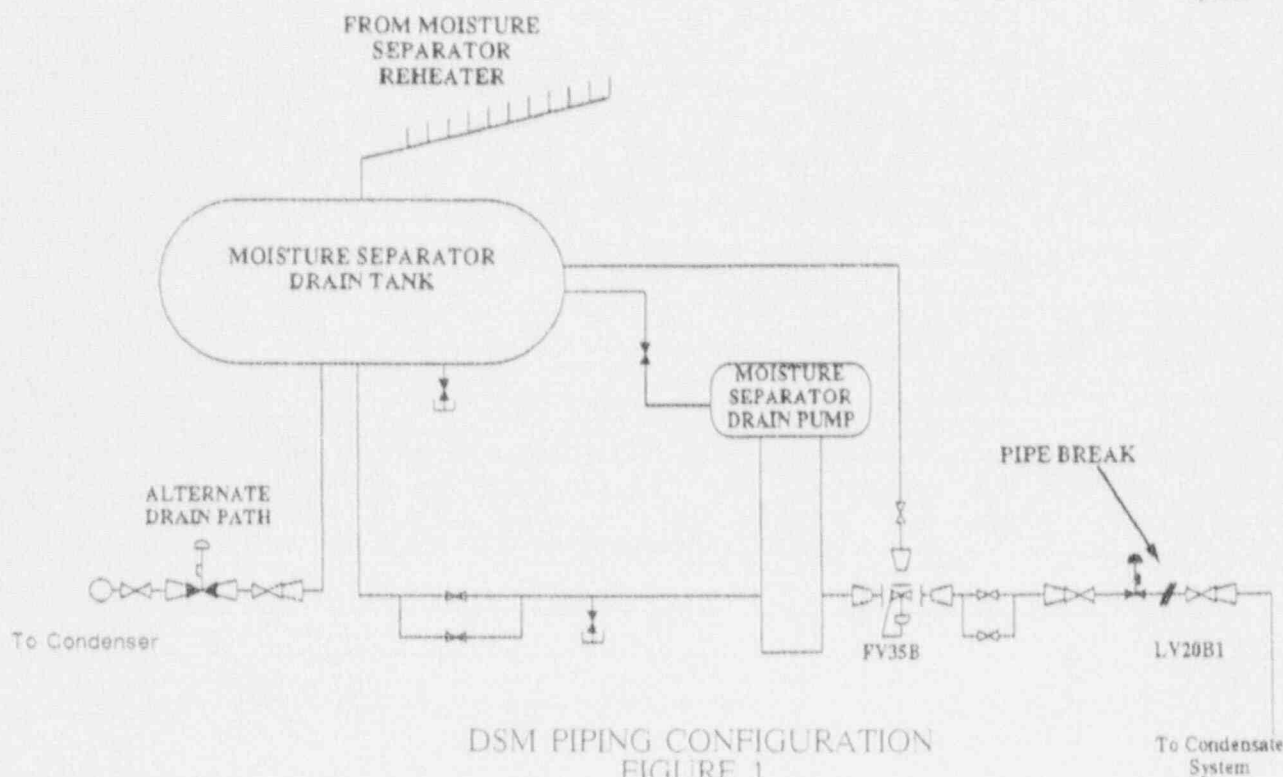
DSM PIPING CONFIGURATION
FIGURE 1

The cause of the failure of the DSM lines was severe wall thinning downstream of the control valves. The wall thickness of the carbon steel, six inch, schedule 40 pipe had decreased from a nominal thickness of 0.280 inches to 0.020 inches at the failure sites. The cause of the thinning is attributed to single phase erosion/corrosion. Piping design, fluid temperature, high fluid velocity, and oxygen content of the fluid contributed to the accelerated wear rate. The original piping design in the early 70's had not considered the significant reductions in fluid oxygen levels that would be achieved by the time the unit was ready for operation. The minimum thickness occurred adjacent to the control valve(s), and increased by 0.011 inches per inch downstream from the valve(s).

The damaged sections of pipe were removed. Temporary pipe caps of a material consistent with the original system design were installed. The plant returned to power utilizing the Moisture Separator drain system alternate drain lines. (See Figure 1). During the third refueling outage (RFO3), which began on February 2, 1991, the six-inch diameter piping unstream and downstream of the level control valves was replaced with six-inch piping having greater erosion/corrosion resistant properties (i.e., 5% chrome-moly, schedule 40 pipe (A-335, grade P5)). The existing piping configuration was determined to be acceptable with the change in piping material.

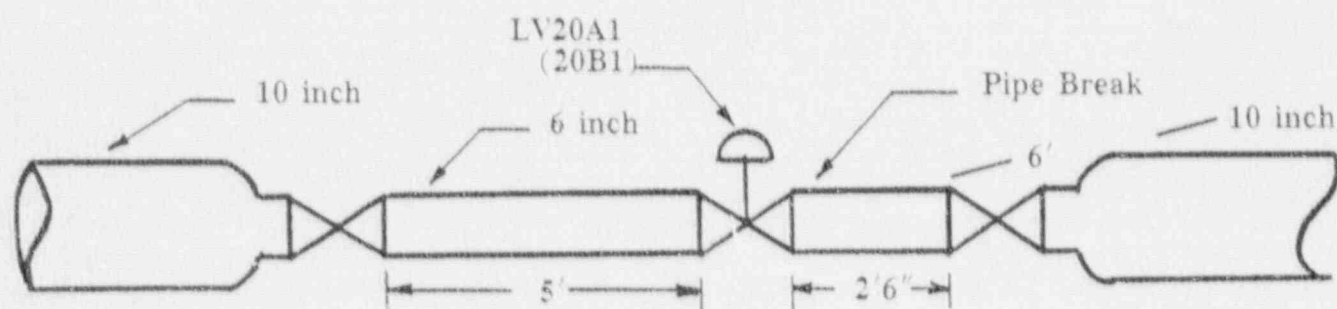
DSM Control Valve Piping Configuration

The configuration of the failed piping was a horizontal run of 10" piping which reduced to 6" piping upstream of a 6" control valve. The 6" piping extended up to a 6" manual isolation valve, then expanded to 10" piping, before tying into the Condensate System. While it is normal to reduce the line size of piping directly upstream of a control valve, in typical piping designs, the piping is increased to the original line size immediately downstream of the associated control valve (see Figure 2). The fluid velocity in the piping downstream of the control valves has been calculated to be in the range of 17 ft/sec, which when coupled with the low oxygen levels produces a high erosion rate.
