Northern States Power Company

MONTICELLO NUCLEAR GENERATING PLANT
Docket No. 50-263 License No. DPR-22

LER 94-015

Failed Component in the Uninterruptible Power Supply Inverter
Causes a Partial Containment Isolation

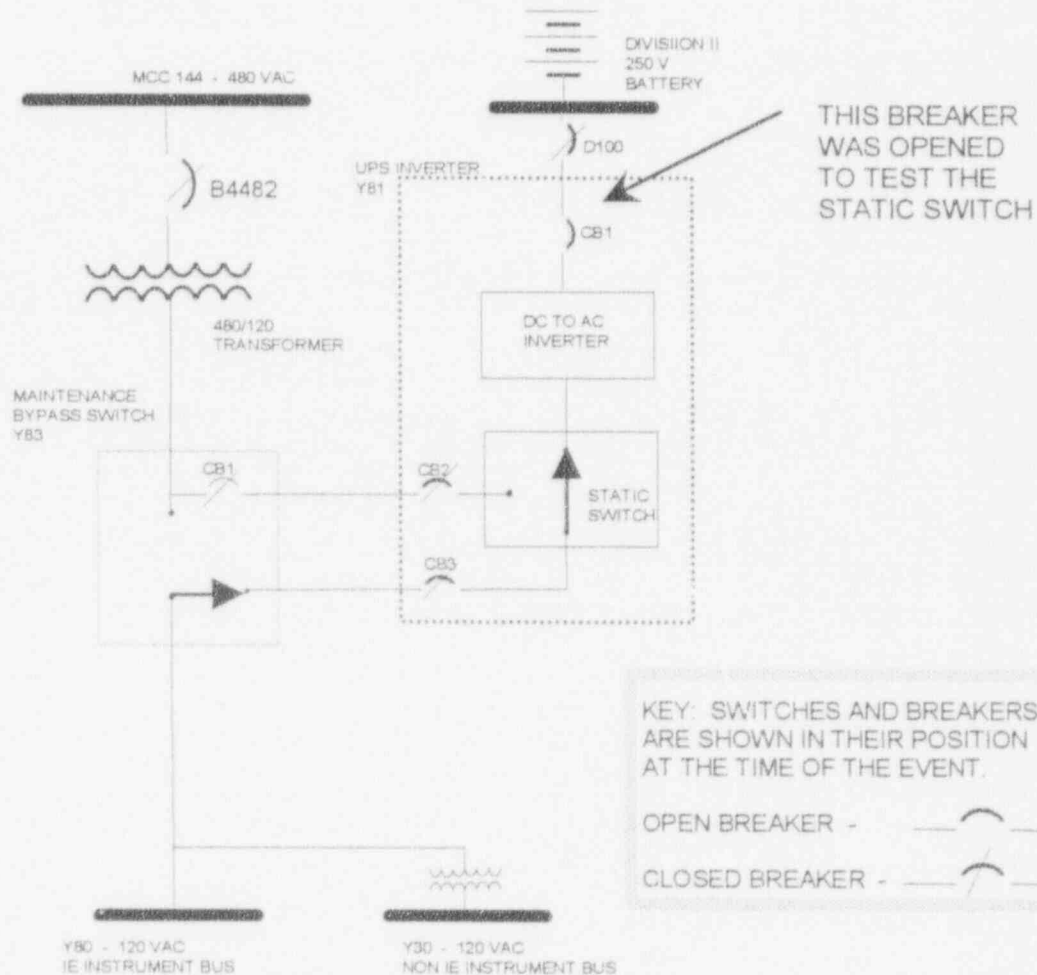
FIGURE 1: DIVISION II UNINTERRUPTIBLE AC DISTRIBUTION SYSTEM

On October 15, 1994 during a refueling outage, a partial containment isolation (EIS System Code: JM) occurred during testing of the Division II Uninterruptible Power Supply Static Switch (EIS Component Code: ASU) per procedure 1292-1. The Division II Uninterruptible Power Supply (EIS System Code: EF) provides power to Instrument Busses (Y30 and Y80). A static switch will automatically switch the busses to the alternate power supply if the logic determines a problem exists with the inverter (EIS Component Code: INVT). Procedure 1292-1 tests this feature by opening the supply breaker (EIS Component Code: 72)(CB-1 on panel Y81, see attached Figure) to the Division II Uninterruptible Power Supply. When this breaker was opened, the static switch failed to transfer to the alternate power supply, leaving the Division II instrument busses without power. This caused a loss of power to the Division II Primary Containment Isolation Logic. A partial isolation occurred including isolation of: Shutdown Cooling (EIS System Code: KE) and Reactor Water Clean Up (EIS System Code: CE); and the startup of the Standby Gas Treatment System (EIS System Code: BH).
