Northern States Power Company

MONTICELLO NUCLEAR GENERATING PLANT
Docket No. 50-263 License No. DPR-22

LER 94-013

Spurious 480 VAC Breaker Trip De-energizes 120 VAC Instrument Bus
Resulting in a Partial Containment Isolation

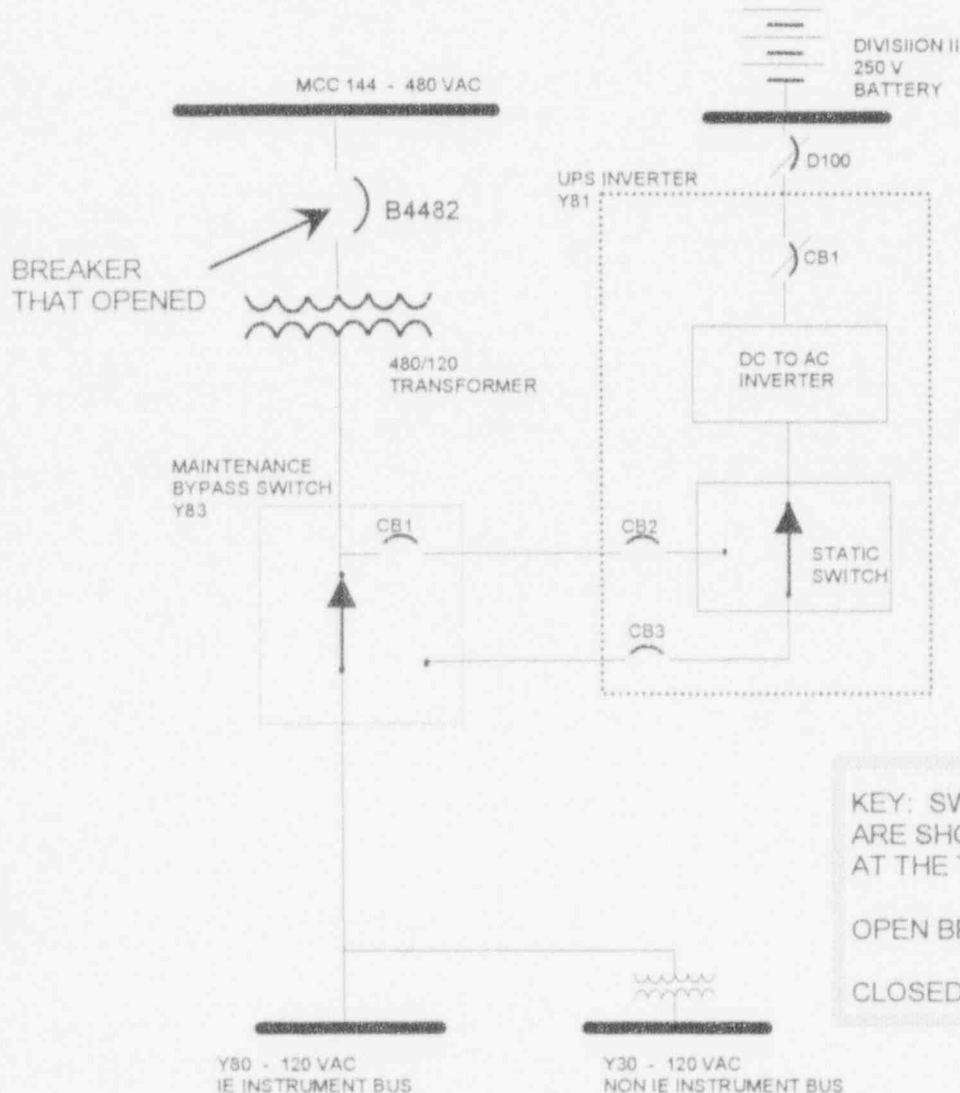
FIGURE 1: DIVISION II UNINTERRUPTIBLE AC DISTRIBUTION SYSTEM

The Division II instrument busses (Y30 and Y80), have two supplies: an inverter (Uninterruptible Power Supply, Y81) (EII Component Code: INVT) and a 480/120 VAC transformer supplied by 480 VAC breaker 4482 (See attached Figure). Prior to the event, the busses were supplied by breaker 4482. The inverter, the normal supply, had been out-of-service for maintenance. Operations was in the process of returning the Division II instrument busses to the inverter when breaker 4482 opened. This de-energized the Division II instrument busses causing a loss of power to the Division II Primary Containment Isolation Logic. A partial containment isolation occurred including isolation of: Shutdown Cooling (EII System Code: KE) and Reactor Water Clean Up (EII System Code: CE); and the startup of the Standby Gas Treatment System (EII System Code: BH).

The cause of the breaker opening could not be determined. The following potential causes were investigated:

No reason for the breaker opening could be found.

1. Operations personnel will review this Licensee Event Report.
2. Training will be provided to operations personnel on appropriate actions to take prior to resetting tripped 480 VAC breakers to aid in trouble shooting.
