Houston Lighting & Power South Texas Project Electric Generating Station P. O. Box 289 Wadsworth, Texas 77483

South Texas Project
Unit 2
Docket Number. STN 50-499
Request for Relief from ASME Section Boiler and Pressure Vessel,
Code, Section XI Requirements
Relief Request RR-ENG-13

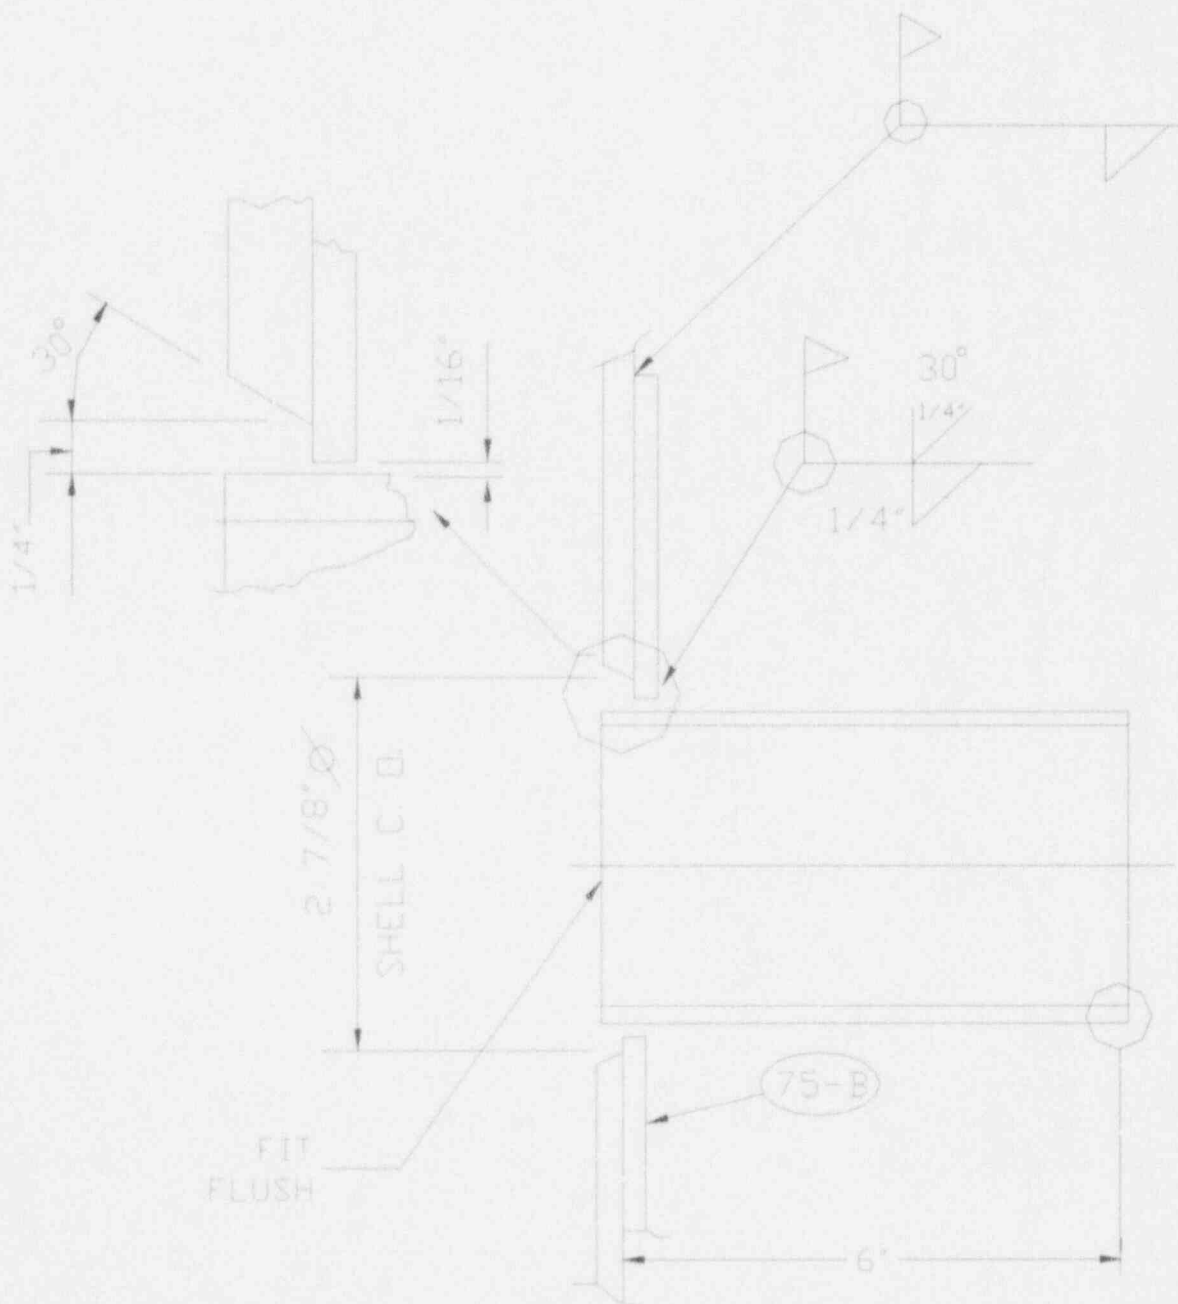
Figure #1 2" Pump Recirculation Nozzle

The scope consists of the nozzle to tank weld and the tank wall behind the reinforcing pad as shown in Figure 1. The tank wall and reinforcing pad are SA240 type 304 material. The pipe nozzle is SA312 type 304 stainless steel with E308 weld material. The 2" nozzle identified as 75A for the pump recirculation line 2"RM-2006 is located 1 foot 6 inches from the tank bottom on the 220 degree azimuth.

A small amount of seepage has been observed from a 1/8" NPT weep hole in the reinforcing pad. It is suspected that the source of the leak is a small defect in the weld of the nozzle to tank wall. The leak was found during plant operations. The intent is to let the through wall defect leak temporarily, subject to monitoring and an evaluation of structural integrity and of the consequences of leakage. Direct observation and nondestructive examination of the through wall defect is not possible at this time due to the joint configuration and presence of a reinforcing pad. An ASME Code repair will be performed as soon as possible, but not later than the next scheduled outage of 30 days or more for Unit 2.

The flaw is expected to be a small through wall pinhole in the weld of the nozzle to tank wall. The leak is currently four drops per hour, and therefore unlikely to cause flooding. However, for analytical purposes it may be noted that system interactions, i.e., consequences of flooding due to the unlikely catastrophic failure of the RMWST tank have been evaluated as described in the UFSAR Section 9.2.7.3. The RMWST tank is located in a compartment in the Mechanical Auxiliary Building (MAB) which is designed to contain the contents of the tank. If both Reactor Makeup Pumps are lost as a result of flooding the MAB, a seismic Category I makeup source would be available by connecting temporary hoses to the vent and drain valves located on the Low Head Safety Injection discharge piping so that refueling water could be delivered to the SFPCCS as described in the UFSAR section 9.1.3.3.2. Low level in the VCT initiates makeup from the RMCS. If the RMCS does not supply sufficient makeup to keep the VCT level from falling to a lower level, a low level alarm is actuated. Manual action may correct the situation or, if the level continues to decrease, a low-low level signal from the level channels causes the suction of the charging pumps to be transferred to the Refueling Water Storage Tank (RWST). Should a loss of the RWST or the RMWST tank occur, the STP can shut down the Unit to Residual Heat Removal (RHR) cut-in via the Boric Acid Tanks (BATs). STP has two BATs, each with a nominal capacity of 33,000 gallons. The minimum capacity is specified in the Technical Specifications. The estimated makeup water usage to take the reactor from hot standby to RHR cut-in conditions is 25,000 gallons. Therefore, the Technical Specification inventory of the BATs is sufficient to shut down the Unit to RHR conditions as described in UFSAR Section 9.3.4.1.

The root cause of the through wall defect is yet to be definitively investigated. The leakage from the weep hole has a slight brown color. The water exiting the weep hole was tested for Sulfate Reducing Bacteria (SRB) and total bacteria which can cause Microbiological Influenced Corrosion (MIC). The result of both tests were negative. If sufficient seepage exists to collect an additional test sample, the sample will be analyzed for the presence of the microbiological organism Gallionella by an outside lab. This tank has a previous history of MIC damage prior to operation that was ASME Code repaired. Based on the previous tank history it is believed that the through wall defect is a preexisting pinhole caused by MIC at the nozzle to tank weld which may have been missed during construction phase repairs. The brown color may be due to corrosion related residue that may have accumulated behind the reinforcing pad and may now be leaching out with the leaking water.

The RMWST is a vertical, austenitic stainless steel tank used for storage of demineralized reactor makeup water. The 2" pump recirculation nozzle is constructed of stainless steel pipe attached to the tank and reinforced with a stainless steel pad outside the tank. The nozzle is welded inside the tank with a full penetration weld and the reinforcing pad is welded to the nozzle and shell with a 1/4" fillet (Figure 1)

The structural integrity of the RMWST tank was evaluated assuming a pinhole of 1/4" diameter in the tank nozzle weld. This estimate is based on the low leakage rate, and historical information which indicates that the probable cause of leakage is a pinhole caused by MIC during construction. The tank had suffered damage due to MIC during the construction phase, which was ASME Code repaired prior to completion of the tank. It is postulated that a pinhole was missed during those repairs and it may have been initially blocked. After years of operation the pinhole may have come unblocked thus leaking. Observations of MIC damage during the construction phase indicated the flaws to be rounded pinholes, generally very small. Assuming a 1/4" pinhole for analytical purposes is conservative. The evaluation below considered all design loading conditions, including dead weight, pressure and seismic loads.

Review of pipe stress analysis calculation identified significant design margins on the pump recirculation nozzle loads based on the as-built configuration. A minimum margin of 67% exists on the nozzle loads for the sustained loadcase, 78% for the upset loadcase and 88% for the faulted loadcase. Based on the substantial margins, compliance with Code Section III stress limits will not be compromised with a postulated through wall pinhole, and catastrophic failure is not credible. From a structural integrity point of view the tank would meet ASME Codes Section III and Section XI even with the postulated defect.

The seepage will be monitored weekly by visual inspection of the reinforcing pad weep hole until ASME Code repairs can be made. A threaded nipple and tubing may be added for leakage collection if necessary. The RMWST compartment in the MAB is monitored on a daily basis by plant operations. Any significant change in the rate of leakage will be followed by a reevaluation of structural integrity of the RMWST tank.

Leave as is, until the next scheduled outage of 30 days or more for Unit 2, subject to the monitoring plan described above, and subject to meeting the criteria for structural integrity described below.

At the next Unit 2 Refueling Outage, the welds in the lower ring and floor of the tank will be inspected visually. Any questionable indications will be liquid penetrant tested. If the results of this inspection give cause for questions about the condition of the rest of the tank, arrangements will be made for additional inspection of the tank interior.

The leakage will be monitored weekly by visual inspection of the reinforcing pad weep hole until ASME Code repairs can be made. Any significant change in the rate of leakage will be followed by a reevaluation of structural integrity of the RMWST tank and increased monitoring.
