SUMMARY REPORT  
ON THE EXAMINATION OF THE  
STEAM GENERATOR TUBE R11-C14  
NORTH ANNA POWER STATION  
UNIT 1

PREPARED BY:  
WESTINGHOUSE ELECTRIC CORPORATION  
FOR  
VIRGINIA ELECTRIC AND POWER COMPANY

SUMMARY ON THE EXAMINATION OF NORTH ANNA  
UNIT 1 STEAM GENERATOR TUBE R11-C14

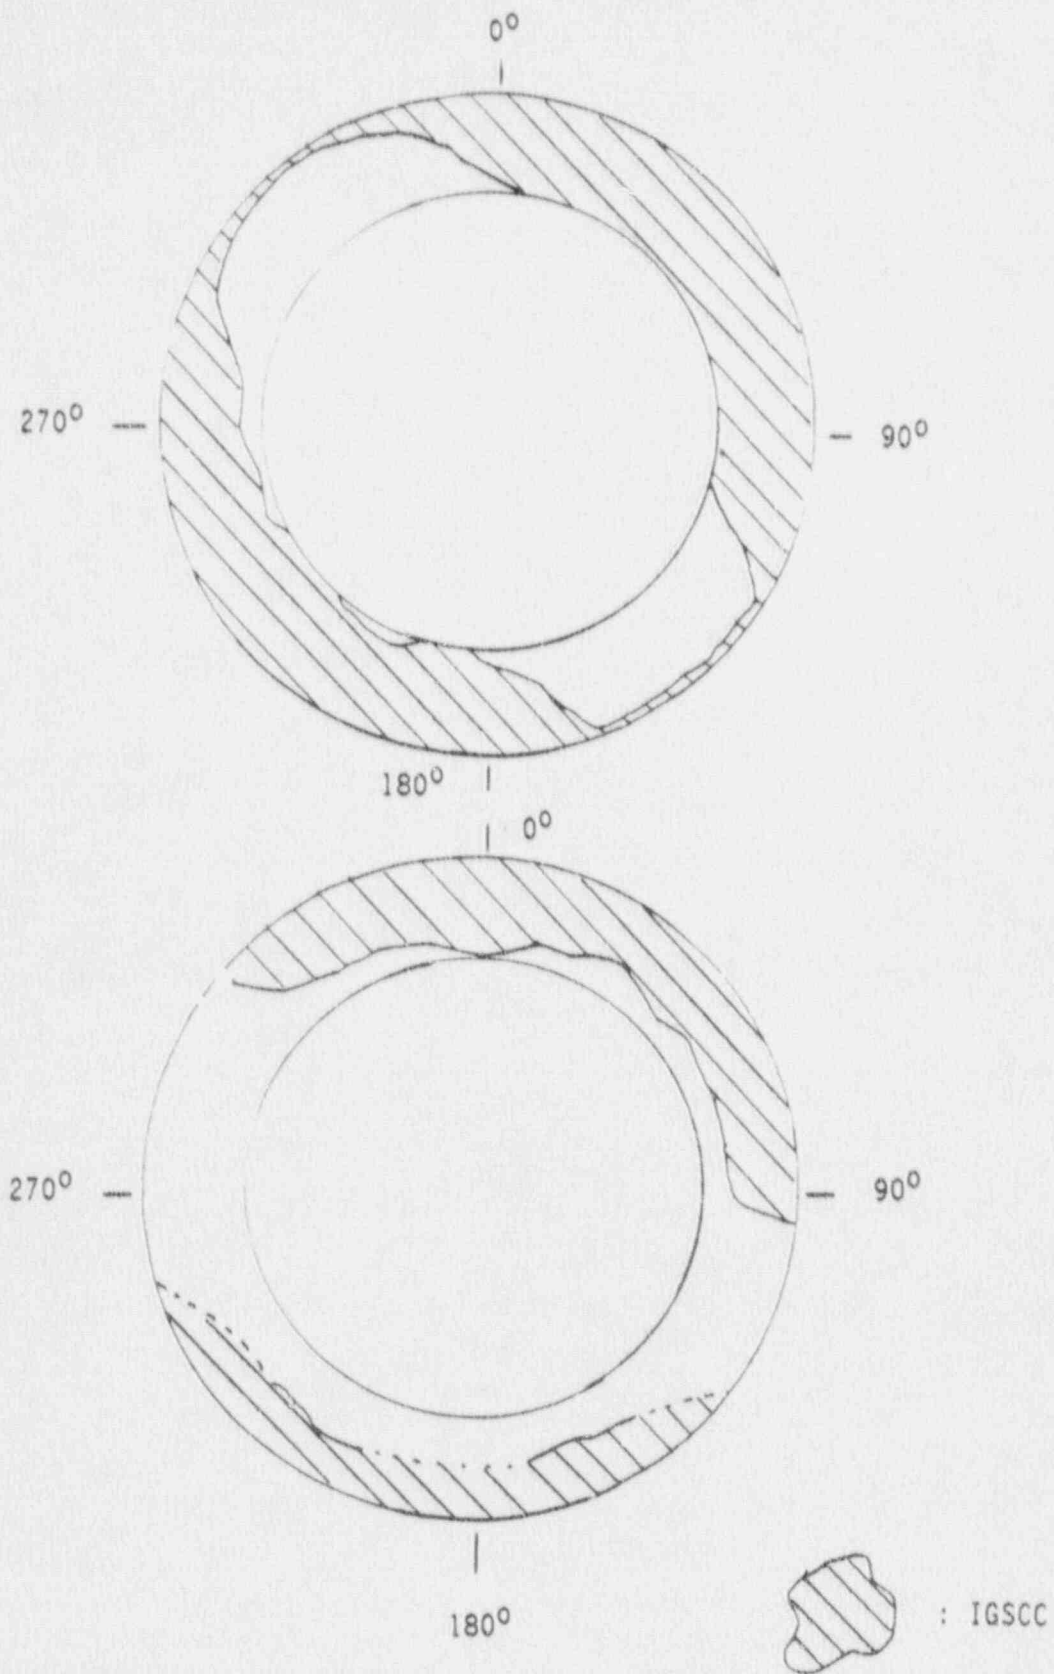
The first support plate crevice region was found to have two regions with circumferential cracking of OD origin. One was located at the support plate top edge and the other at the support plate bottom edge. No cracks were found within the support crevice region between the cracking at the support plate edges. The more extensive corrosion occurred at the support plate top edge where the cracking was located from the support plate top edge to 0.2 inches below. The microcrack network at the support plate top edge formed a continuous 360° macrocrack with two regions with deep (greater than 40% deep) penetrating microcracks. One of the two regions with deeper cracks was 124° long and was located from 348° to 112°. The other was 113° long and was located from 168° to 281°. Both regions had locations where the cracking was throughwall. The maximum length of throughwall cracking was 90°. The two regions were more or less diametrically opposite and were centered near the apex of the tube ovality. Table 1 and Figure 1 present a summary of the crack depths at selected locations by SEM fractography.

The circumferential cracking at the support plate bottom edge occurred in two separate microcrack networks which formed two continuous macrocracks separated by regions without any cracking. The cracking was located from the support plate bottom edge to 0.15 inches above the bottom. One region with cracking was 135° long and was located from 315° through 360/0° to 90°. The second region was 112° long and was located from 135° to 247°. Again, the two regions were centered near the apex of the local ovality. Table 1 and Figure 1 present a summary of crack depths found at the support plate bottom edge. The crack depths for one of the two cracking regions was determined by SEM fractography. At the other

region, where the cracking was judged to be less deep based on visual examination of deformed tube sections, the crack depths were determined by metallography. Consequently, the depth of cracking is not as extensively characterized in comparison to SEM fractographic observations. The maximum depth of cracking at the support plate bottom edge was 98% throughwall.

Figure 1 Sketch of OD origin IGSCC found at the top edge (top sketch) and at the bottom edge (bottom sketch) of the first support plate crevice region of Tube R11-C14. Crack front positions are based on SEM fractography except for crack front on bottom sketch near 180° which is based solely on metallography.
