SEQUOYAH NUCLEAR PLANT (SQN) UNITS 1 AND 2 - DOCKET NOS. 50-327 AND
50-328 - FACILITY OPERATING LICENSES DPR-77 AND 79 - SPECIAL
REPORT 91-03 - FIRE PROTECTION PLAN

ENCLOSURE
14-Day Follow-Up Report
Special Report 91-03

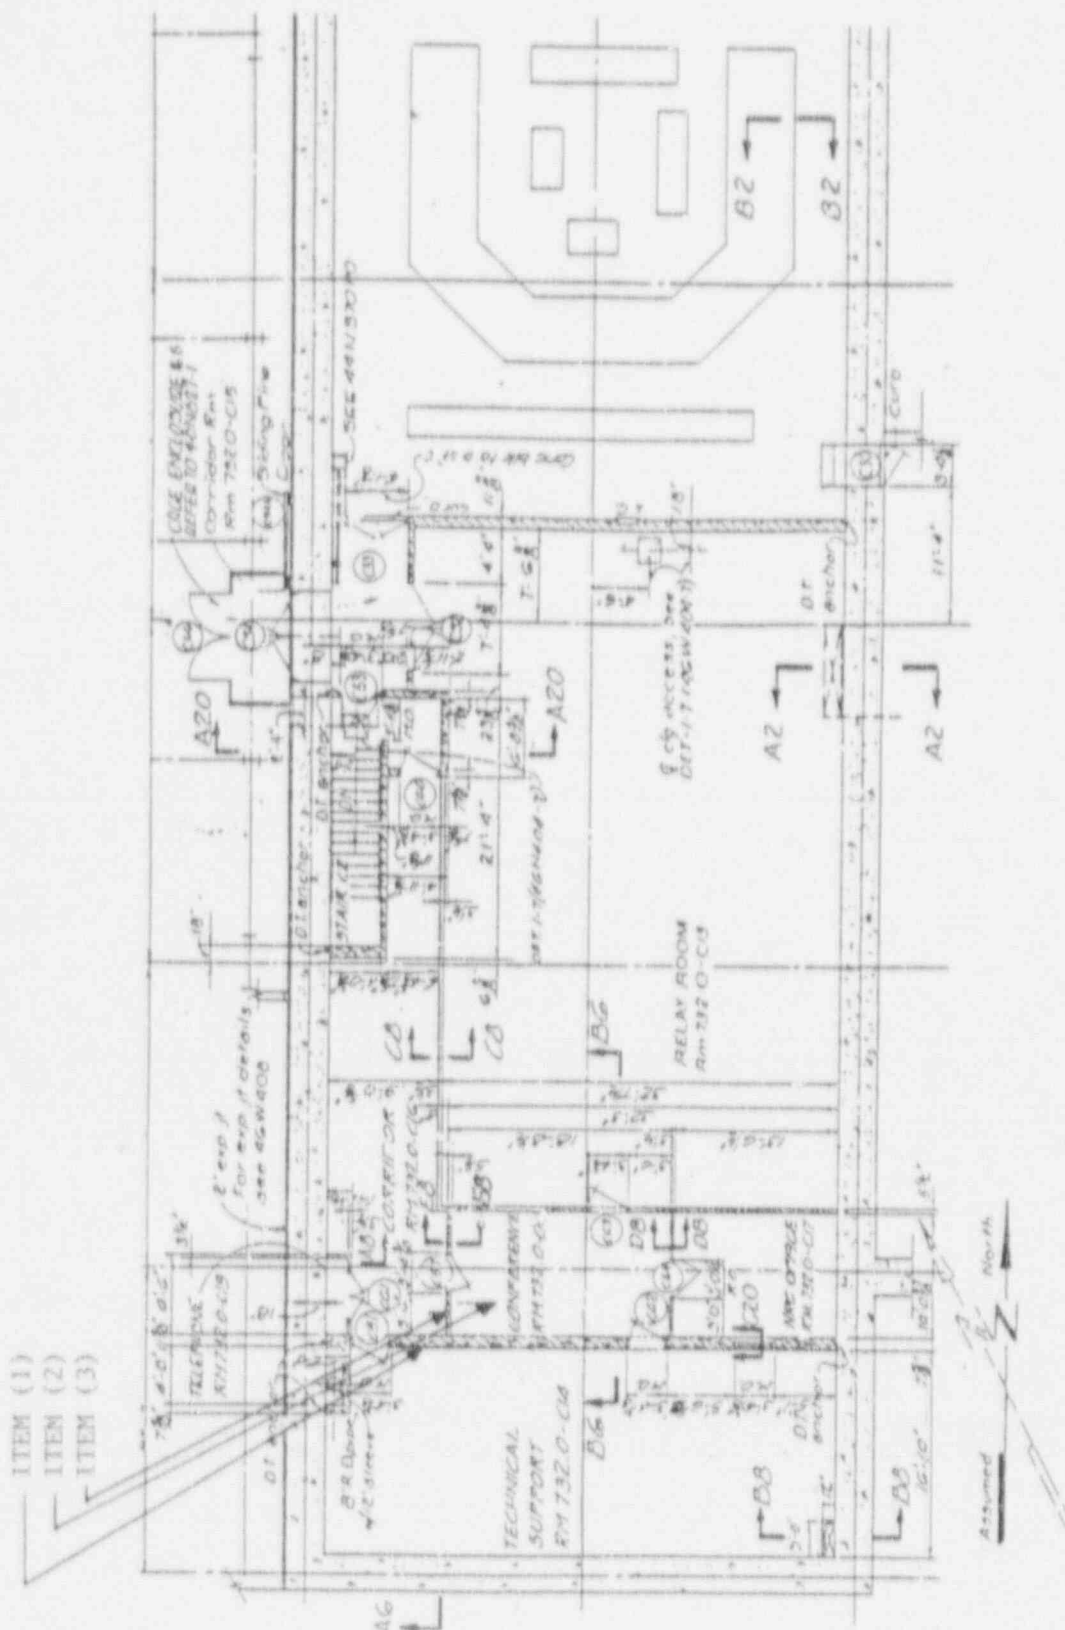
PARTIAL PLAN ELEVATION 734

1. The design of the plaster wall panel above Door C51 located on Elevation 732 of the control building requires installation of plaster on both faces of the wall extending to the concrete roof. However, the plaster on the corridor side of the wall extends only to the suspended corridor ceiling. Therefore, the as-constructed configuration of this wall does not meet the 1-1/2-hour fire rating required by TVA's fire protection plan.

2. The design of the ceiling above the NRC office and conference room adjacent to the Technical Support Center on Elevation 732 of the control building requires installation of two layers of 5/8-inch fire code gypsum board on top of the metal deck. These gypsum boards are not installed. Additionally, two deficiencies were identified in the design configuration of the ceiling. Neither the wood fiber plaster on the underside of the ceiling nor the use of gypsum board on top of the metal deck meets an Underwriters' Laboratory (UL) listed configuration. Therefore, the as-constructed configuration does not meet the fire rating required by the design, and the design of the wall cannot be confirmed to comply with the 1-1/2-hour fire rating required by TVA's fire protection plan.

3. The design of a small section of wall located above the NRC conference room ceiling at the corridor wall requires installation of fire code gypsum board on both faces of the wall. However, the gypsum board is installed on the corridor side only, leaving the wall studs exposed above the conference room ceiling. The effect of this noncompliance on TVA's fire protection plan is being evaluated.

These discrepancies will be corrected as part of modifications required to correct discrepancies identified by Special Report 90-11, Revision 2, dated March 27, 1991. As stated in Special Report 90-11, Revision 2, the walls at Fire Doors C57 and C63 in the NRC office and conference room in the Technical Support Center will be replaced with UL-approved material that extends to the concrete ceiling. This modification will eliminate the requirement for the intermediate ceiling in the NRC office and conference room to be fire rated for compartmentation (Item 2) and will replace the small section of wall at the corridor (Item 3). The plaster wall panel above Door C51 currently extends to the asbestos ceiling that is being removed in this modification (Item 1). Therefore, the scope of the modification has been increased to include reworking this wall to ensure compliance.

1. The walls at Fire Doors C57 and C63 in the NRC office and conference room in the Technical Support Center will be replaced with UL-approved material that extends to the concrete ceiling by October 1, 1991 (previous commitment in Special Report 90-11).
2. The plaster wall panel above Door C51 will be reworked by October 1, 1991.
3. A supplemental response will be provided detailing the cause and any further corrective actions by June 7, 1991.
