Nebraska Public Power District

CNSS830073

Report No.: 50-298-82-14-01
Report Date: February 3, 1983
Occurrence Date: June 7, 1982
Facility: Cooper Nuclear Station
Brownville, Nebraska 68321

A condition was discovered which indicated an abnormal degradation of the Class IN Reactor Water Clean-up (RWCU) System pressure boundary inside primary containment.

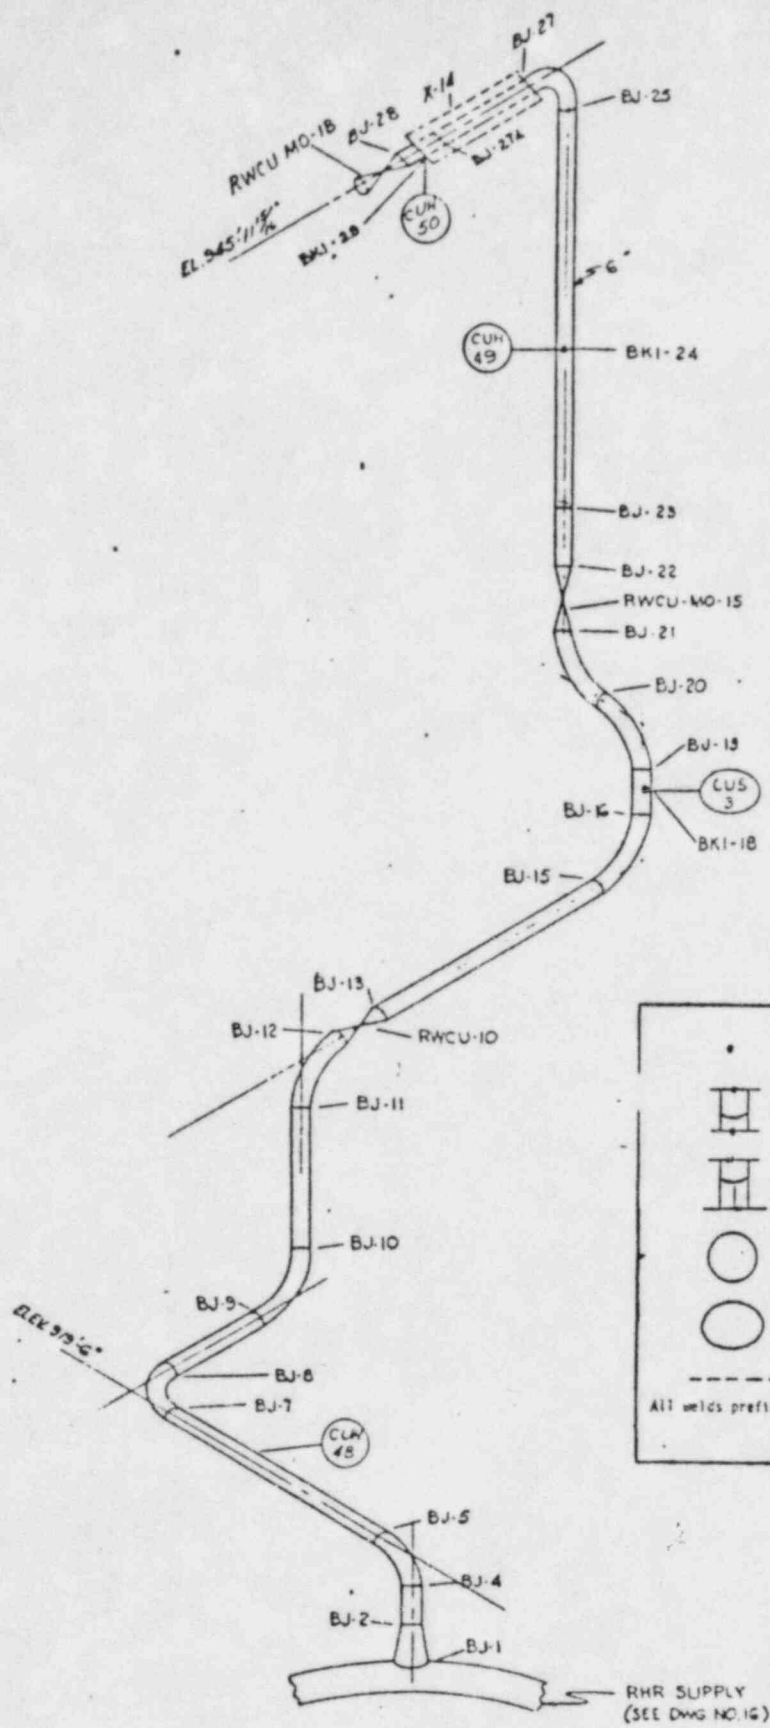
| MODEL: NONE | REV: 4-6-78 | TITLE: CLEAN UP COOPER NUCLEAR STATION | |

During the scheduled replacement of RWCU-MO-15, a six inch 900 pound austenitic stainless steel Anchor Darling gate valve, rejectable indications were detected in the heat affected zones (HAZ) of welds BJ-20 and 23 (reference CNS ISI Drawing #3). The indications were detected by liquid penetrant examination on the inside diameter of welds BJ-20 and 23 near the valve. Subsequent examination of the balance of six inch welds on the RWCU line also produced rejectable indications in welds BJ-13 and 15. The rejectable indications in welds BJ-13 and 15 were detected by ultrasonic (UT) examination.

The failure mode in welds BJ-20 and 23 has been identified as Intergranular Stress Corrosion Cracking (IGSCC), due to weld joint sensitization. Failure analysis was performed by Rockwell International under the direction of the Electric Power Research Institute (EPRI). A detailed report is available from EPRI.

BJ-20 had several circumferential indications in its HAZ. Two transverse indications were present in the HAZ of BJ-23. At the time of occurrence, there was speculation that the indications were IGSCC. This has been verified through failure mode analysis conducted by the Rockwell International Science Center for EPRI. This analysis has determined the cause of IGSCC to be weld joint sensitization, therefore it is concluded that failure was not service induced. These two weld failures are the first cases of IGSCC in this plant.

The piping and fittings affected by the rejectable welds were replaced. The pipe was replaced by material identical to that used in construction. Fittings used were Type 304L, low carbon nuclear grade fittings rather than the Type 304 fittings used in plant construction. Measures were taken to control heat input to the replacement welds, to avoid sensitization of the weld joints.
