Subject: Waterford 3 SES
Docket No. 50-382
License No. NPF-38
Reporting of Licensee Event Report

Waterford Steam Electric Station Unit 3

Shutdown Cooling Malfunction due to Ineffective Work Controls

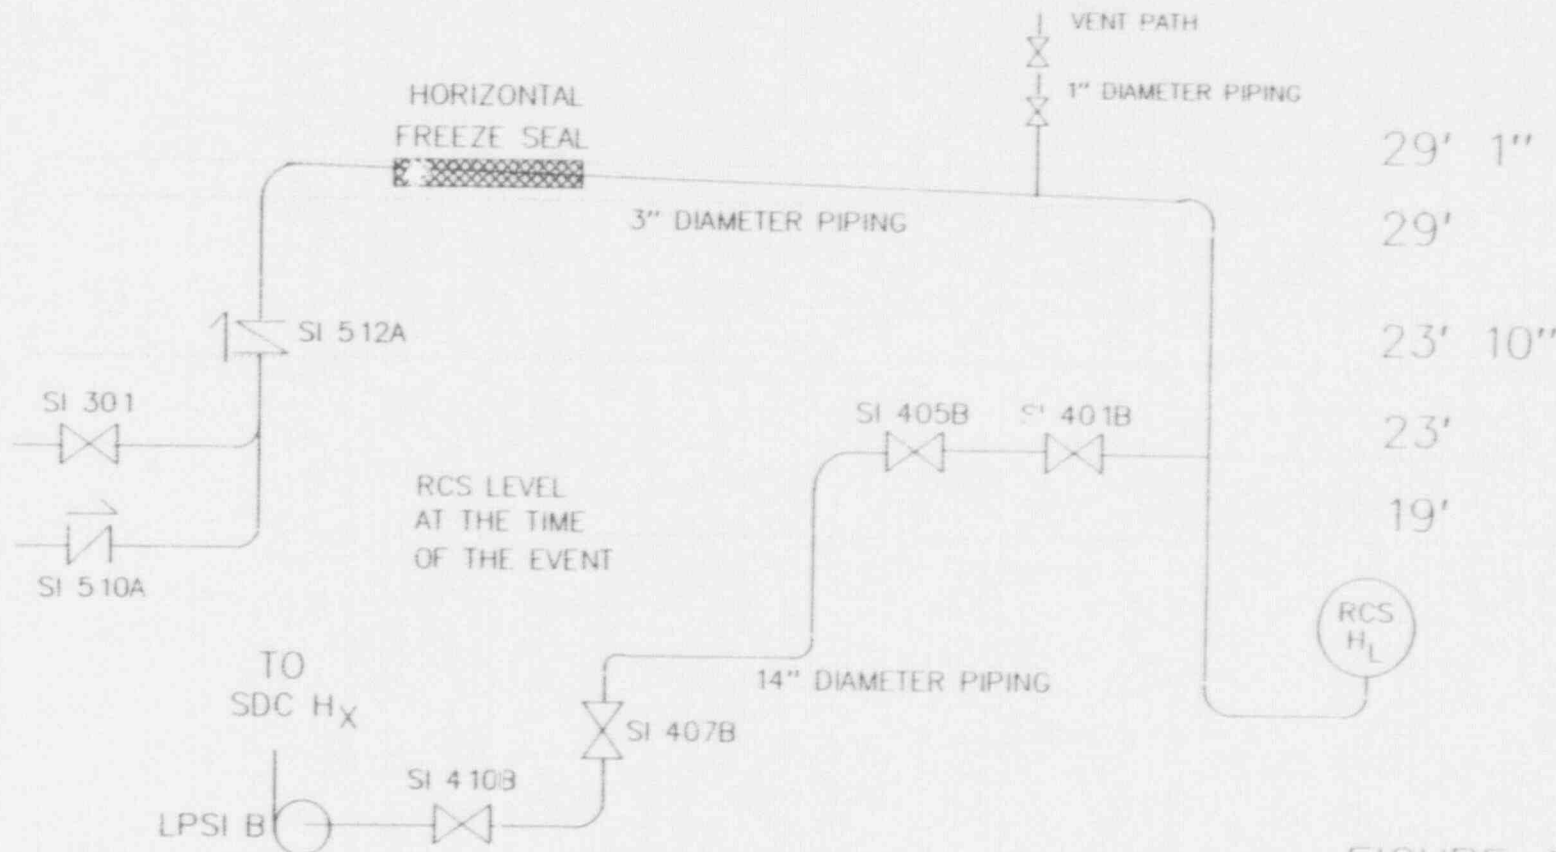
FIGURE 1

On October 6, 1990, Condition Identification (CI) number 271453 was generated reporting boron buildup around the hinge pin cover and bonnet on Safety Injection (SI) valve 512A. Planning and Scheduling Department scheduled the repair of SI 512A in conjunction with the seat repair of SI 301 since both valves could be repaired with the same freeze seal. SI 301 is the reactor coolant loop 1 hot leg injection drain valve (Figure 1).

On April 18, 1991, a Carbon Dioxide (CO2) freeze seal was placed on the horizontal piping between the high point vent and SI 512A (Figure 1). The RCS level was approximately 44 feet MSL, with plant operation in Mode 6, when repairs were initiated. SDC was in service on the 'A' train. A 3 inch frost band was achieved and repairs to SI 301 were completed.

The shutdown cooling malfunction was initiated with the removal of the bonnet from SI 512A. SI 512A is located at an elevation level of 23 feet 10 inches MSL. Removal of the bonnet provided an opening, at atmospheric pressure, on a 3 inch piping path located at an elevation of 23 feet 10 inches MSL. The 3 inch piping connects to the top of a loop seal, located at an elevation of 23 feet MSL (Figure 1). Since the RCS vessel level was only 19 feet MSL, the loop seal was drained and subsequently, the LPSI pump 'B' became air bound and lost net positive suction head (NPSH), resulting in a loss of SDC flow.

The cause of the failure to establish proper freeze seal was air entrapment in the piping while forming the freeze seal. The horizontal piping where the freeze seal was applied was approximately 1 inch higher than the vent path, allowing air to be entrapped in the piping. The horizontal section of piping was vented and air remained entrapped because the vented flow path was from the RCS side of the piping and the entrapped air between the vent and SI 512A could not have been vented due to the physical arrangement of the piping.

SI VALVE ELEVATIONS
