July 20, 1983

Report No.: 50-298-83-11
Report Date: July 20, 1983
Occurrence Date: July 10, 1983
Facility: Cooper Nuclear Station
Brownville, Nebraska 68321

Identification of Occurrence:

A condition was discovered which indicated an abnormal degradation of the Class IN Core Spray (CS) system pressure boundary inside primary containment.

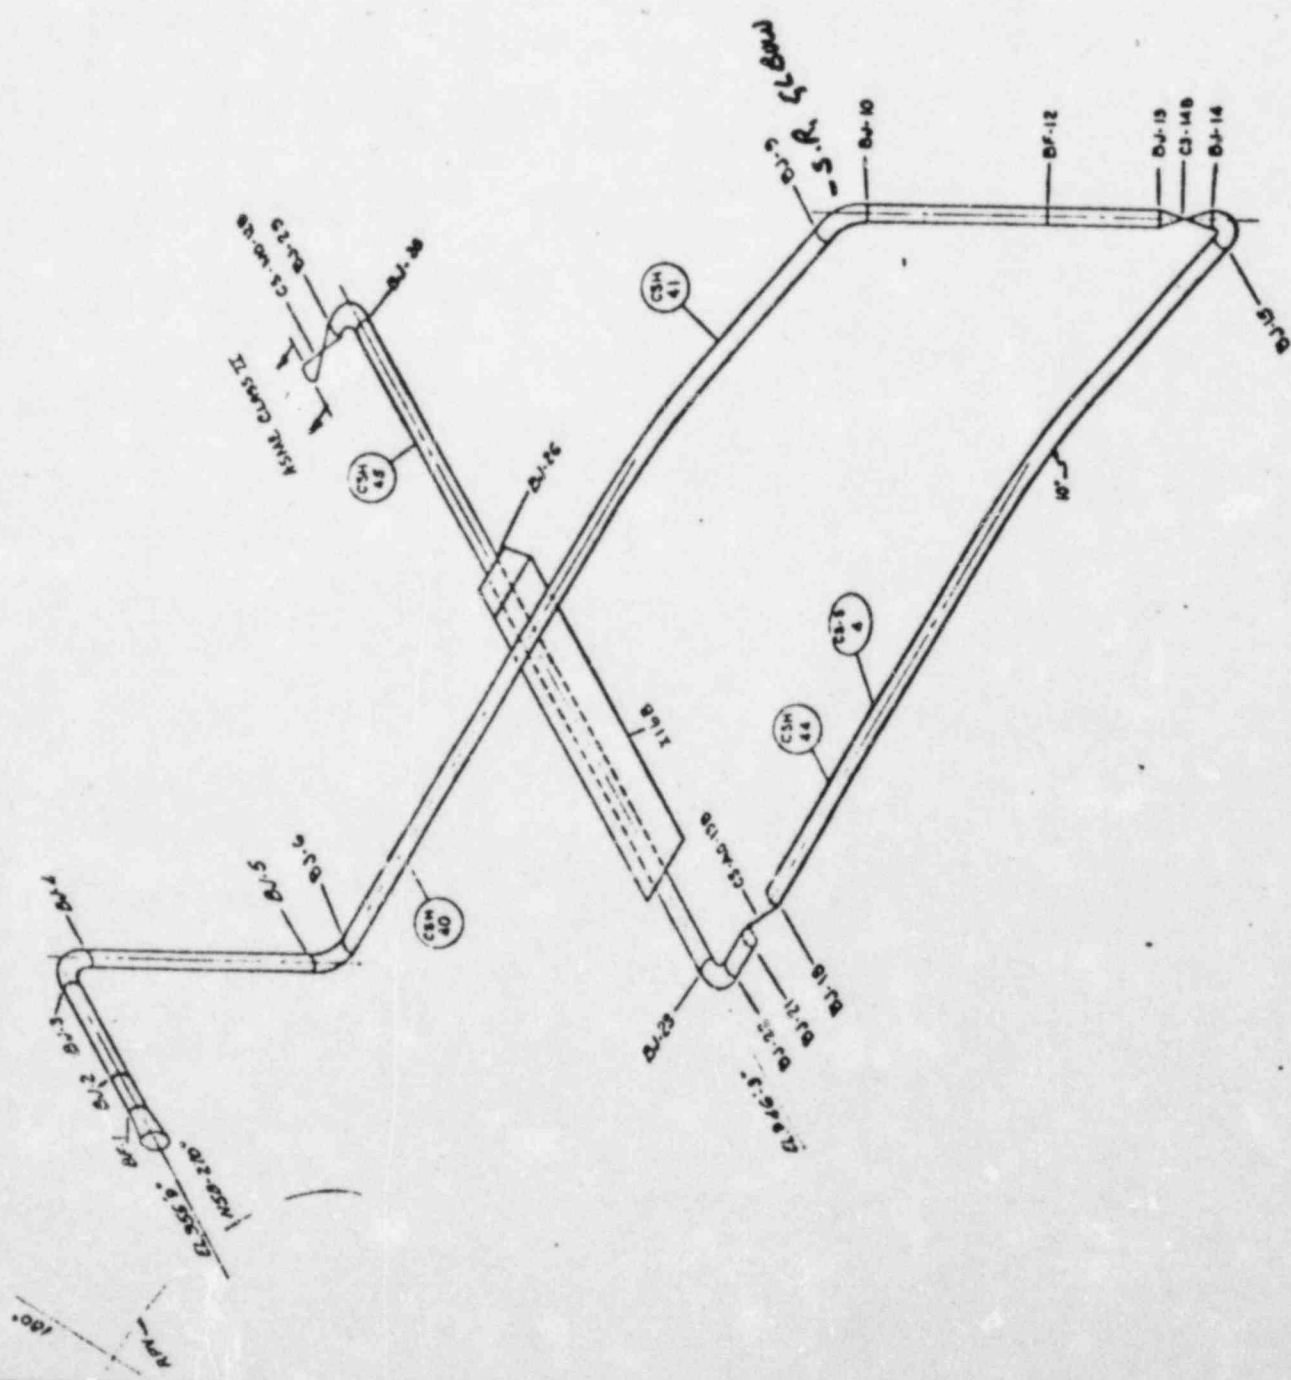
DATE: 2-4-76	DESIGNED BY: H. P.
TITLE: CORE SPRAY LOOP - B	APPROVED BY: C
REFERENCE: JELCO ISO: 2501-1	REVISION NUMBER:

1 0 All rejectable indications found in subject 10" CS piping are due to Intergranular

1 1 Stress Corrosion Cracking (IGSCC). Affected welds will be repaired by weld overlay

The mode of failure in welds CSA-BJ-2, 5, 6, 9, 10, 12; CSB-BJ-2, 3, 4, 5, 6, 9, 10 and 12 is IGSCC.

All welds with rejectable indications are currently being prepared for weld overlay repair. Core Spray piping will be replaced in conjunction with Reactor Recirculation and Reactor Water Cleanup piping replacement, during a future outage.

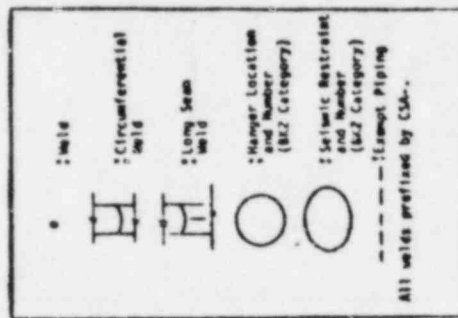
GENERAL ELECTRIC		APPROVED BY: <i>116</i>		DESIGNED BY: J. D.
MODEL: NONE		DATE: 4-5-78		APPROVED: C
TITLES				
CORE SPRAY LOOP-A				
COOPER NUCLEAR STATION				
REFERENCES				
JELCO #001: 2501-1				
JELCO #002: 2502-1

The subject ten inch CS welds were scheduled for examination after finding IGSCC in RWCU piping. Welds CSA-BJ-5 and 6 were visually observed to be leaking by maintenance personnel who were grinding the weld crowns off in preparation for UT inspection. However, the subsequent UT inspection showed that the cracks were 50% through wall and near through wall in welds CSA-BJ-6 and 5, respectively. These UT results were verified by two independent UT inspection teams. Subsequent liquid penetrant exams of each weld failed to reveal the presence of cracks. It is recognized that the grinding performed on the BJ-5 weld crown could have sealed an existing through wall crack. It is questionable, however, whether or not weld BJ-6 was actually leaking. For stress and weld overlay analysis purposes, the actual as found UT data will be used.
