PEACH BOTTOM ATOMIC POWER STATION

SUBJECT: Licensee Event Report  
Peach Bottom Atomic Power Station - Unit 2

Reference:	Docket No. 50-277
Report Number:	2-91-012
Revision Number:	00
Event Date:	05/14/91
Report Date:	06/10/91
Facility:	Peach Bottom Atomic Power Station RD 1, Box 208, Delta, PA 17314

FACILITY NAME (1) Peach Bottom Atomic Power Station -- Unit 2										DOCKET NUMBER (2) 0 5 0 0 0 2 7 7				PAGE (3) 1 OF 0 3		
TITLE (4) Technical Specification Violation due to Failure to Perform Testing as a result of Improper Development of Original Procedure																
EVENT DATE (5)			LER NUMBER (6)				REPORT DATE (7)			OTHER FACILITIES INVOLVED (8)						
MONTH	DAY	YEAR	YEAR	SEQUENTIAL NUMBER	REVISION NUMBER	MONTH	DAY	YEAR	FACILITY NAMES				DOCKET NUMBER(S)			
									PBAPS -- Unit 3				0 5 0 0 0 2 7 8			
0 5	1 4	9 1	9 1	0 1	2	0 0	0 6	1 0	9 1					0 5 0 0 0		
OPERATING MODE (9)		THIS REPORT IS SUBMITTED PURSUANT TO THE REQUIREMENTS OF 10 CFR 5. (Check one or more of the following) (11)														
N		20.402(b)				20.405(c)				50.73(a)(2)(iv)				73.71(b)		
POWER LEVEL (10)		20.405(a)(1)(i)				50.38(a)(1)				50.73(a)(2)(v)				73.71(c)		
0 0 0		20.405(a)(1)(ii)				50.38(a)(

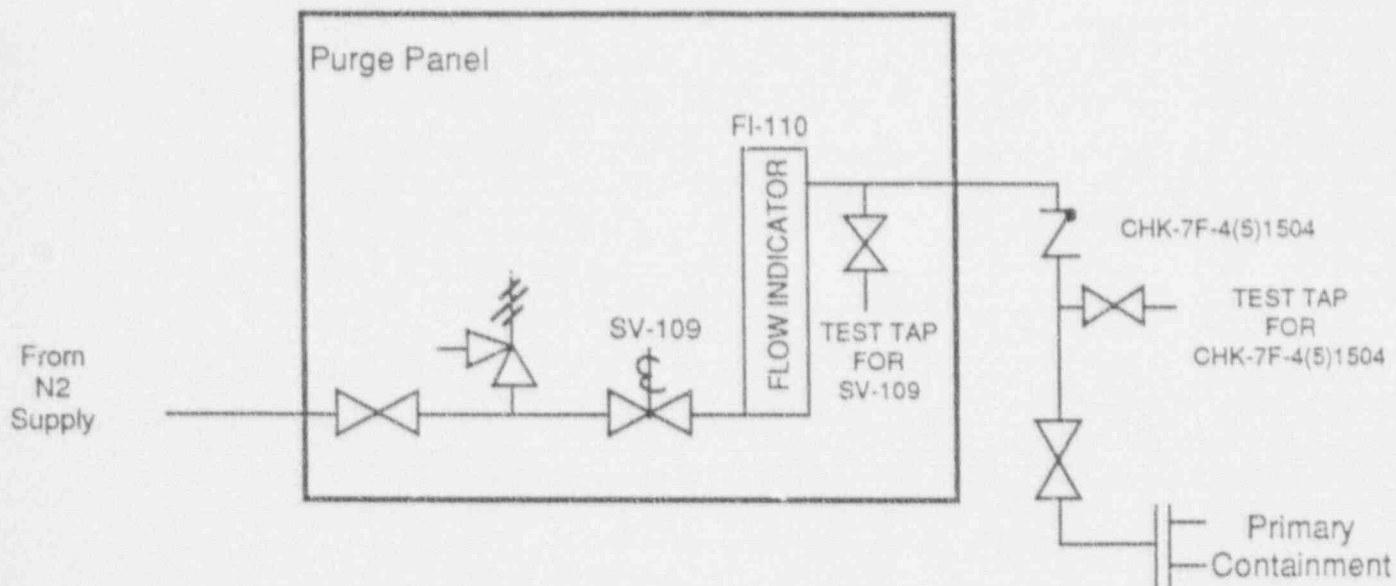
## ATTACHMENT 1 SIMPLIFIED TIP PURGE LINE

On 5/14/91 during the performance of a Local Leak Rate Test (LLRT) on the Unit 3 Traversing Incore Probe (TIP) System purge line isolation valves, it was discovered that one of the isolation valves (SV-109) was not actually being leak rate tested. This is a violation of Technical Specification 4.7.A.2.F which requires that LLRT's be performed on primary containment isolation valves once each operating cycle. Although LLRT's had been performed on the TIP purge line isolation valves during each of the past operating cycles, SV-109 had been essentially isolated during the test by a rotometer type flow indicator (FI-110) which is installed in the piping between the test tap and SV-109 (see attached figure). The same condition was subsequently identified to exist on the Unit 2 TIP purge piping.

During the performance of ST 30.133, "TIP Purge Supply", the technician (Utility, non-licensed) performing the test requested the unit operator to stroke SV-109 to prove its operability since its solenoid operator had recently been replaced. With measured leakage reading zero on the installed test equipment, SV-109 was opened. Measured leakage, which should have gone off-scale with the valve open, remained at zero. The technician realized at this point that the ball which indicates flow in FI-110 was forced downscale on its seat since the LLRT was applying pressure on the outlet side of the rotometer. Since previous LLRT's performed on SV-109 on both Unit 2 and 3 used the same method, true leakage rates had not been measured. This method of leak rate testing SV-109 has been used since the LLRT requirements for these valves became effective in 1985.

The cause of this event was an inadequate review of the TIP System purge piping configuration during the original development of the LLRT procedure. The effects of reverse flow on FI-110 during the LLRT was not fully recognized.

Following the discovery of this event, the LLRT procedures for SV-109 on both Unit 2 and 3 were temporarily modified to allow leak rate testing downstream of FI-110. Leakage through SV-109 on both Unit 2 and 3 was verified to be within acceptance limits.

The LLRT procedures for SV-109 on both Unit 2 and 3 will be permanently revised to allow leak rate testing downstream of FI-110.

A modification will be considered to either relocate the test tap on FI-110 to provide a more suitable means of adequately leak rate testing SV-109.
