LIMERICK GENERATING STATION

U.S. Nuclear Regulatory Commission  
Attn: Document Control Desk  
Washington, DC 20555SUBJECT: Licensee Event Report  
Limerick Generating Station - Unit 2

Reference:	Docket No. 50-353
Report Number:	2-89-010
Revision Number:	01
Event Date:	October 13, 1989
Report Date:	June 20, 1991
Facility:	Limerick Generating Station P.O. Box A, Sanatoga, PA 19464

FACILITY NAME (1) Limerick Generating Station, Unit 2										DOCKET NUMBER (2) 0 5 0 0 0 3 5 3 1 OF 0 17										PAGE (3) 1 OF 0 17			
TITLE (4) Unit 2 HPCI System in a Degraded Condition due to a Personnel Error Which Resulted in Condensate Accumulating Inside the Turbine Exhaust Pipe.																							
EVENT DATE (5)			LER NUMBER (6)				REPORT DATE (7)			OTHER FACILITIES INVOLVED (8)													
MONTH	DAY	YEAR	YEAR	SEQUENTIAL NUMBER	REVISION NUMBER	MONTH	DAY	YEAR	FACILITY NAMES					DOCKET NUMBER(S)									
														0 5 0 0 0 0 0 0 0 0 0 0 0 0 0 0									
1	0	1	3	8	9	8	9	0	1	0	0	1	0	6	2	0	9	1	0 5 0 0 0 0 0 0 0 0 0 0 0 0 0 0				
OPERATING MODE (9)		THIS REPORT IS SUBMITTED PURSUANT TO THE REQUIREMENTS OF 10 CFR 50.73 (Check one or more of the following) (11)																					
1		20.40

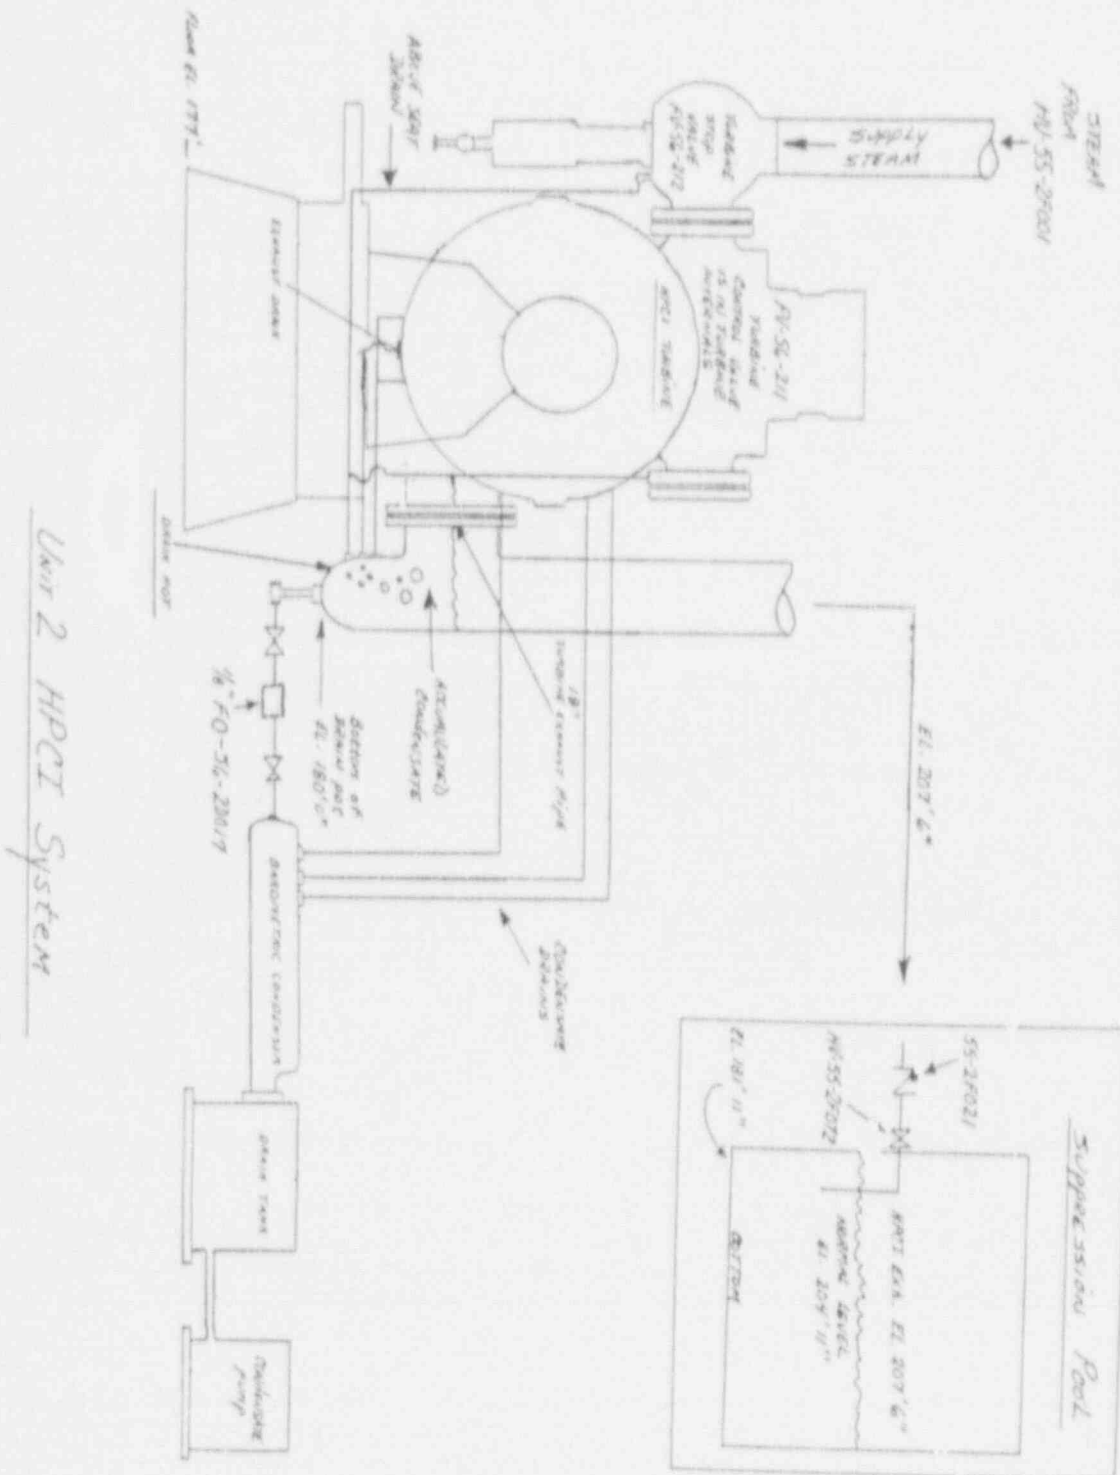
## FIGURE 1

On October 13, 1989, at 1855 hours, the Unit 2 High Pressure Coolant Injection (HPCI) (E11S:BQ) system was declared inoperable due to a condensate accumulation inside the HPCI turbine exhaust pipe resulting from a drain pipe flow orifice (FO) (E11S:OR), FO-56-2D017, blockage (Refer to figure 1). This event resulted in the HPCI system being in a degraded condition which alone could have prevented the fulfillment of its safety function needed to shutdown the reactor and mitigate the consequences of an accident.

The HPCI system engineers discovered that steam was leaking past the seat of the HPCI Steam Supply Valve (HV-55-2F001) to the above valve seat drain of the HPCI Turbine Stop Valve (FV-56-212). The above seat drain for FV-56-212 empties into the HPCI turbine exhaust pipe drain pot, which empties to the HPCI barometric condenser (E11S:CDU) through a 1 inch diameter drain line that contains the 1/8 inch FO. The engineers observed that the piping below the FO was not hot indicating that the leaking steam and resultant condensate was not passing through the FO. The engineers concluded that the FO was clogged which resulted in the collection of condensate in the exhaust piping. The leaking steam was passing through the collected condensate resulting in the observed "bubbling" sound.

The cause of this event was the accumulation of small pieces of debris which blocked the 1/8 inch FO which prevented condensate from draining from the HPCI turbine exhaust pipe to the barometric condenser. A personnel error is the most probable cause that lead to the addition of debris into the turbine exhaust pipe which later resulted in the FO blockage. The condensate accumulation inside the drain pot and the turbine exhaust pipe was a combined effect of steam leaking past the seat of HV-55-2F001 and the blocked FO.

Plant Staff and Engineering have determined the probable cause of the FO blockage to be the result of the accumulation of scale, rust, or grinding debris from original construction. This debris was introduced into the HPCI exhaust pipe when the Suppression Pool (SP) (E1S:BT) was inadvertently overfilled during Unit 2 start-up activities on April 18, 1989 (prior to initial fuel load). This resulted in advertently flooding of the Unit 2 HPCI turbine and exhaust pipes. Overfilling of the SP occurred when water was being transferred from the refueling water storage tank to the SP for temporary storage. During this transfer, the permanent plant SP level indicators and alarms were not in service and temporary local level indication was installed. However, a start-up engineer failed to open the isolation valve for the temporary level indicator, and actual water level was not indicated. The SP water flowed through the normally open HPCI Turbine Exhaust Isolation Valve, HV-55-2F072, and leaked past the seat of the HPCI Turbine Stop Check Valve, 55-2F021, to the turbine. The SP water leaked past the check valve due to insufficient differential pressure to close the valve. While water was being transferred from the refueling water storage tank to the SP, and individual in the Unit 2 HPCI pump room noticed water flowing from the turbine shaft seals. The MCR was immediately notified and the transfer of water was stopped. The debris then settled inside the HPCI turbine exhaust pipe drain pot, and later accumulated inside the FO creating the blockage. The condensate from the leaking steam collected in the drain pot and eventually started to fill the turbine exhaust line and turbine.

Engineering has concluded that the current design of the HPCI turbine exhaust pipe drain pot with a FO is adequate for draining of anticipated condensate. Since the debris causing the FO blockage was blown back up towards the drain pot, this problem may recur. Therefore, the following actions are being taken to verify flow through the FO and preclude further FO blocking.

1. For the Unit 1 and 2 HPCI systems, weekly routine tests (RT) will be written and performed to verify flow through both FCs. Although the Unit 1 HPCI turbine exhaust drain system has not experienced any problems, the system will be inspected weekly as an added precaution. These tests are expected to be written and implemented by November 30, 1989.

2. For the Unit 2 HPCI system, a flush of the HPCI drain pot will be performed during the next appropriate HPCI outage. The steam flow during HPCI system testing adequately flushes the turbine casing and exhaust pipe. Since the bottom of the exhaust pipe drain pot is not in the flow path of the exhaust steam, this is a collection point for any debris, and a flush of the drain pot and its drain pipe is necessary.

3. The blocked FO has been flushed per Action 2 stated above, and the weekly RTs implemented in Action 1 have been performed satisfactorily for a period of eight (8) months. Based on an evaluation of the satisfactory test performances, and no recurrence of the FO blockage, the RT frequency has been changed from weekly to quarterly, and a modification was deemed unnecessary.
