Tennessee Valley Authority, 1101 Market Street, Chattanooga, Tennessee 37402

SEQUOYAH NUCLEAR PLANT (SQN) UNITS 1 AND 2 - FACILITY OPERATING LICENSES  
DPR-77 AND DPR-79 - SPECIAL REPORT 91-09 - FIRE PROTECTION PLAN

ENCLOSURE  
14 Day Follow-Up Report  
Special Report 91-09

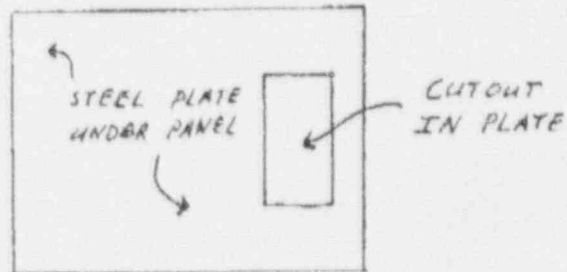
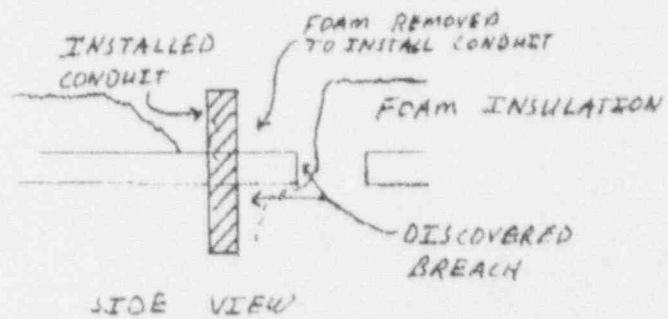
The craftsmen inadvertently proceeded to breach the foam insulation in the bottom of Cabinet III to support the conduit installation. While removing the foam insulation, the subject breach (hole in foam insulation to spreading room) was made. A simplified sketch of the breach is attached. It appears that the craftsmen were not aware that they had inadvertently breached the ECRPB through the foam insulation. The craftsmen proceeded to install the conduit in the bottom of Cabinet III through the steel plate and prepared to install the cable.

The breach discovered from the MCR to the cable spreading room resulted from inadvertent installation of a conduit in panel 2-M-13, Cabinet III instead of Cabinet II. A failure to initiate appropriate documentation and tracking paper for the inadvertent Cabinet III breach also appears to have contributed to failure to correct this condition. Investigation into the cause of the condition is ongoing. The results will be provided in Licensee Event Report (LER) 50-327/91012.

The breach penetrated the fire barrier between the MCR and the cable spreading room. The continuous presence of personnel in the MCR in conjunction with existing fire detection and suppression systems in both the MCR and cable spreading room, provide assurance that a fire in these areas would be identified in order to initiate appropriate response actions.

Because the breach also penetrated the ECRPB, the operability of the control room emergency ventilation system (CREVS) was evaluated. At the time of discovery, no other breaches were open in the pressurization boundary. The size of the discovered breach was calculated to be within limits such that operability of CREVS was not impacted. An evaluation of potential CREVS operability impacts since the breach was initially opened is ongoing. The results will be included in LER 50-327/91012.

Upon discovery of the breach, the operability of fire detection systems in the affected areas was verified, and the breach included in fire watch patrols, in accordance with LCO 3.7.12. A work request was initiated to repair the breach. At approximately 1600 EDT on June 12, 1991, the breach was sealed. Documentation for sealing the breach was completed, and LCO 3.7.12 exited at 1327 EDT on June 13, 1991.
