CLINCH RIVER BREEDER REACTOR PLANT PROJECT (CRBRP) FAULT EVALUATION REPORT

FAULT EVALUATION REPORT

FAULT NO. 1

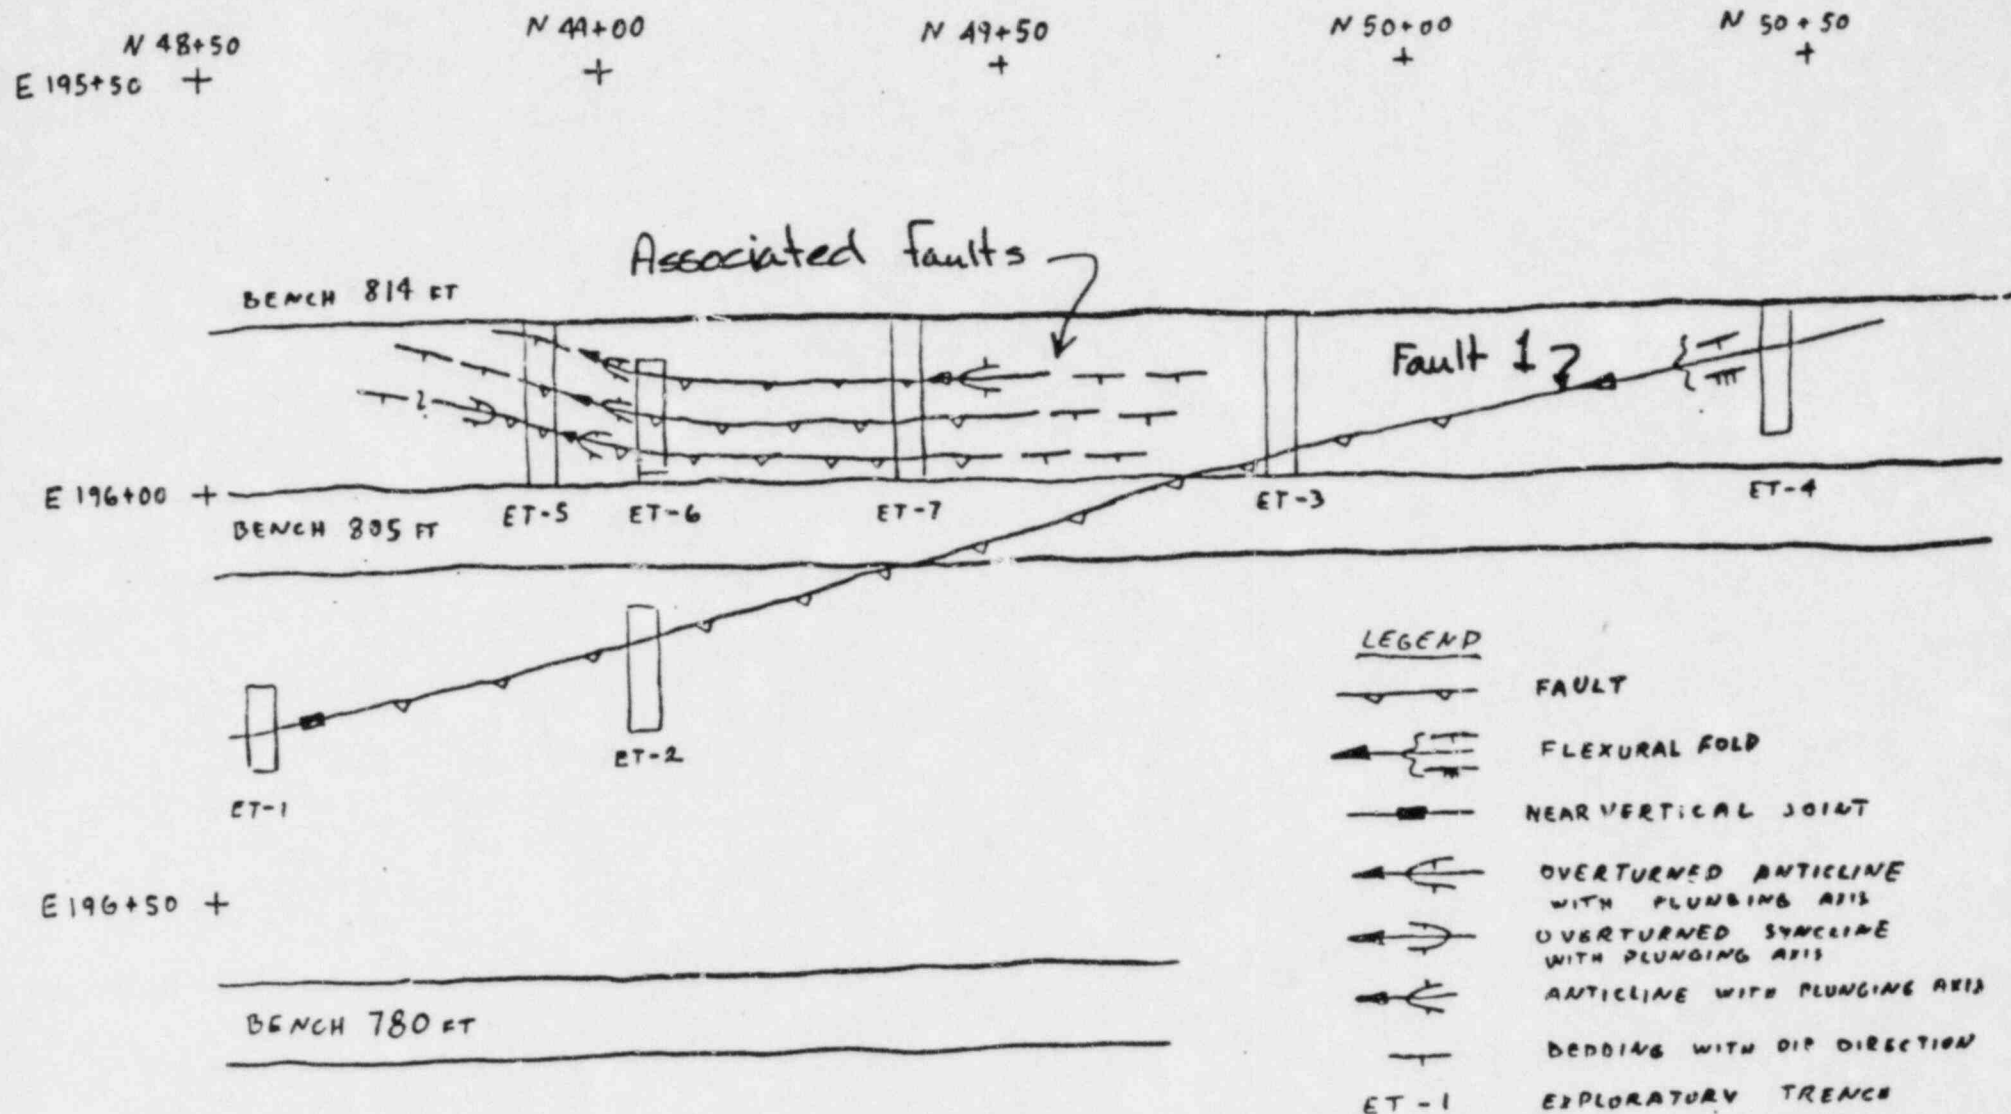
FIGURE 2  
 FAULT DETAIL MAP  
 (PLAN)

The fault is located in residual soil of the Unit A Upper Siltstone formation within the Chickamauga Group and comprises a series of localized bedding distortions and minor offsets of the type described in PSAR Section 2.5.1.1.3.1. Characterization and limits of the traces of the fault were studied by trenching in the area. Observations and measurements of the fault show movement along planes striking NE and steeply dipping to the SE. Several associated fault planes were observed to terminate by gradual transition into bedding planes or joints, and extended vertically from 1.8 feet to over 10 feet, and were traced laterally for a maximum distance of approximately 150 feet. Characteristics of the fault between stations N48+50 and N50+50 are shown on the Fault Detail Map (Figure 2). Photographs of the fault are presented in Appendix A.

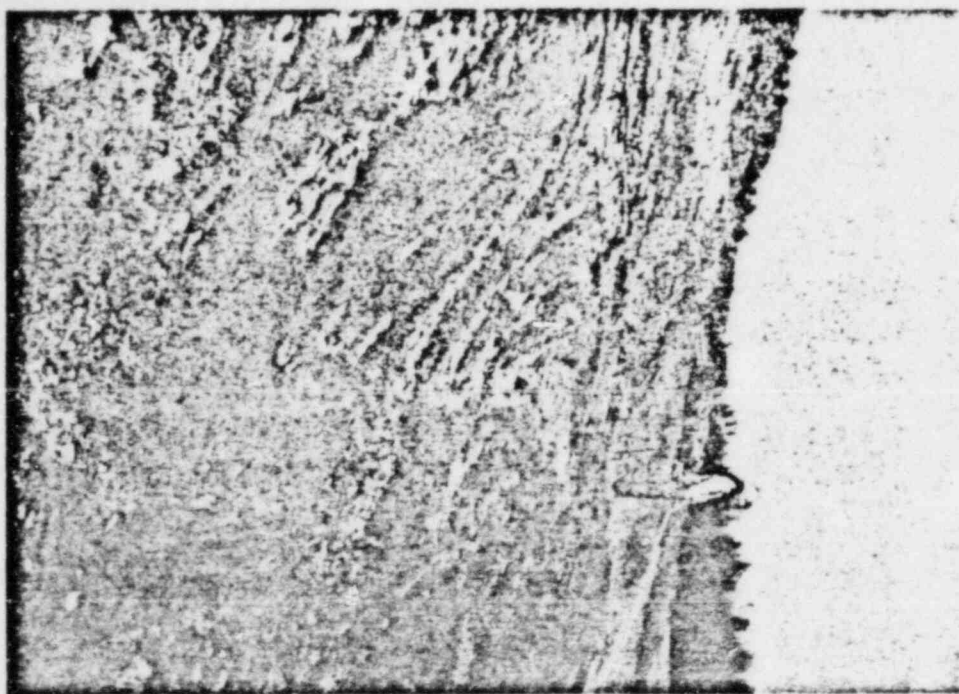
#### PHOTO No. 1

Surface exposure on the East slope of the West ridge, view NNW along strike between N48+00 and N53+00, and E195+75 and E196+30 and Elevations 780 to 815.

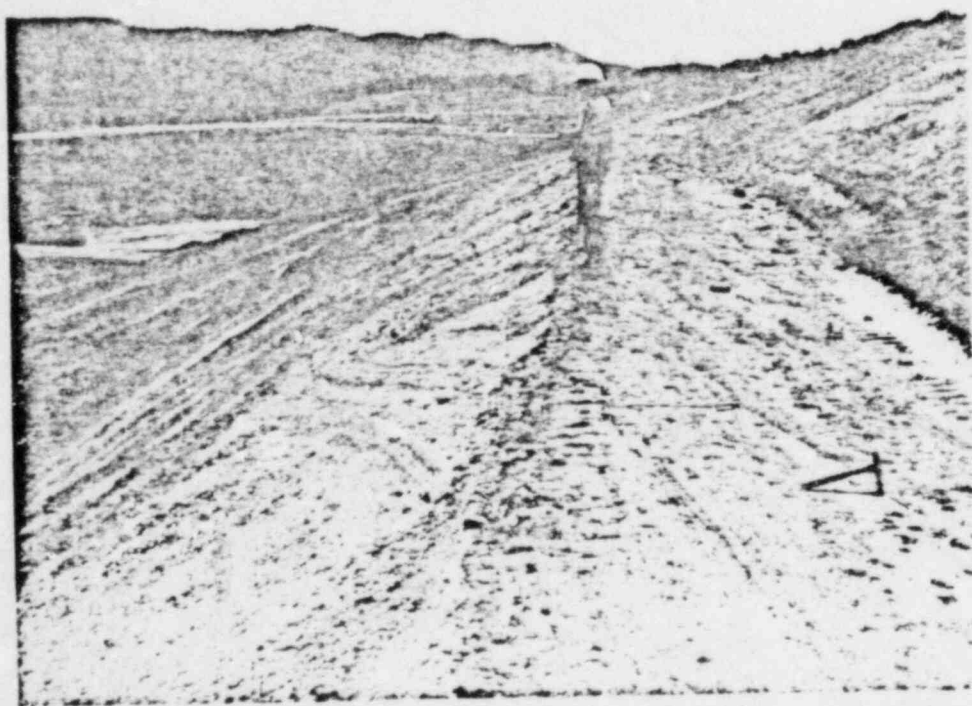
#### PHOTO No. 2

Surface exposure on the East slope of the West ridge, view SSE along strike.

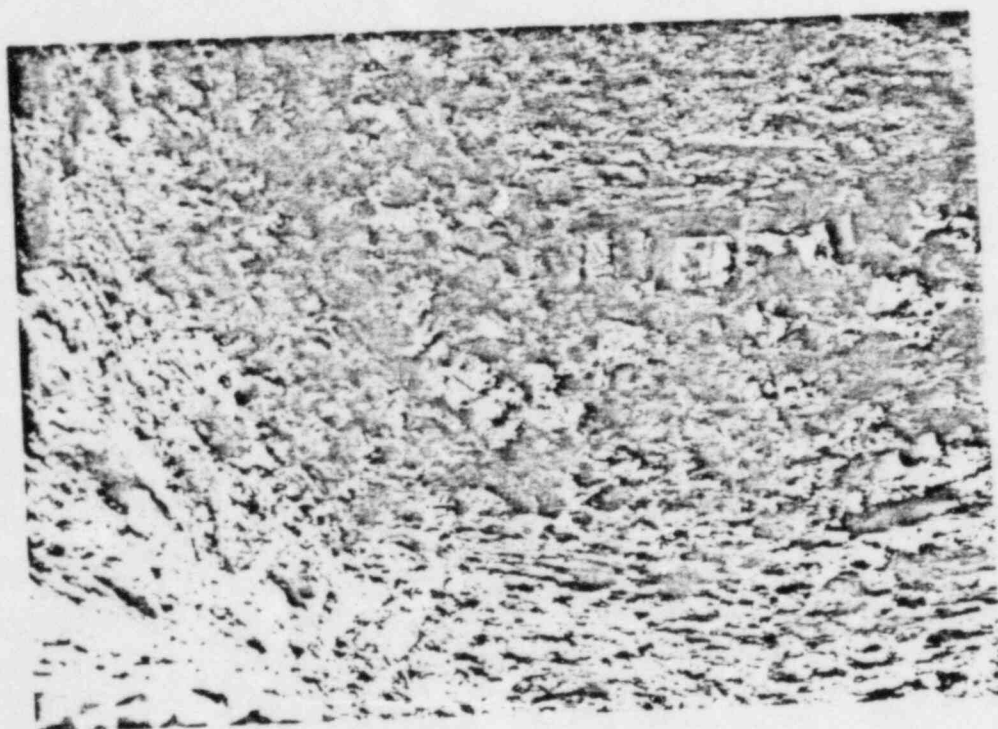
#### PHOTO No. 3

Exploratory trench #4, North wall, close-up view of fold axis, slight off-set of chert bed.

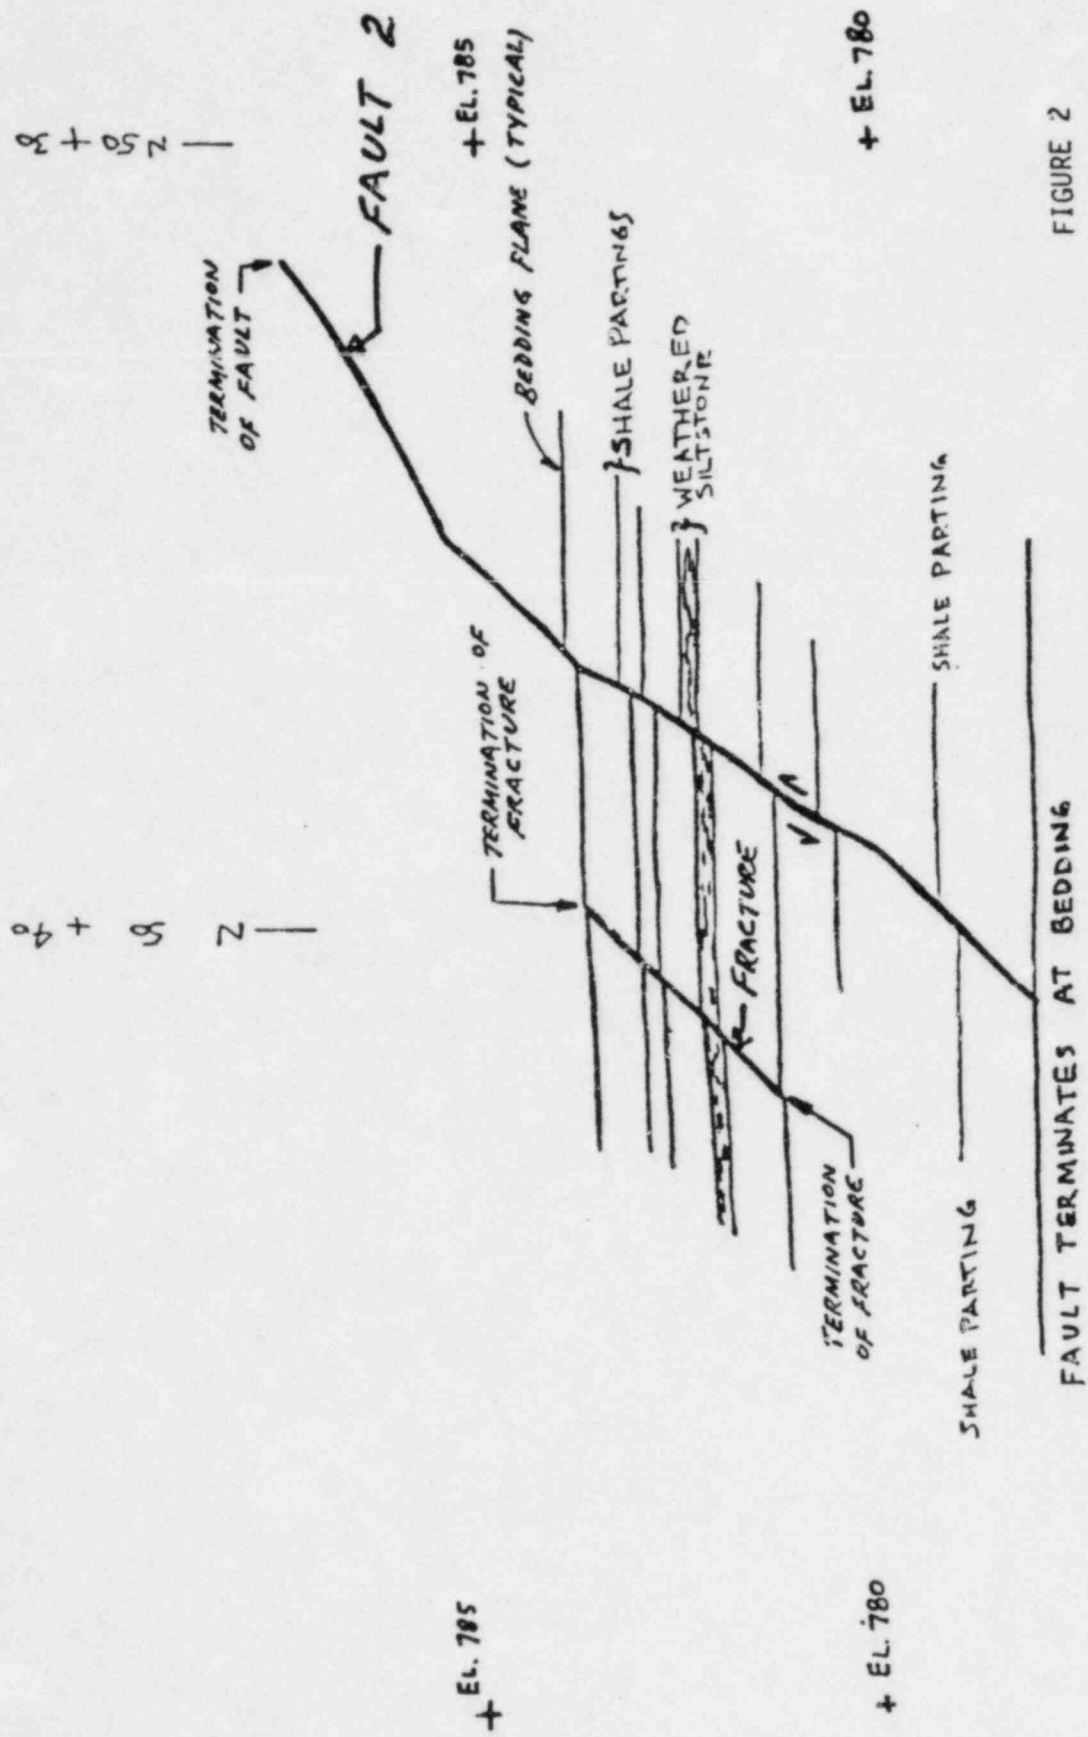
FIGURE 2

The main fault, and an associated fracture which produced minor displacement, are approximately three feet apart and are shown on the attached Fault Map (Figure 2). A second associated fracture with minor displacement is approximately 25 feet to the North and is almost identical to the two features identified above. Photographs of the fault are presented in Appendix A.

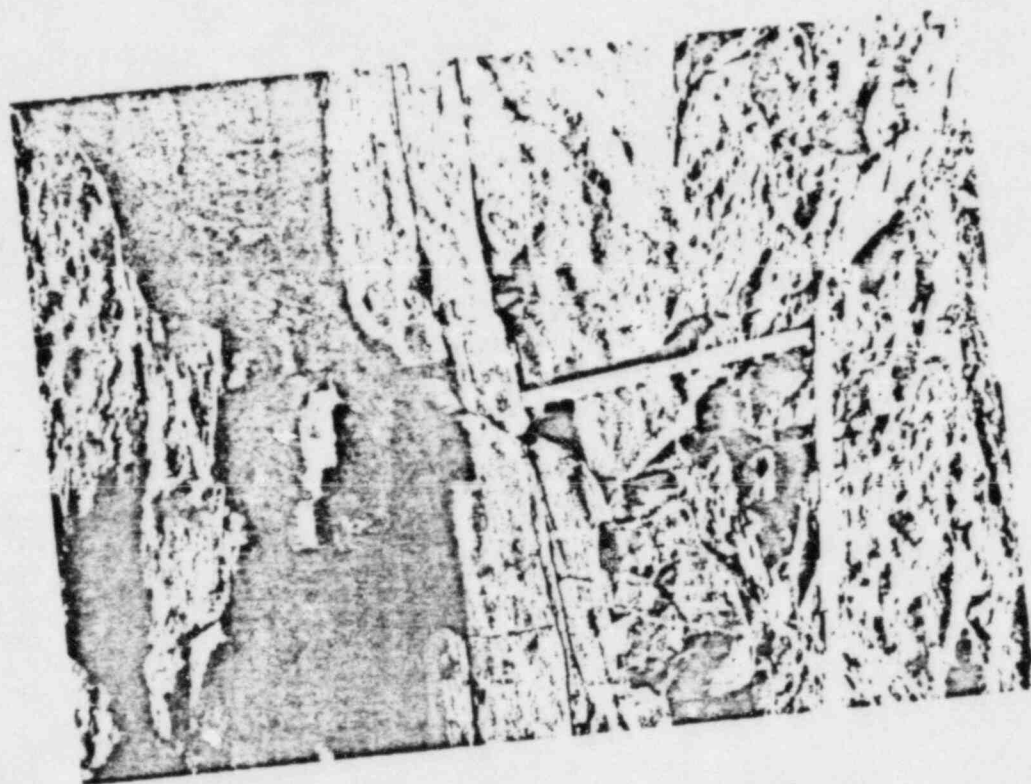
PHOTO NO. 1

N50+36, E201+65 at upper terminating point, to the bench at  
Elevation 780 (bottom of picture).

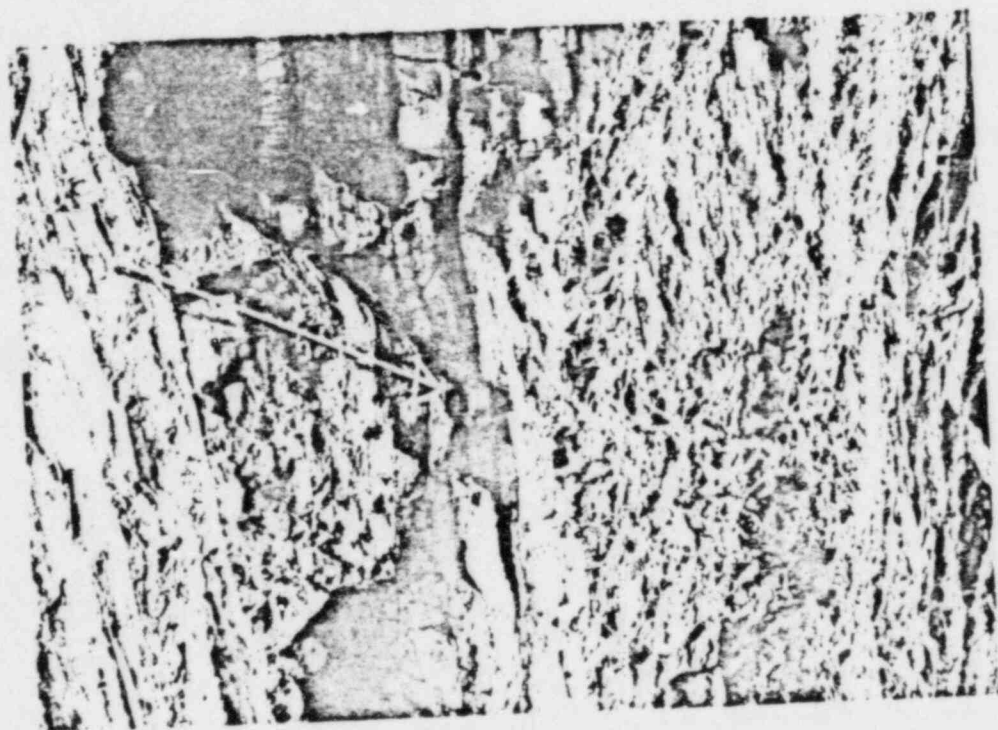
PHOTO NO. 2

Close-up view of apparent off-set (0.2 ft.)

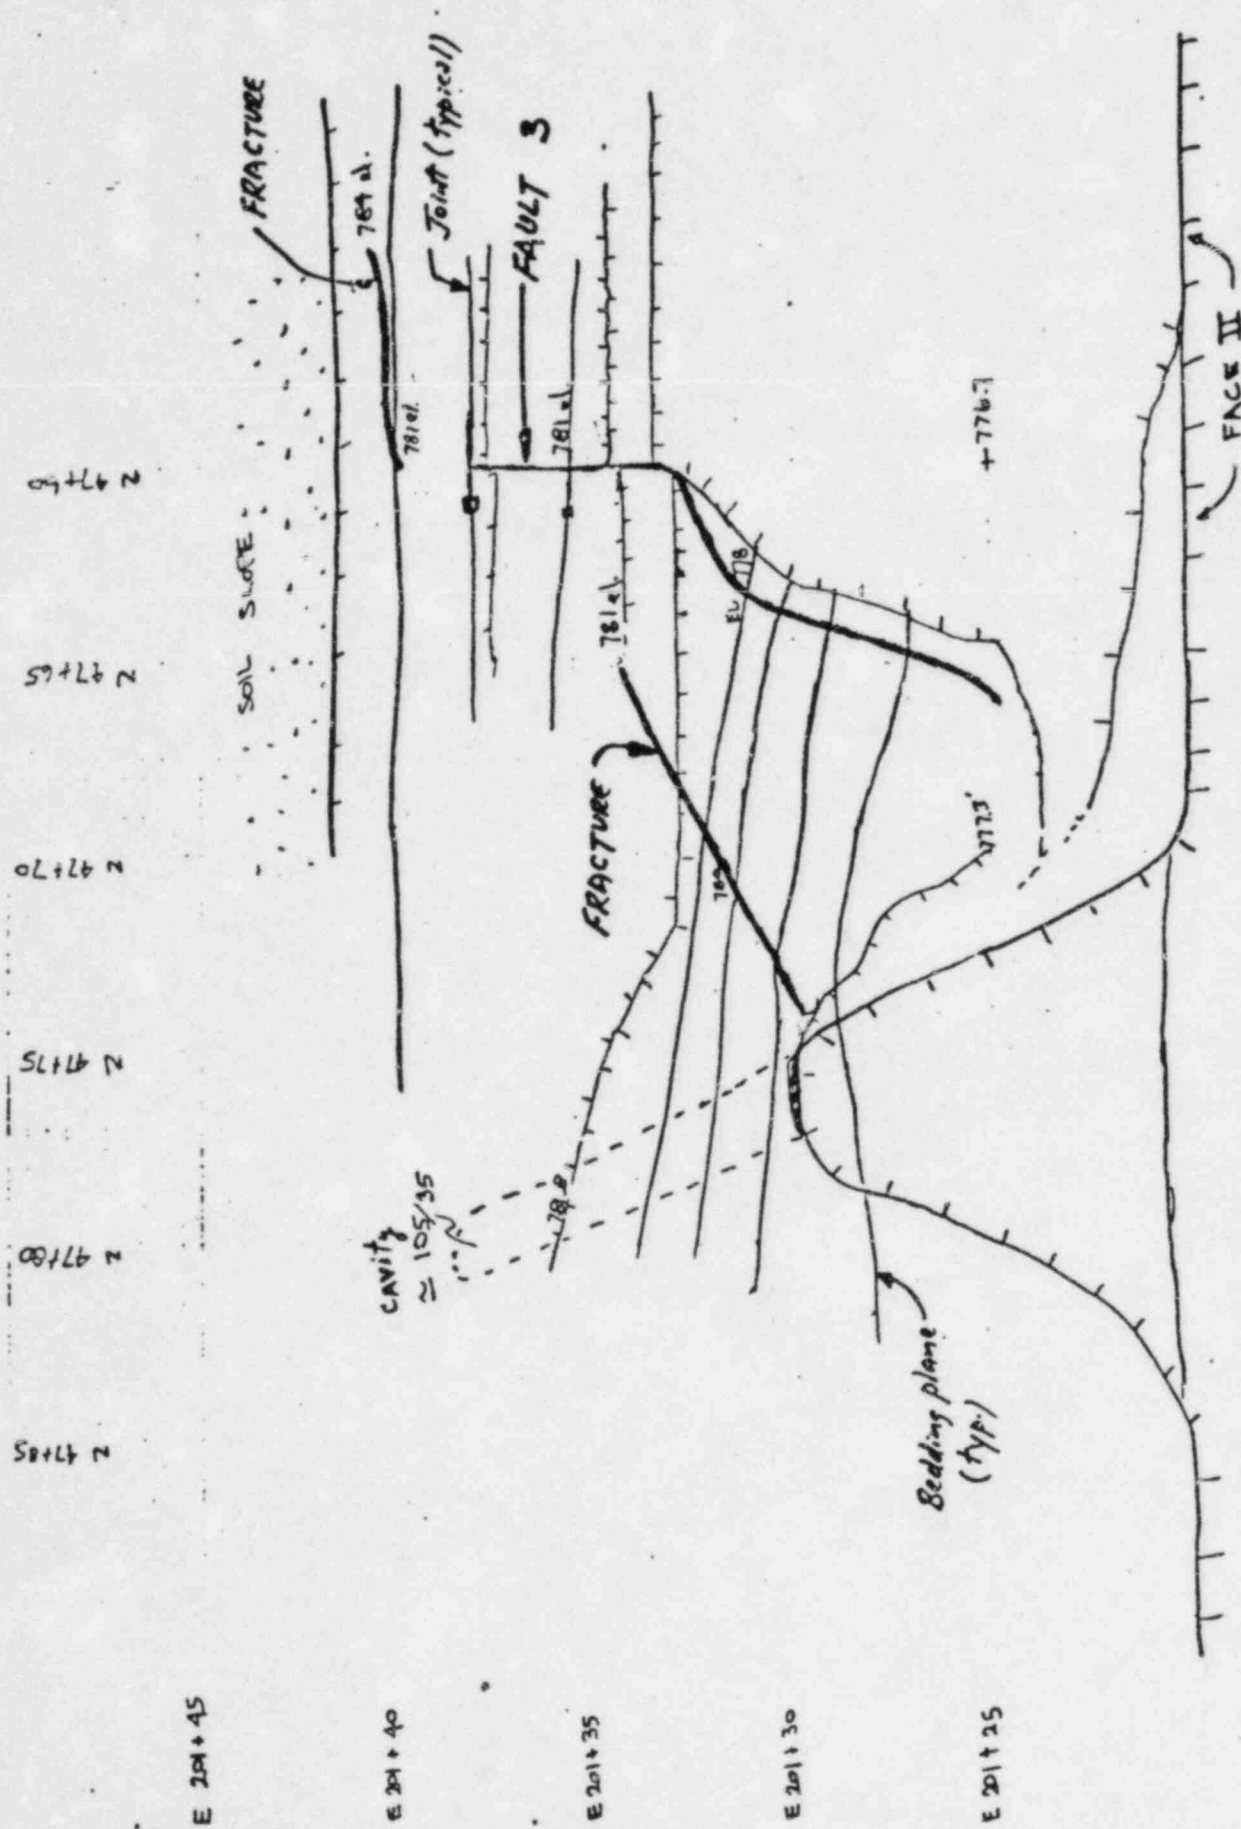
FIGURE 2  
FAULT MAP  
(PLAN)

Locations of the main fault trace and associated fractures are shown on the attached Fault Map (Figure 2). Photographs of the fault are presented in Appendix A.

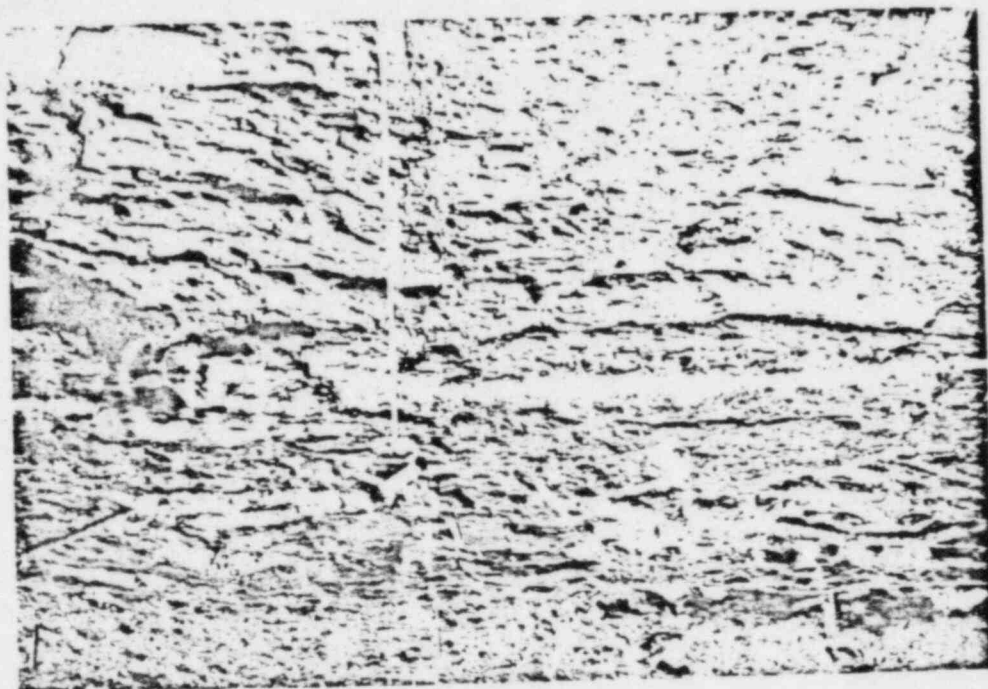
PHOTO NO. 1

N47+60, Elevation 780, at approximately E201+35

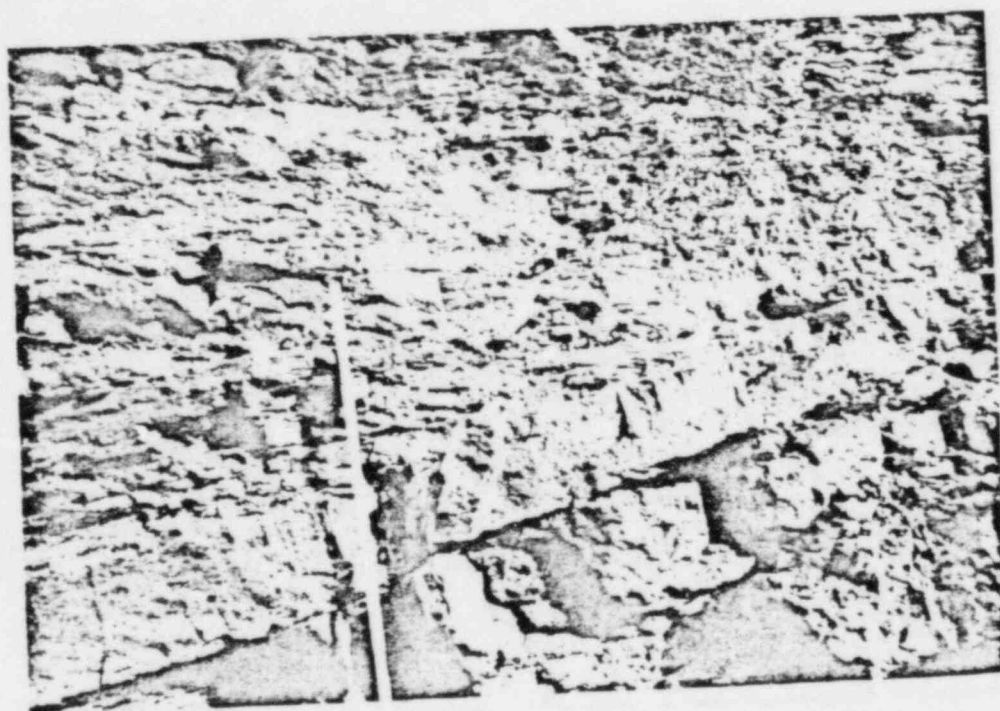
PHOTO NO. 2

Fracture associated with the fault, below El. 780, North of N47+70
