NYN- 95004

January 16, 1995

Subject: Licensee Event Report (LER) 94-010-01: Potential Fuel Damage Due to RCP Turning  
Vane Capscrew Locking Cup Failure

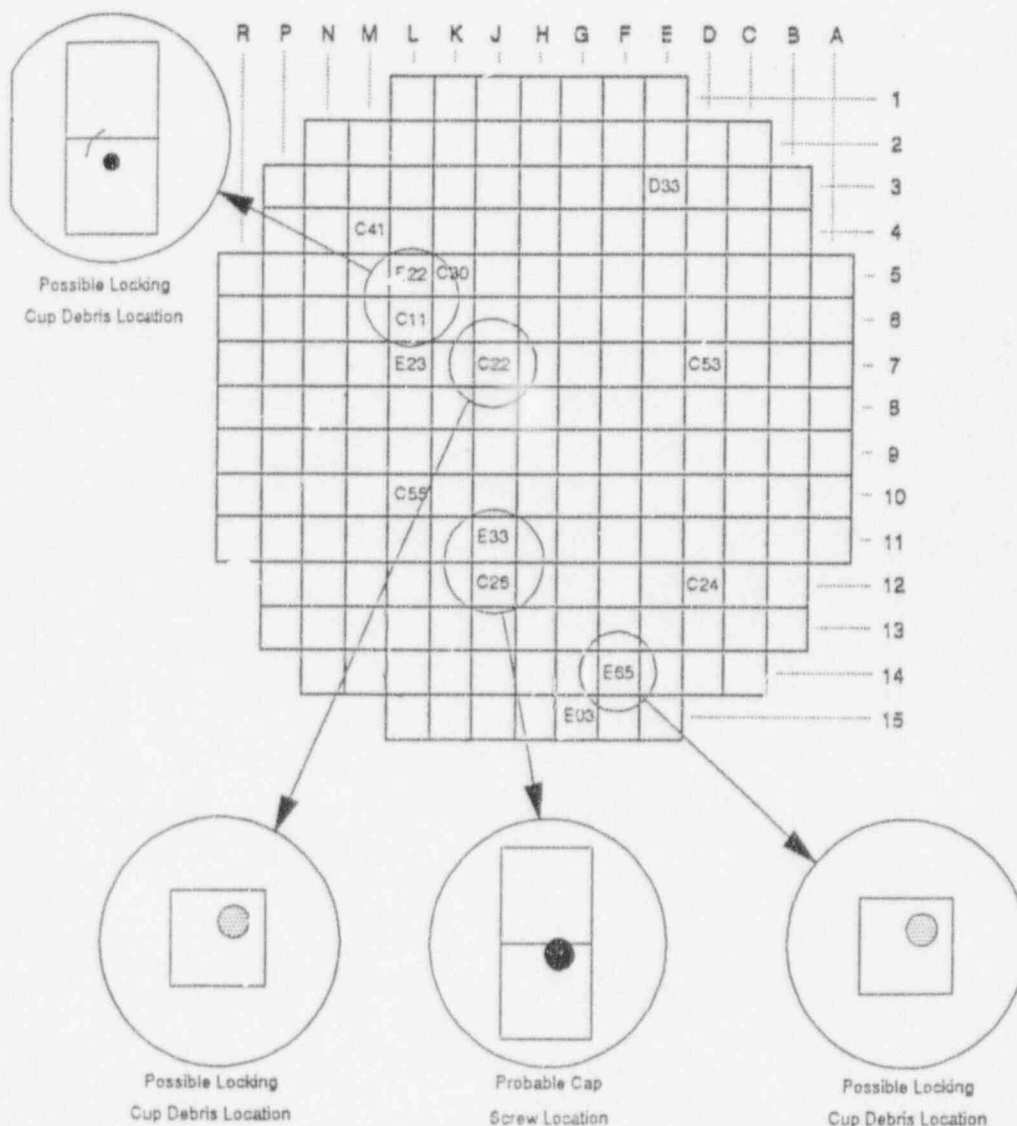
**Figure 1**  
**Location of Bottom Nozzle Damage**

On June 21, 1994, it was discovered that the bottom nozzle of two fuel assemblies (Assembly C26 and E33, see Table 2 and Figure 1) were eroded by a foreign object. No degradation to the fuel pins themselves was discovered. On June 22, 1994, based upon the extent of the erosion to the two fuel assemblies, North Atlantic made a non-emergency 4 hour report pursuant to 10CFR50.72(b)(2)(i) due to the potential for further degradation of the fuel assembly bottom nozzles leading to possible future fuel degradation. Although the TVCSs are not considered to be a basic component, the wearing of the fuel assembly bottom nozzle did have the potential to eventually erode into the fuel pin cladding. The fuel pins are considered to be a basic component because the cladding is a fission product barrier which functions to keep offsite exposure within the limits of 10CFR100. Westinghouse Electric Corporation, the reactor coolant pump vendor, has evaluated the locking cap and TVCS failure and determined that the event is not reportable pursuant to 10CFR21. North Atlantic has also evaluated the aforementioned condition and determined that it did not constitute a significant safety hazard in accordance with 10CFR21.

A video inspection was performed of the Cycle 3 fuel assemblies bottom nozzle. The inspection identified fourteen fuel assemblies with worn or burnished bottom nozzles. The inspection results are presented in Table 2, Fuel Assembly Bottom Nozzle Inspection Results. Of the inspected fuel assemblies, only one bottom nozzle was worn to the extent that it would not be reused. However, this assembly was scheduled for discharge after Cycle 3. This assembly had a hemispherical section worn out of the bottom nozzle. It is postulated that the wear was caused by the fretting of the TVCS positioned vertically under the assembly.

ASSEMBLY ID	CONDITION	HYPOTHESIZED CAUSE
C26	Hemispherical section worn out of bottom nozzle extending to face 1 of plate	TVCS fretting against surface
E33	Wear gouge on face 3 skirt plate of bottom nozzle	TVCS fretting against surface
C11	Gashes and marring on bottom nozzle, extending to face 1 of nozzle	TVCS locking cup fretting against surface
E22	Gouges on face 3 skirt plate of bottom nozzle	TVCS locking cup fretting against surface
E65	Marring on bottom nozzle	TVCS locking cup fretting against surface
E23, D33, E03	Minor scratches in oxide on bottom nozzle	Debris contact against surface
C22	Random nicks and burnish area on bottom nozzle	TVCS locking cup or debris fretting against surface
C53, C24, C41, C30, C55	Burnishing on bottom nozzle	TVCS locking cup or debris fretting against surface

Other noted assemblies had burnishing on bottom nozzle

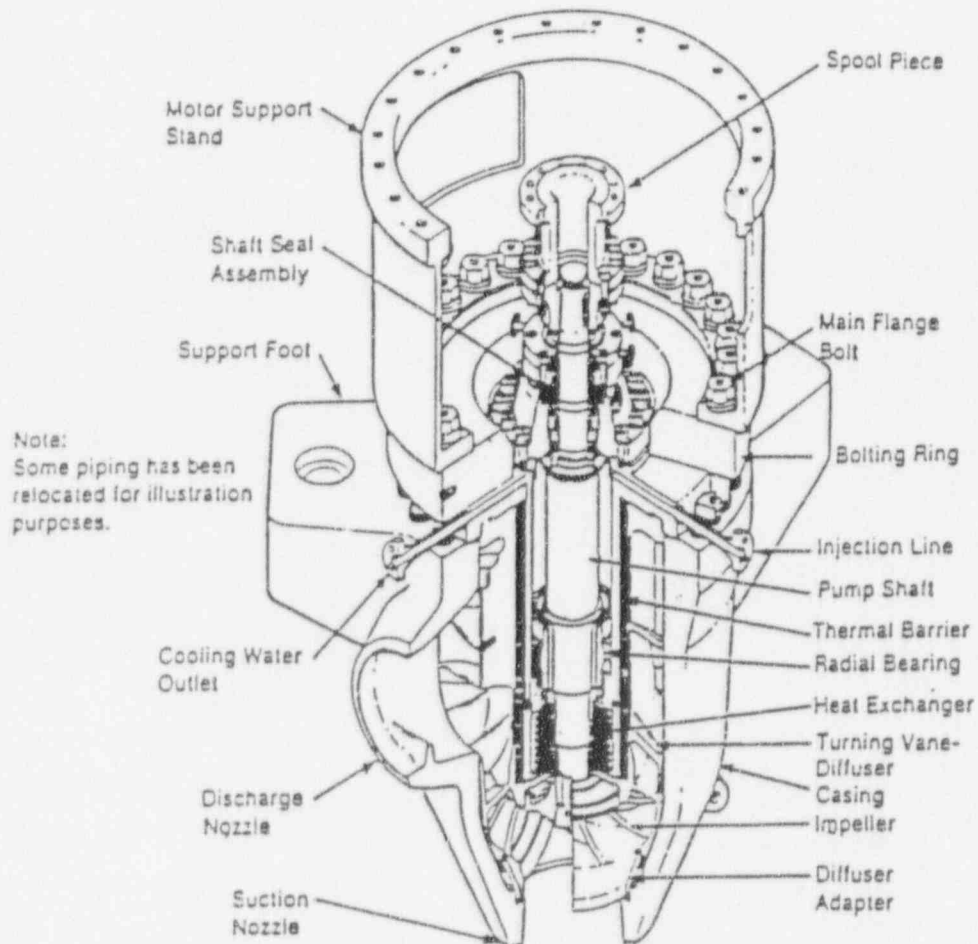
Figure 2  
RCP Cutaway View

Seabrook Station is a four loop Westinghouse Pressurized Water Reactor (PWR) with Westinghouse Model 93A-1 RCPs. The hydraulic section of each RCP consists of a casing, impeller, diffuser adapter, and turning vane diffuser. The turning vane diffuser is a stationary component attached to the thermal barrier flange by twenty-three turning vane cap screws, and is located above the pump impeller (see Figure 2, RCP Cutaway View). Each TVCS is a 10 inch long threaded bolt, one and a half inches in diameter. The TVCSs hold the turning vane casting to the thermal barrier flange. This bolted joint is located inside the pump such that the locking cups and TVCS heads are exposed to the reactor coolant fluid; however, the joint is not part of the RCS boundary.

The TVCS locking cups function as a bolt anti-rotation device to prevent the bolts from turning during plant operation. The locking cups are fabricated from 304 stainless steel and inserted into the turning vane counterbore. The spring action of the split locking cup presses two bosses into holes in the counterbore. In addition, the locking cups are staked at two locations into slots in the head of the TVCS.

The TVCS and the locking cup dropped into the turning vane diffuser due to degradation of the locking cup and loss of TVCS preload torque. The TVCS and locking cups were carried in the cold leg flow stream into the lower plenum of the reactor vessel where the flow stream carried the objects to the underside of the lower core support plate. It is postulated that the debris found its way through the flow holes in the lower core support plate and began to wear at the fuel assembly bottom nozzles.

The release of the locking cup and the TVCS was evaluated with assistance from the vendor, Westinghouse Electric Corporation. The root cause of the TVCS and locking cup release is the original equipment design did not adequately consider the flow induced vibration of the locking cup and the loss of TVCS preload torque. The flow induced vibration caused the locking cups to erode and release from the turning vane. The TVCS subsequently backed out due to the loss of preload torque and the affects of vibration and gravity at a low/zero operating load.

North Atlantic replaced the TVCSs and locking cups on all four RCPs with a new design. The new TVCSs have been redesigned using 316 stainless steel to reduce their susceptibility to intergranular stress cracking corrosion. The redesigned locking cups are made from 304 stainless steel and is capped at one end. The locking cup will cover the TVCSs with two tabs resting in machined notches in the screws. The top of the locking cup is welded to the turning vane with two 1/8 X 1 inch fillet welds. The welds are sized to exceed the load carrying capability of the locking cup tabs. Each TVCS and locking cup has a unique serial number which identifies the location of these components to a specific RCP.
