CORPORATION
Crystal River Unit 3
Docket No. 50-302

Subject: Licensee Event Report (LER) 94-014-00

TITLE (4)
Reactor Building Fan/Cooler Operation Develops Cooling System Flow Imbalance and Heat loading Having the Potential for Operation Outside the Design Basis

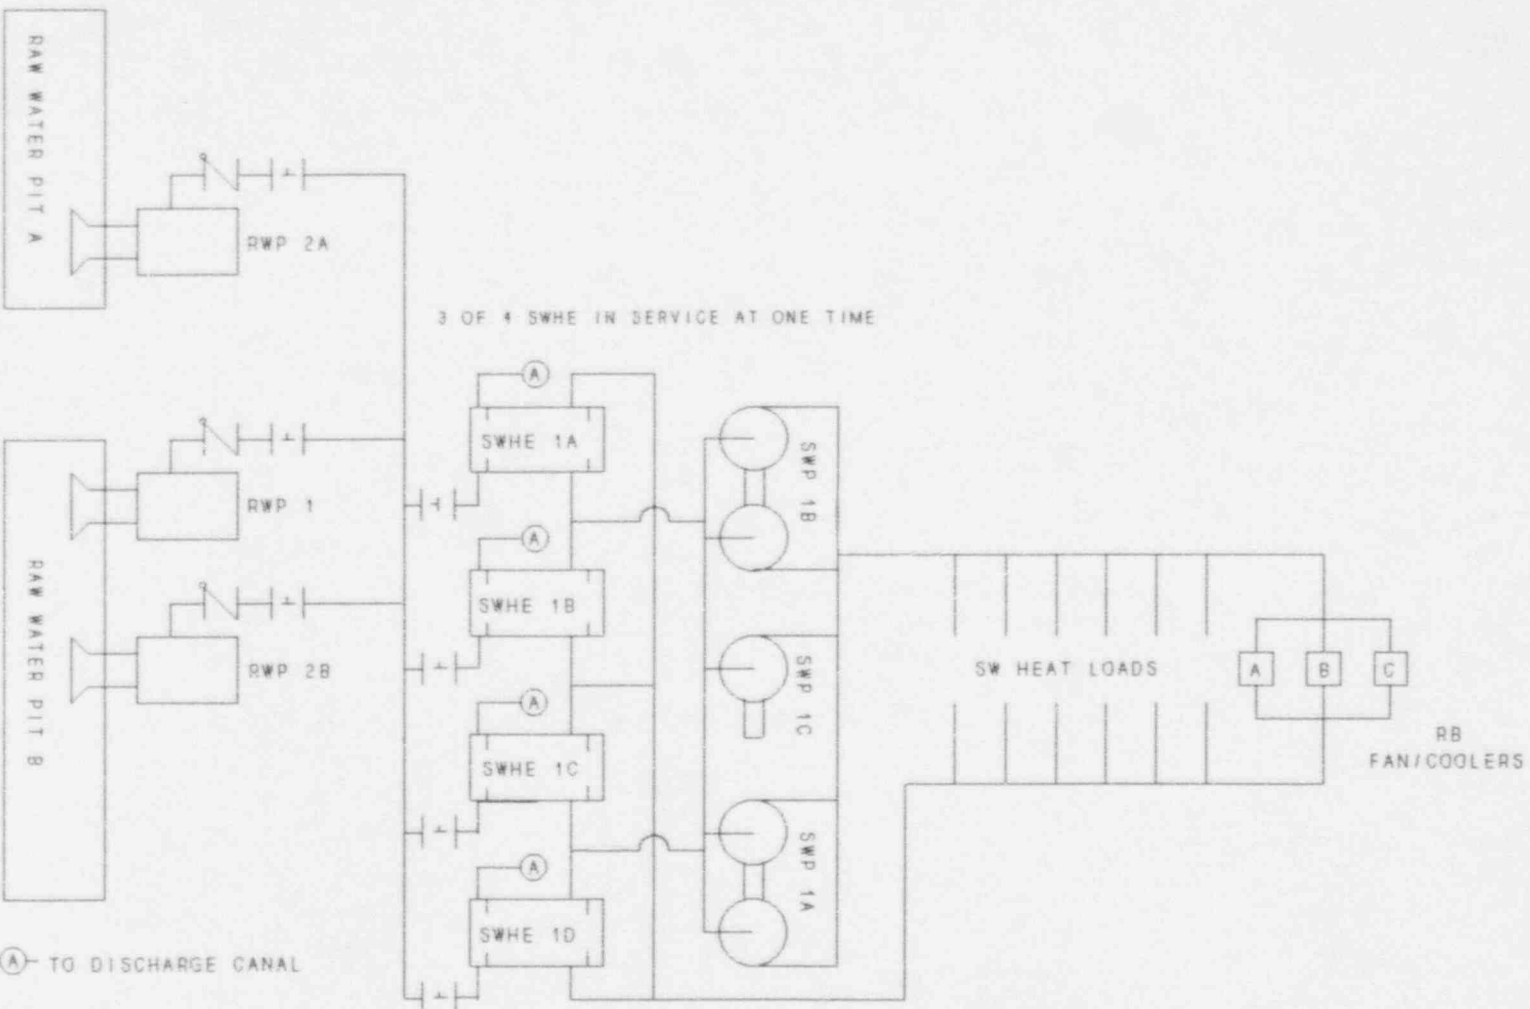
SW SYSTEM SIMPLIFIED FUNCTIONAL FLOW DIAGRAM

indicated that the SW system is flow balanced for two RBCU operation. Valving in the third RBCU with the system balanced for two may result in some or all of the ES components receiving less than their design level of cooling water flow. FPC management determined, as an interim action, to administratively preclude three RBCU operation post ES, rather than to attempt to perform a hydraulic analysis for the system and a subsequent thermal analysis for all affected ES components at reduced, and difficult to accurately estimate, cooling water flow rates.
