SUBJECT: Calvert Cliffs Nuclear Power Plant
Unit No. 1; Docket No. 50-317; License No. DPR 53
Licensee Event Report 94-008; Technical Specification Violation Due to Two
Reactor Protective System Channels Out-of-Service During Surveillance Test

TITLE (4) Technical Specification Violation Due to Two RPS Channels Out-of-Service During Surveillance Test

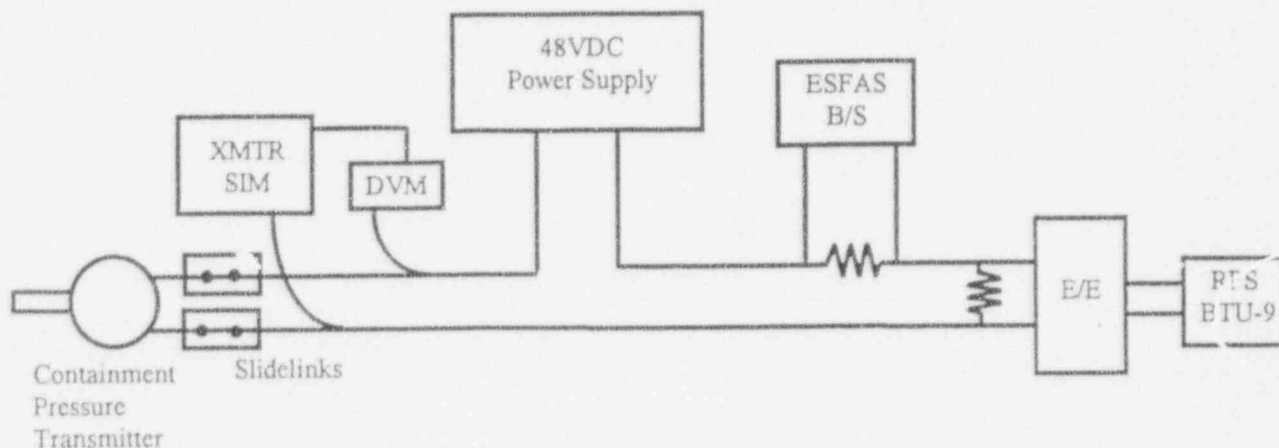
FIGURE 2

CURRENT LOOP SCHEMATIC DIAGRAM FOR HIGH CONTAINMENT PRESSURE
