Subject: Byron Generating Station Units 1 and 2  
Braidwood Generating Station Units 1 and 2  
Fire Protection  
NRC Docket Nos. 50-454 and 50-455

Responses to 18 NRC Concerns  
Raided During the July 12-15, 1983

Byron Fire Protection Audit

RESPONSES TO FIRE PROTECTION SITE AUDIT CONCERNS

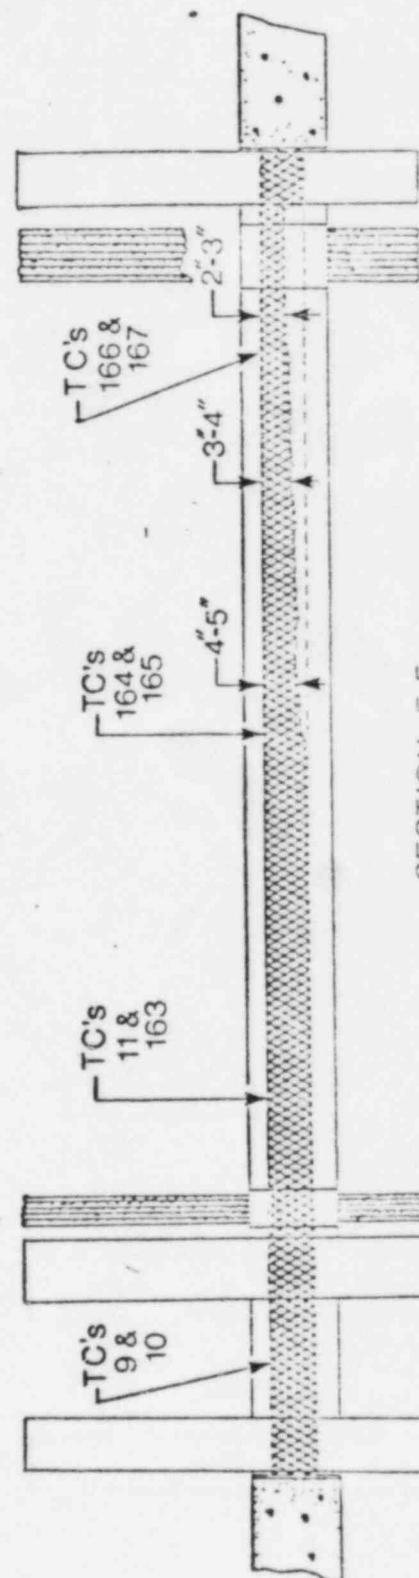
SECTION F-F  
THERMOCOUPLE ARRANGEMENT AND  
POST-TEST OBSERVATIONS

The fire test was conducted for three hours in accordance with the ASTM E-119 time/temperature curve. Throughout the test, an even blanket of flame covered the plan area of the furnace. All combustible materials located on the exposed surface of the slab quickly ignited and continued to char throughout the test. During the first 2 hours of the test, very little smoke was generated from the cables used in this specimen. Water began to evaporate through the hairline crack (noted prior to the test) at the center of the seal. This was evidenced by moisture highlighting the crack.

During the test, the west side of the penetration's substrate (concrete with the 1/4" thick steel plate liner) was level. This portion of the slab was supported by the edge of the furnace and remained level. Although no deflection of the slab was noted here, slab expansion did occur as evidenced by 1/16"-1/8" wide cracks at the corners of the slab.

The opposite side of the penetration (cast concrete with no steel liner) was not supported by the edge of the furnace and as a result was exposed to more heat than the concrete substrate with the steel liner. This lack of support and exposure to greater heat caused the concrete to expand and visibly deflect downward into the furnace.

The downward deflection of the concrete resulted in a combined shear/twisting action on penetration seal during the fire test. The most severe downward deflection of the concrete occurred near the damming board divider. During the fire test it was observed that the seal twisted and sloped here to follow the slab's deflection. At this point of the severest slab deflection, several small cracks and a small bulge occurred on the seal surface. This was a result of strain release of the twisted seal. During the fire test, higher surface temperatures were obtained in this area. After the fire test, it was noted that some of the seal's exposed surface had fallen from this area also. Outside of the area of the seal affected by the deflection of the slab, seal surface temperatures remained relatively cool and no loss of material was observed after the conclusion of the test.
