Project No. 8304
September 19, 1983
W3-HE-LP-007

Subject: Waterford III SES
Analysis of Cracks and Water Seepage in
Foundation
Report No. 8304-1

WATERFORD III SES
ANALYSIS OF CRACKS AND WATER SEEPAGE
IN FOUNDATION MAT
LOUISIANA POWER & LIGHT COMPANY
REPORT NO. 8304-1
SEPTEMBER 19, 1983

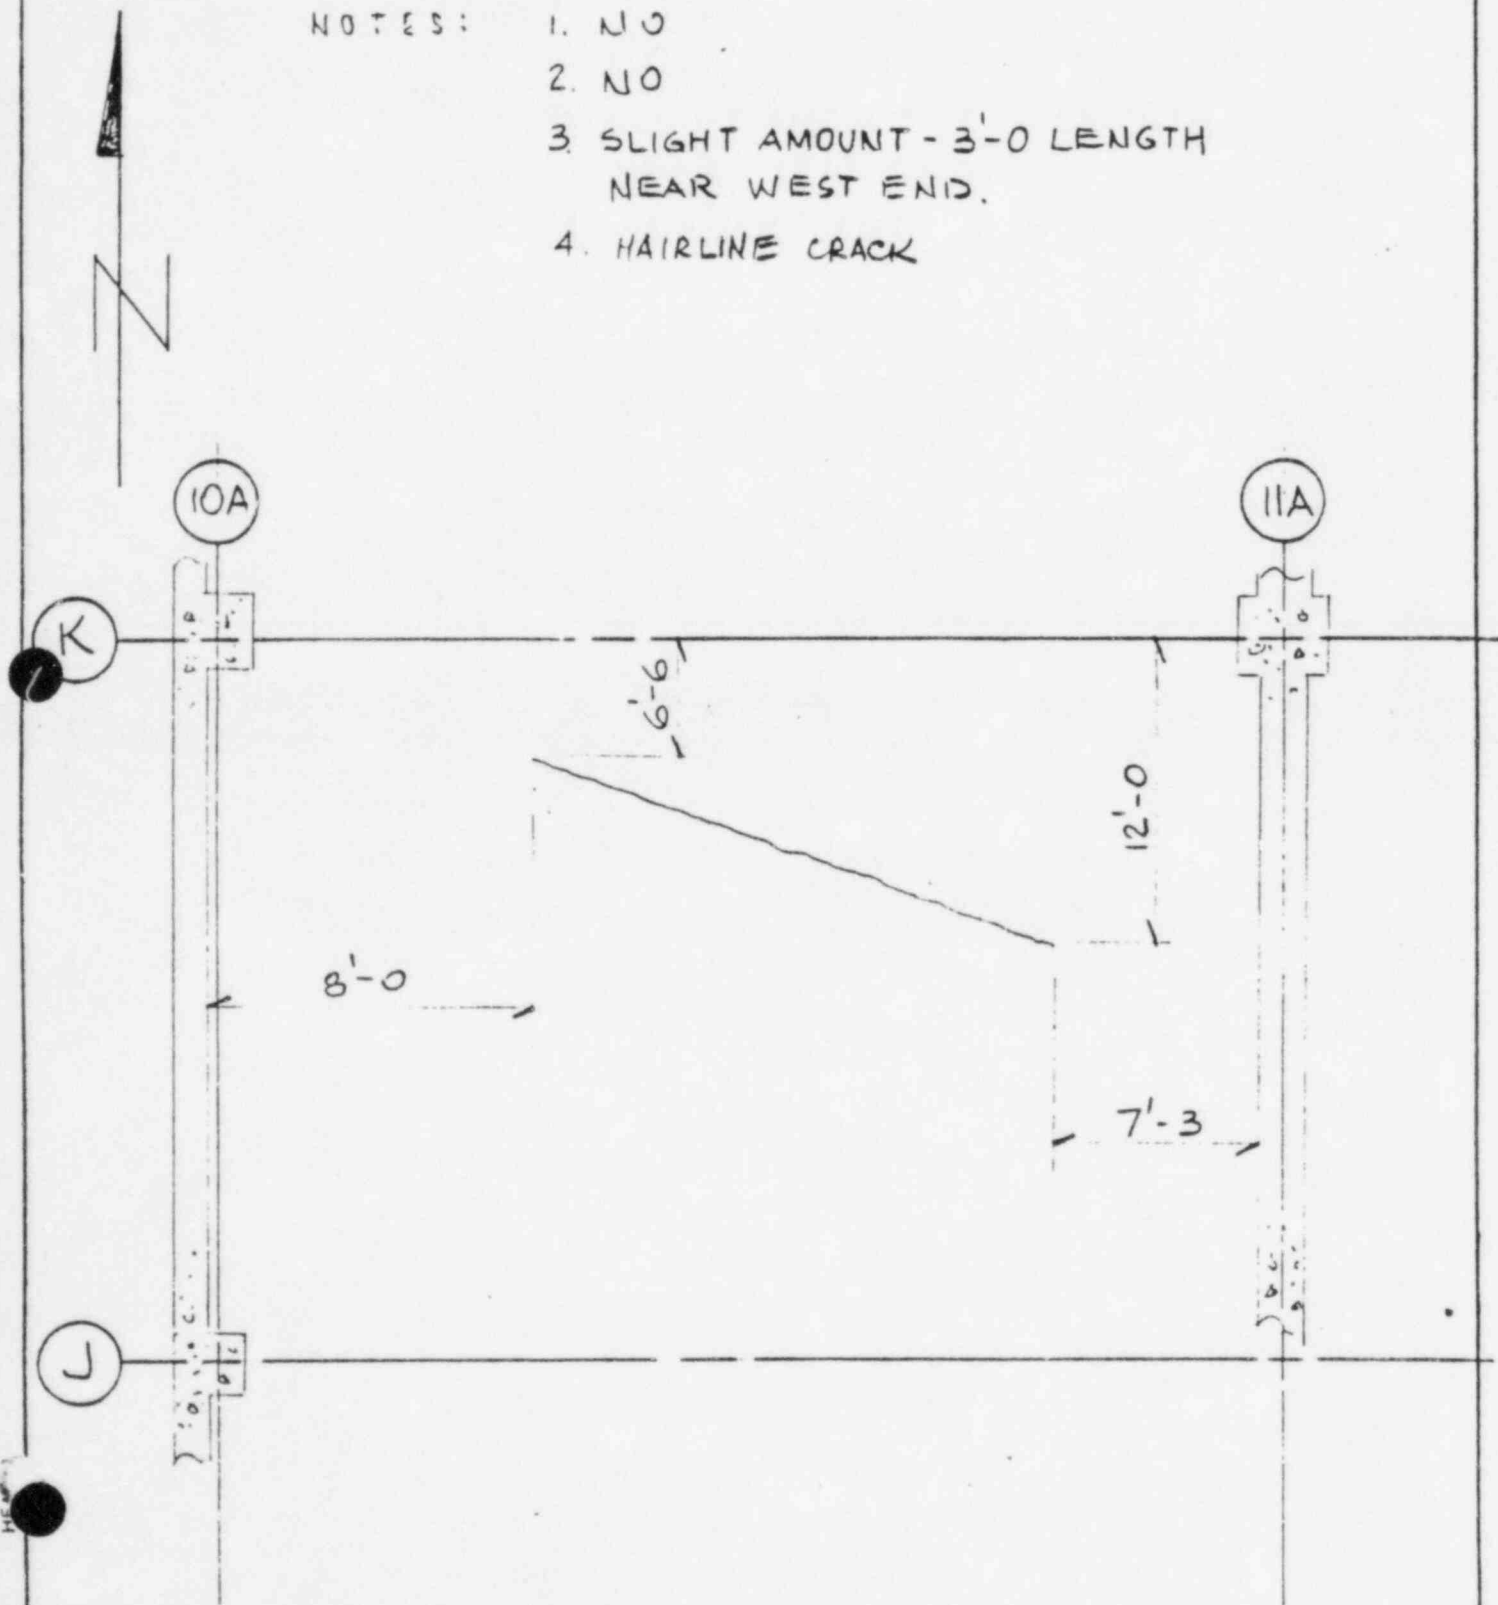
3. SLIGHT AMOUNT - 3'-0 LENGTH
NEAR WEST END.

4. HAIRLINE CRACK

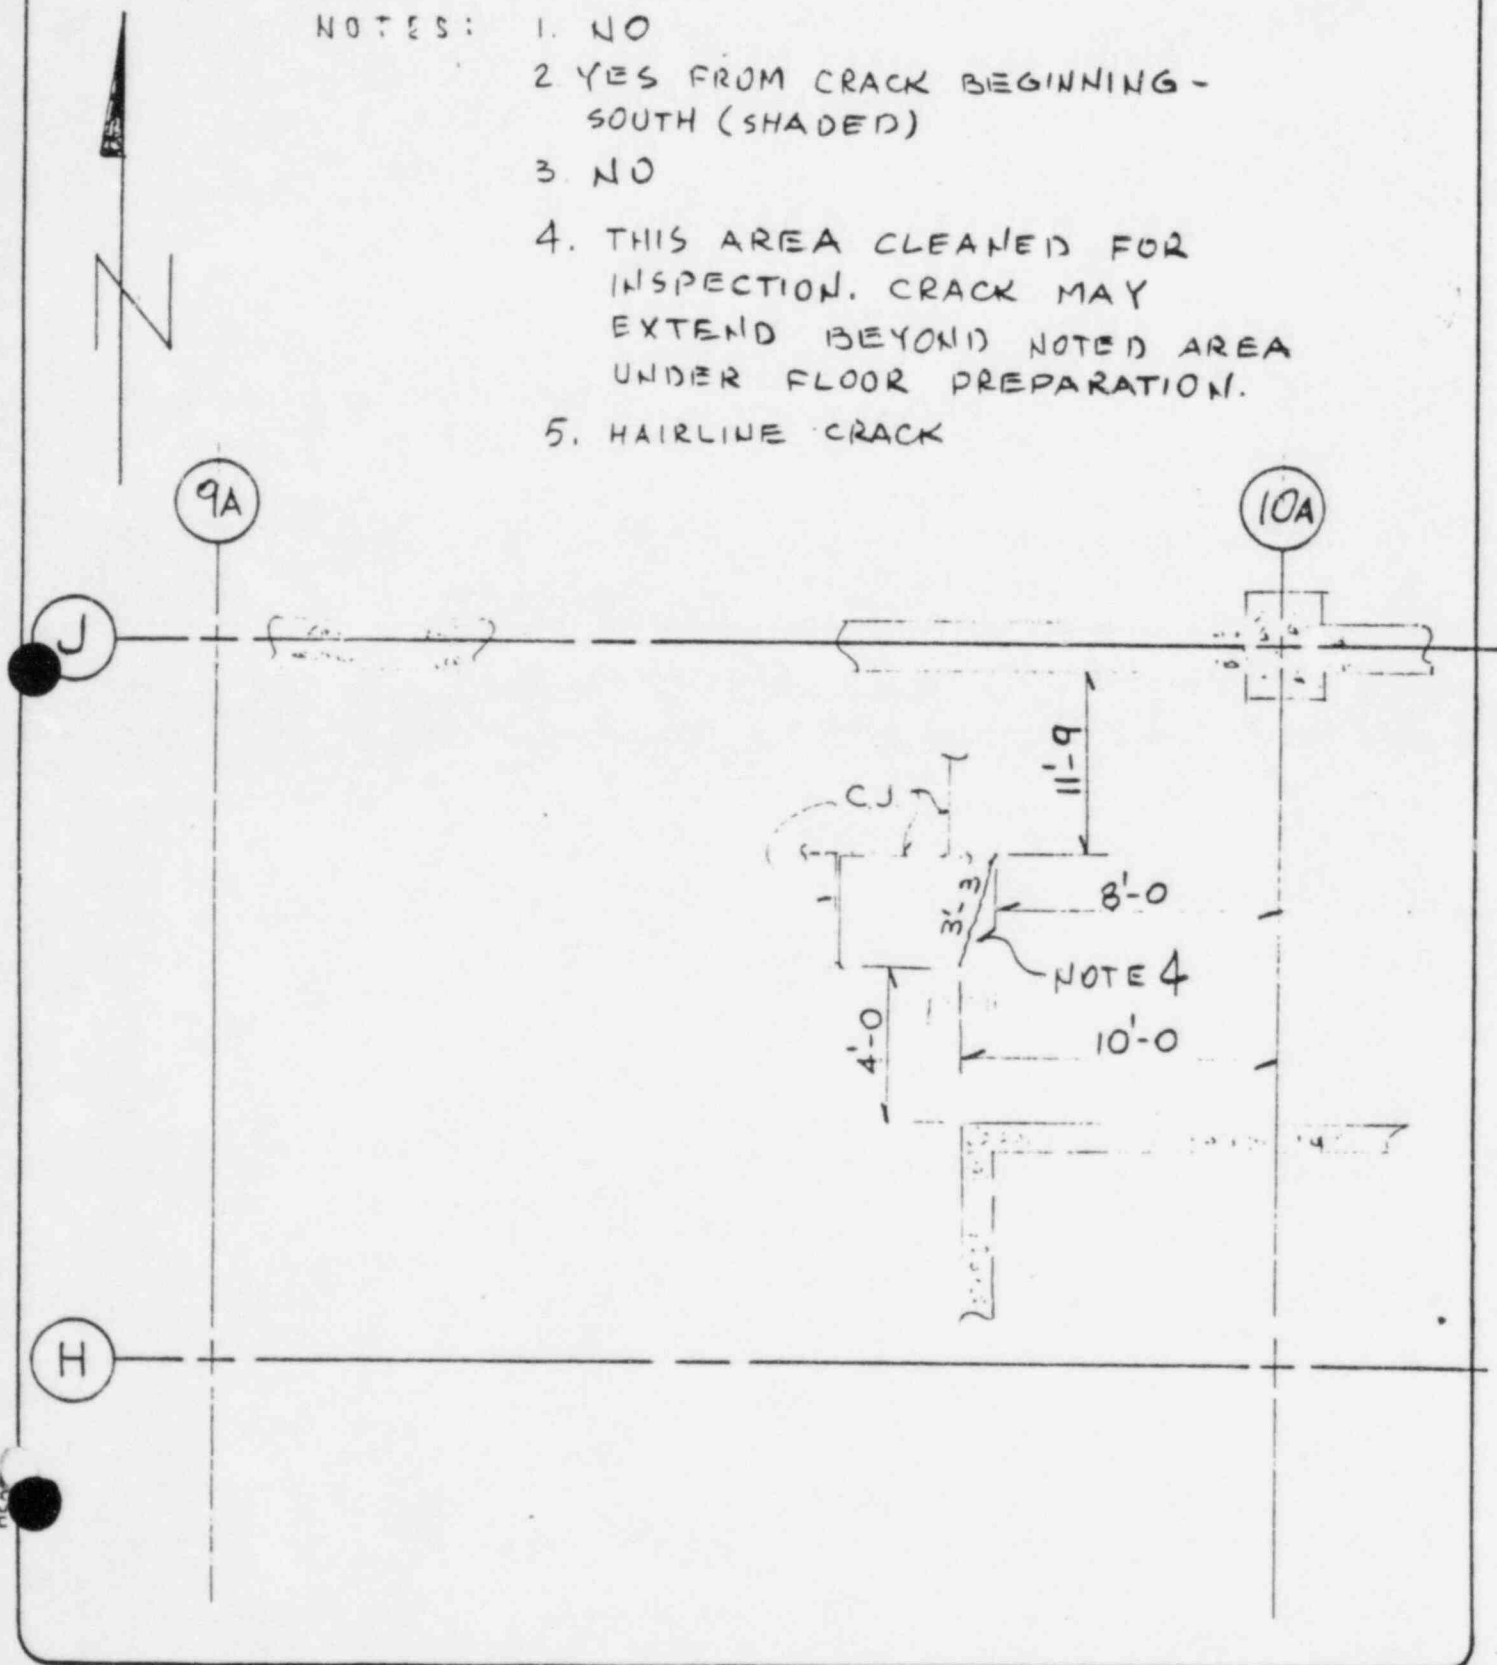
1. NO
2. YES FROM CRACK BEGINNING - SOUTH (SHADED)
3. NO
4. THIS AREA CLEANED FOR INSPECTION. CRACK MAY EXTEND BEYOND NOTED AREA UNDER FLOOR PREPARATION.
5. HAIRLINE CRACK

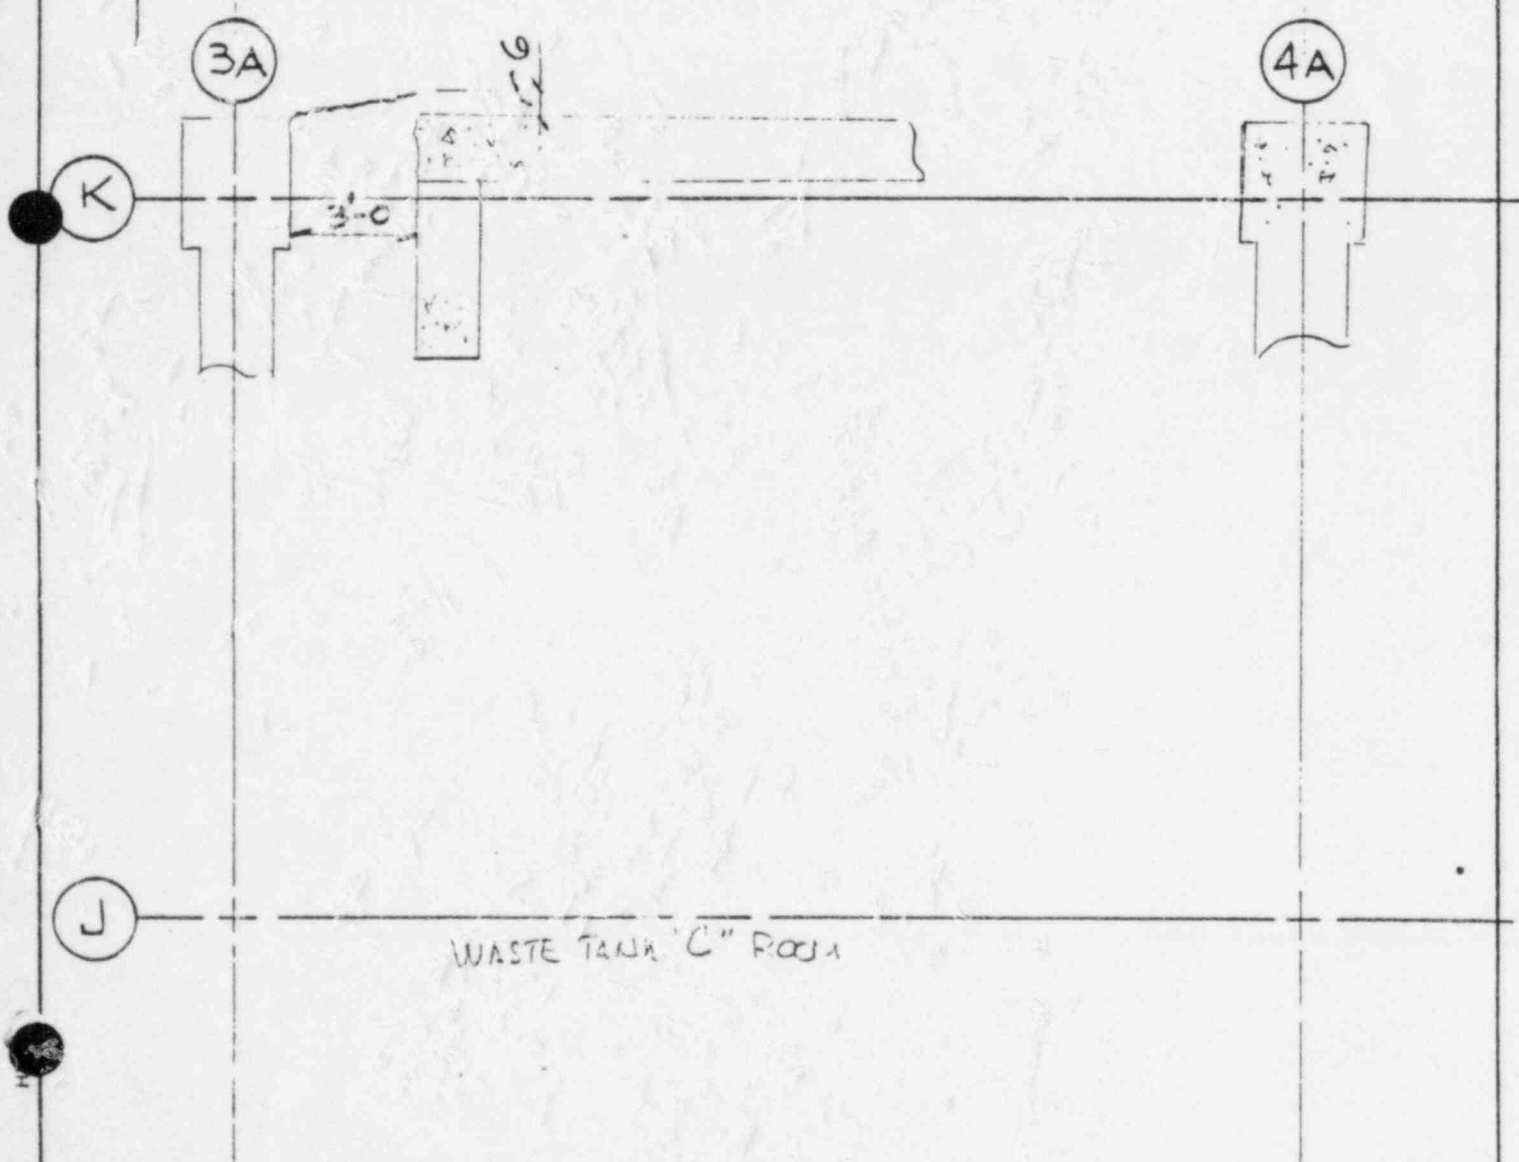
3. DAMP IN THE MIDDLE 9" LENGTH

4. HAIRLINE CRACK

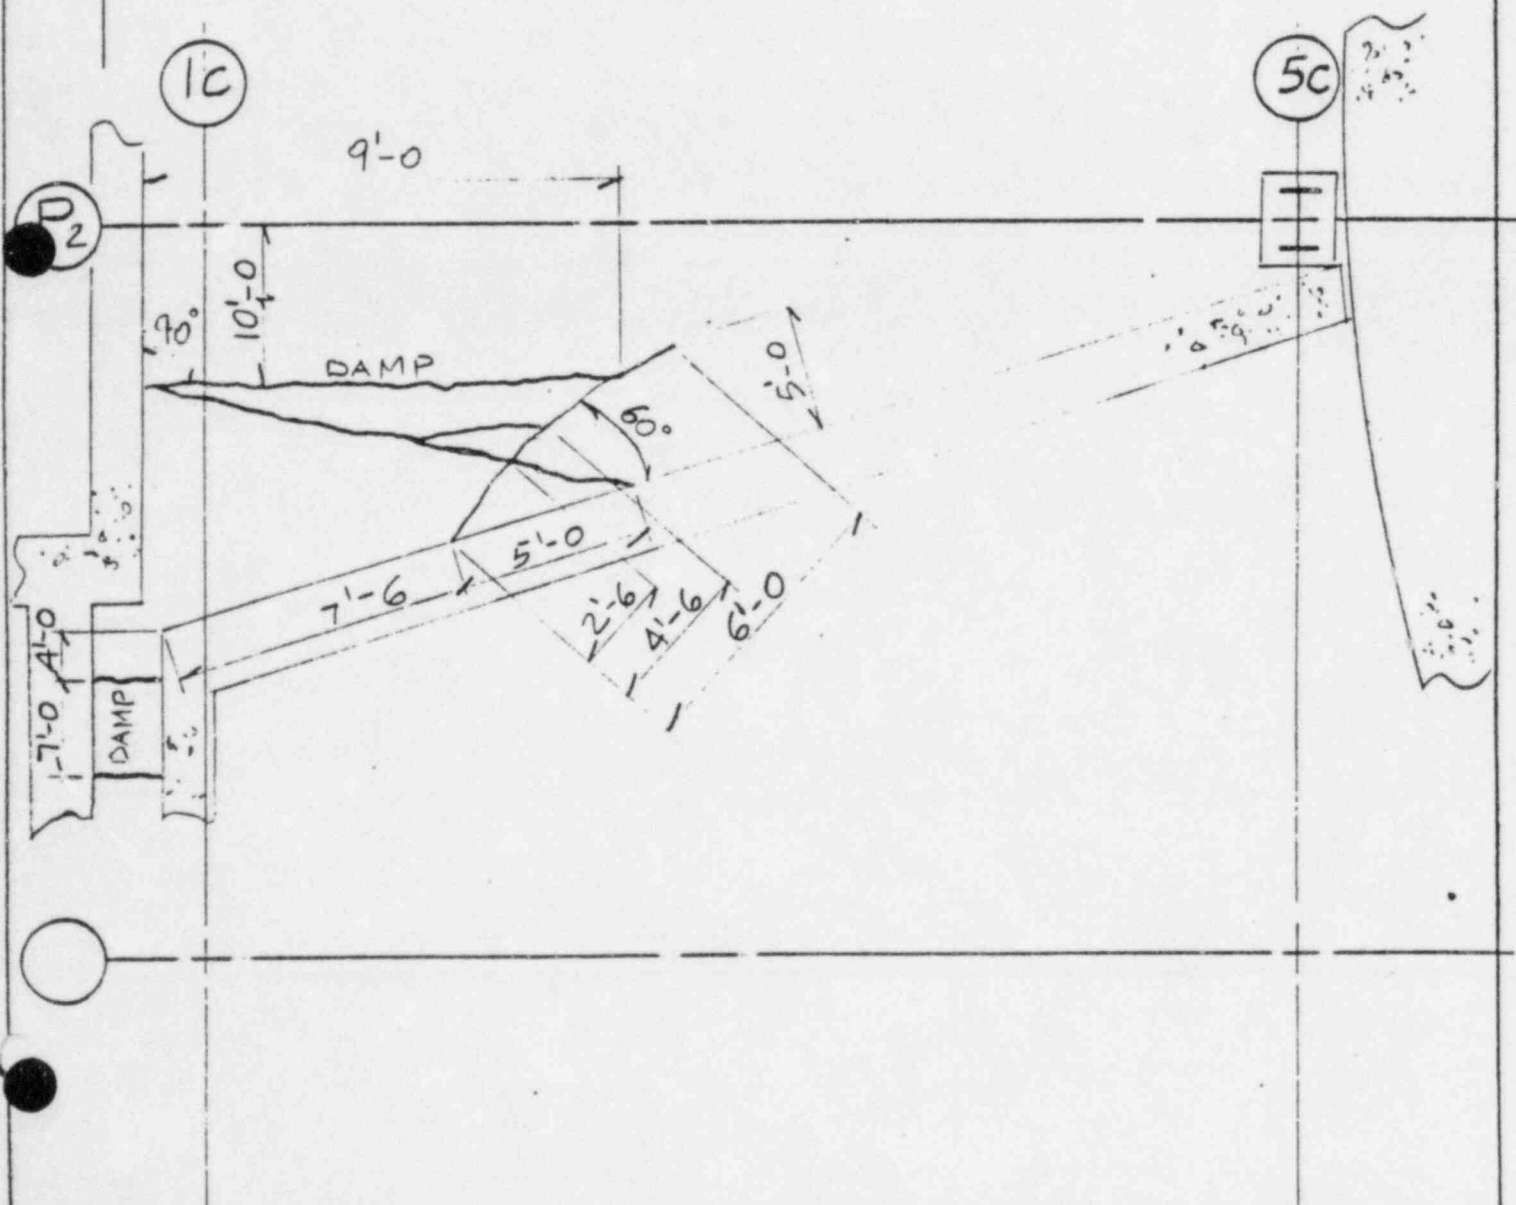
NOTES: 1. NO
2. NO
3. YES
4. HAIRLINE CRACK

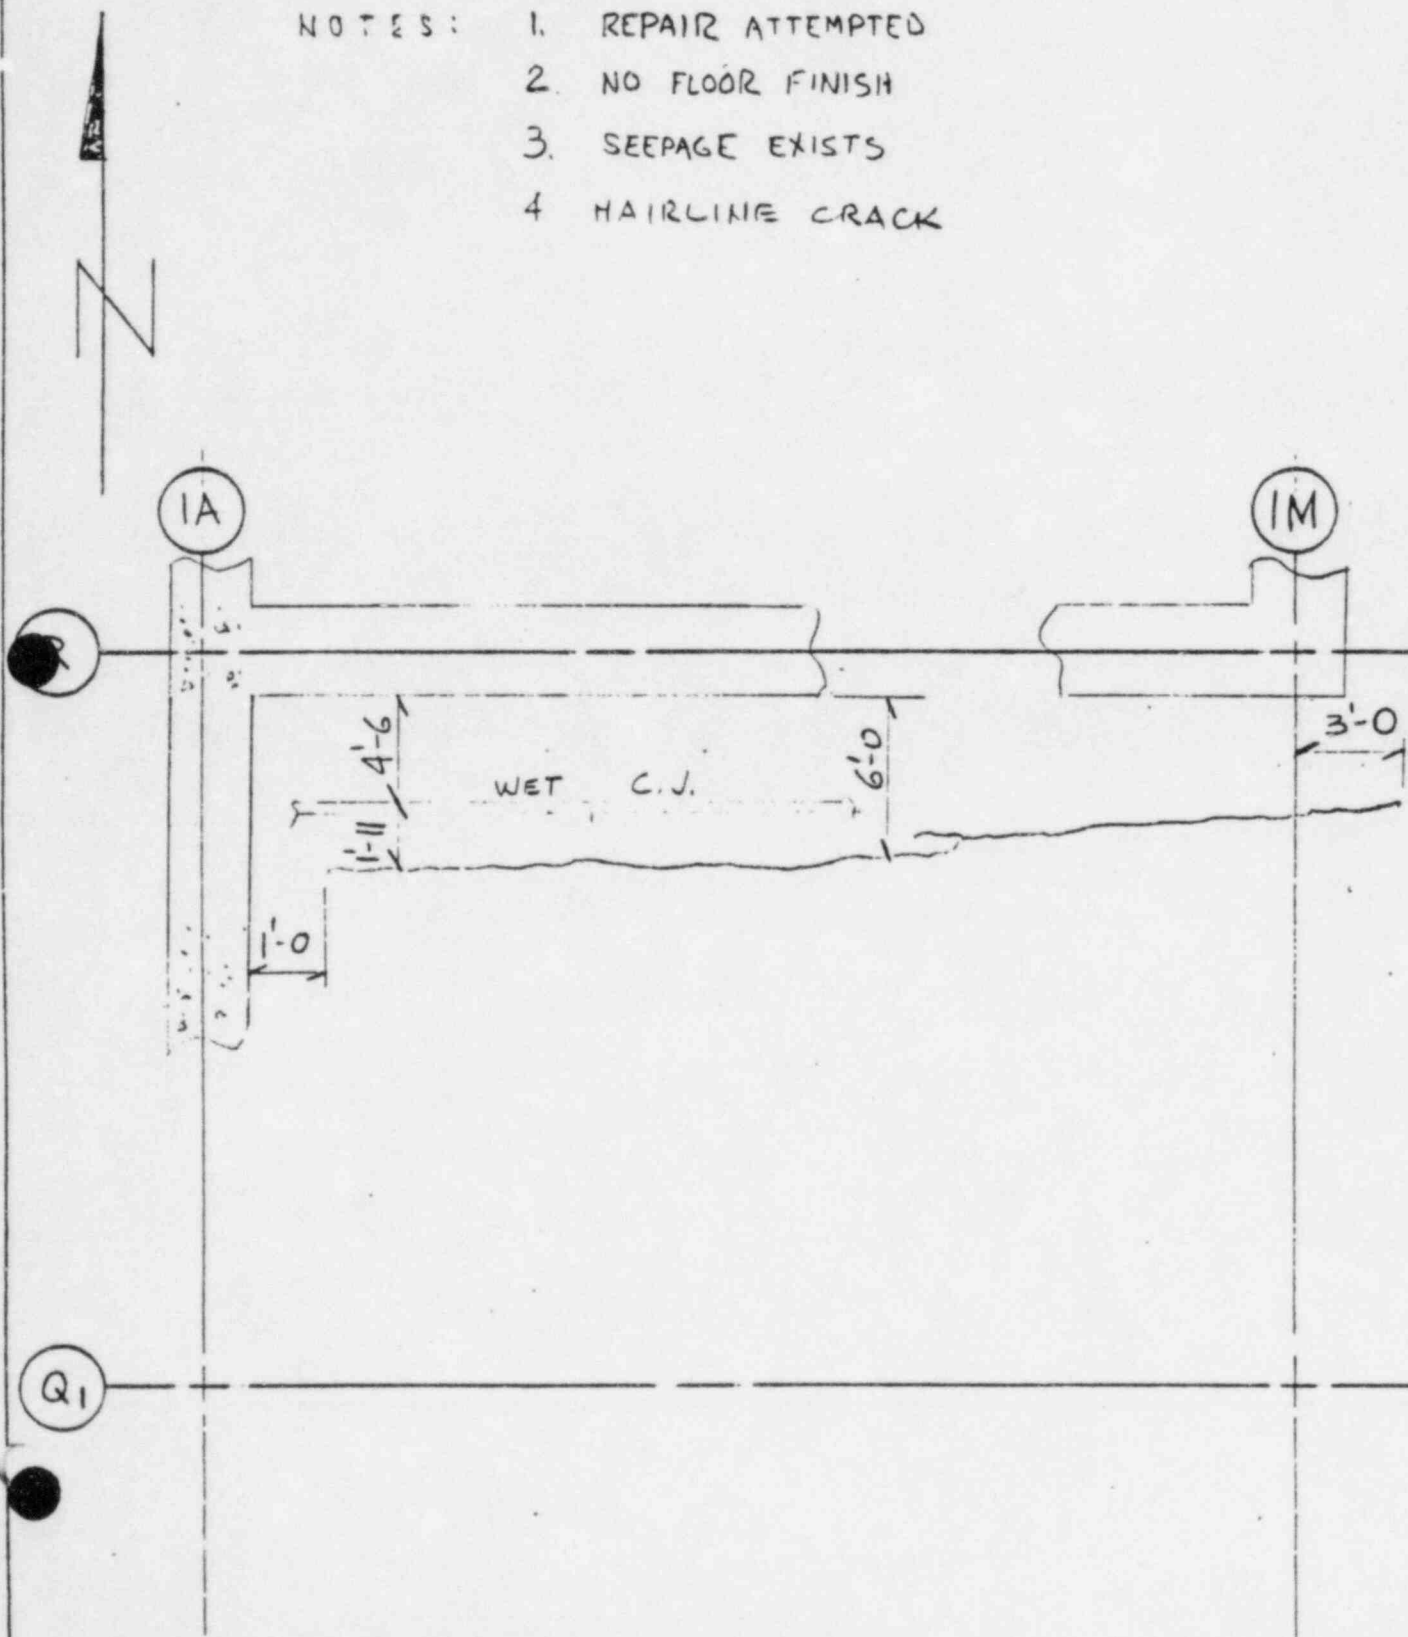
- NOTES:
1. REPAIR ATTEMPTED
 2. NO FLOOR FINISH
 3. SEEPAGE EXISTS
 4. HAIRLINE CRACK

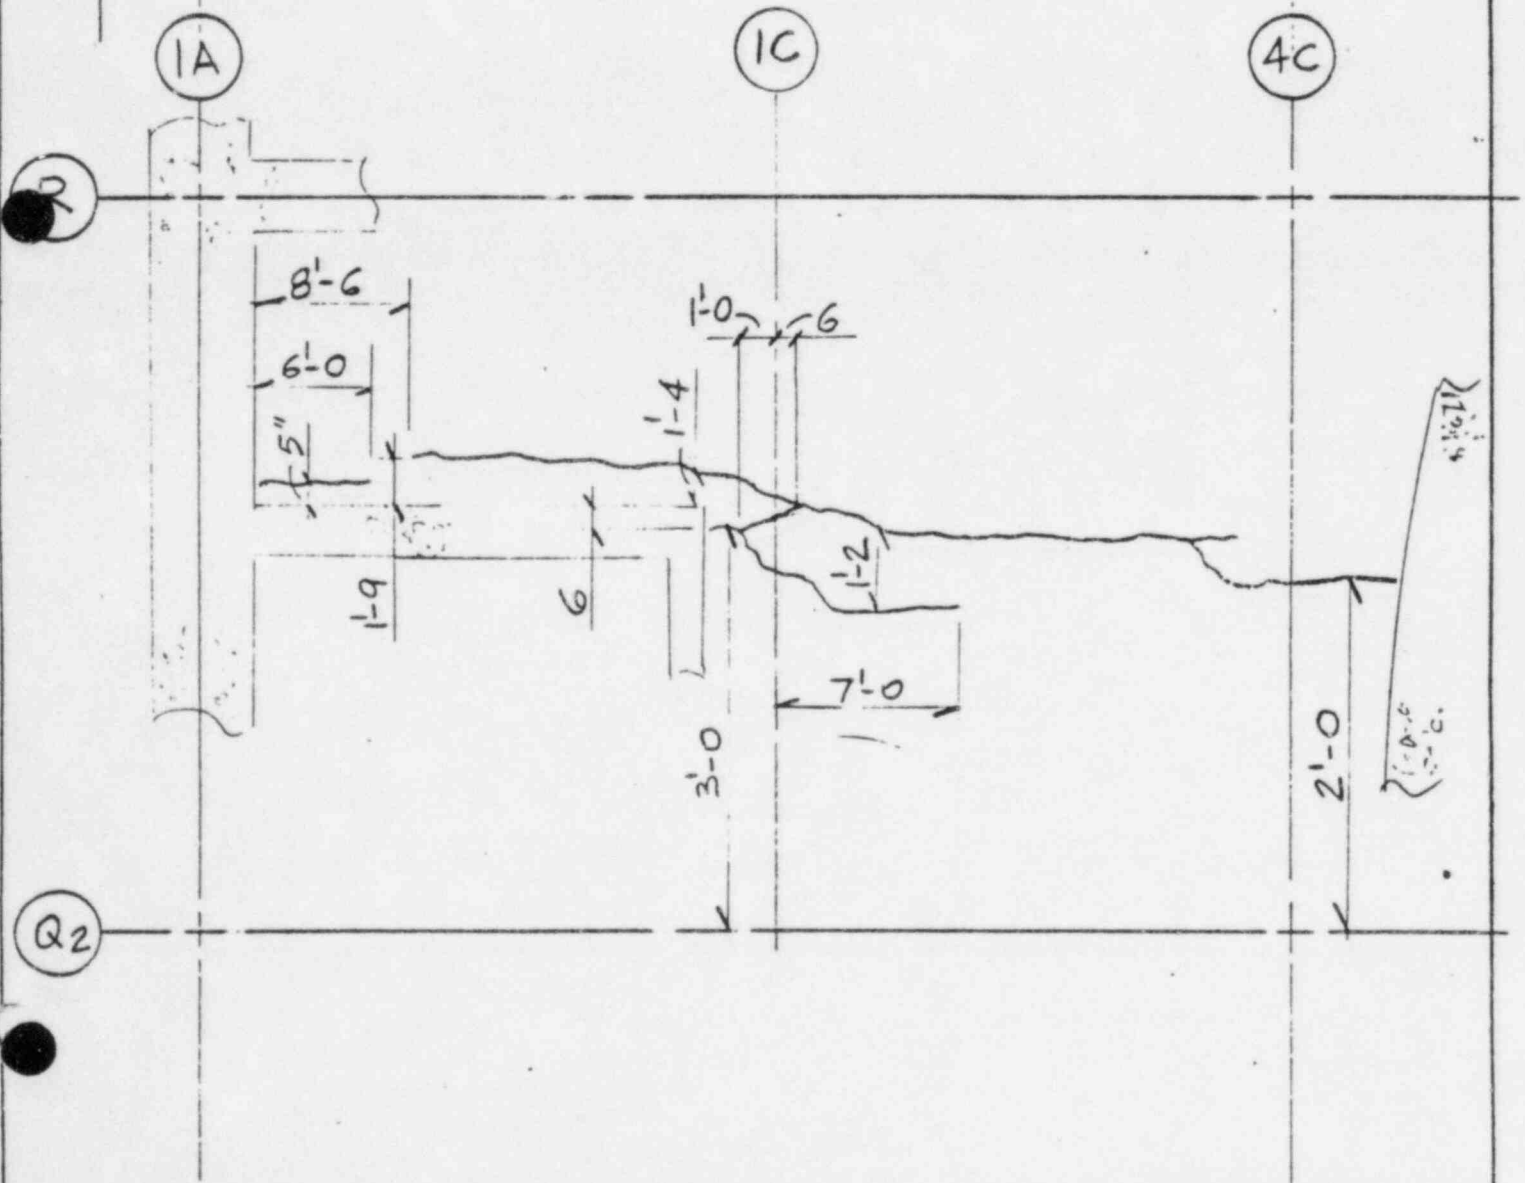
- NOTES:
1. REPAIR ATTEMPTED
 2. NO FLOOR FINISH
 3. NO EVIDENCE OF SEEPAGE
 4. HAIRLINE CRACK

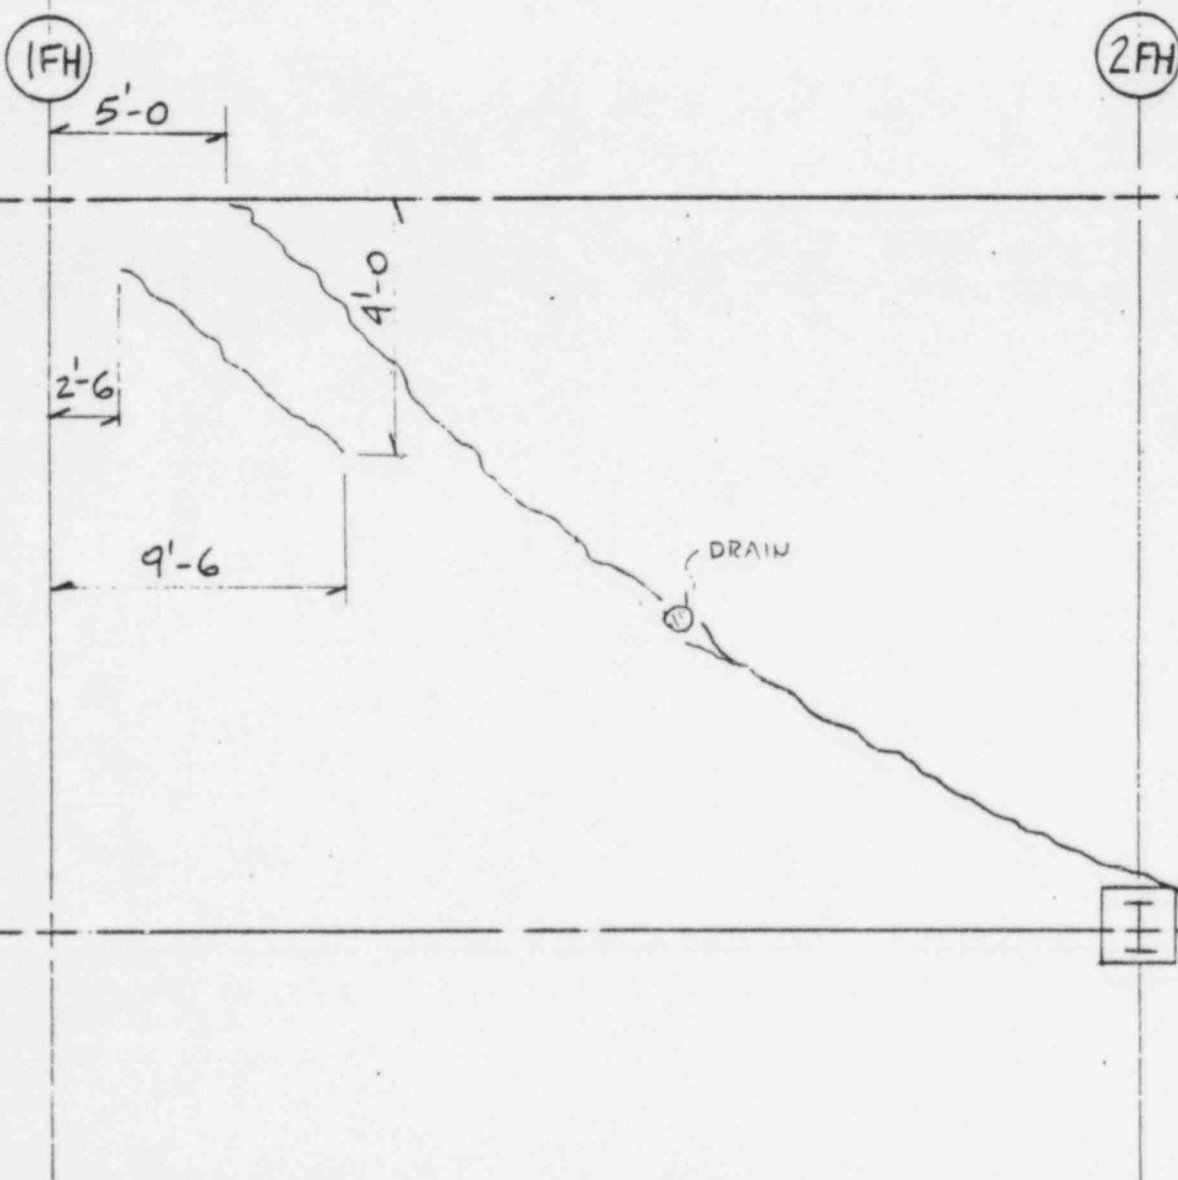
- NOTES:
1. NO REPAIR
 2. NO FLOOR FINISH
 3. SEEPAGE EXISTS
 4. HAIRLINE CRACK

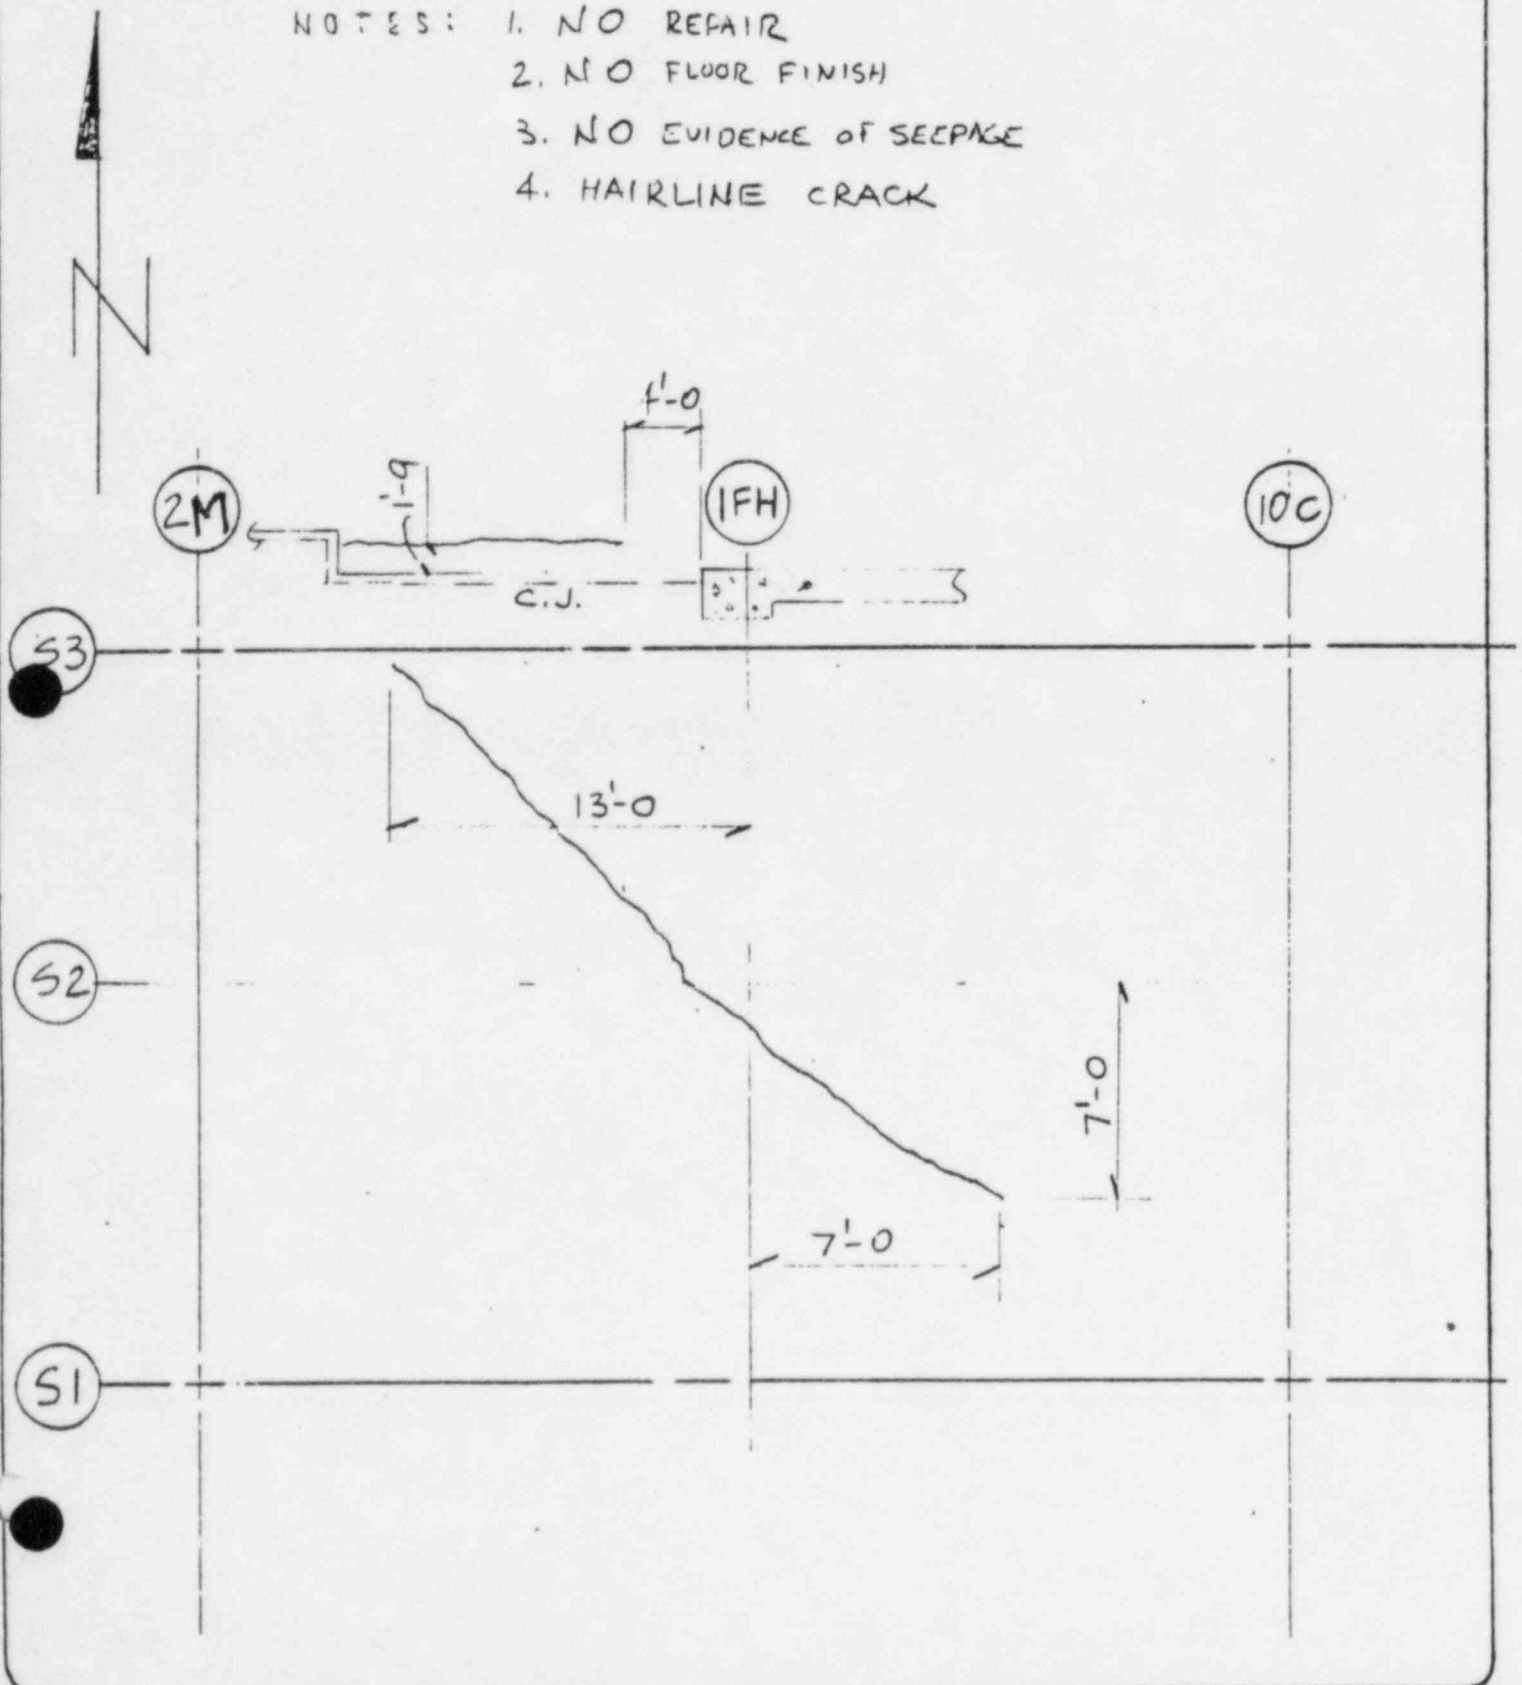
- NOTES:
1. NO REPAIR
 2. NO FLOOR FINISH
 3. NO EVIDENCE OF SEEPAGE
 4. HAIRLINE CRACK

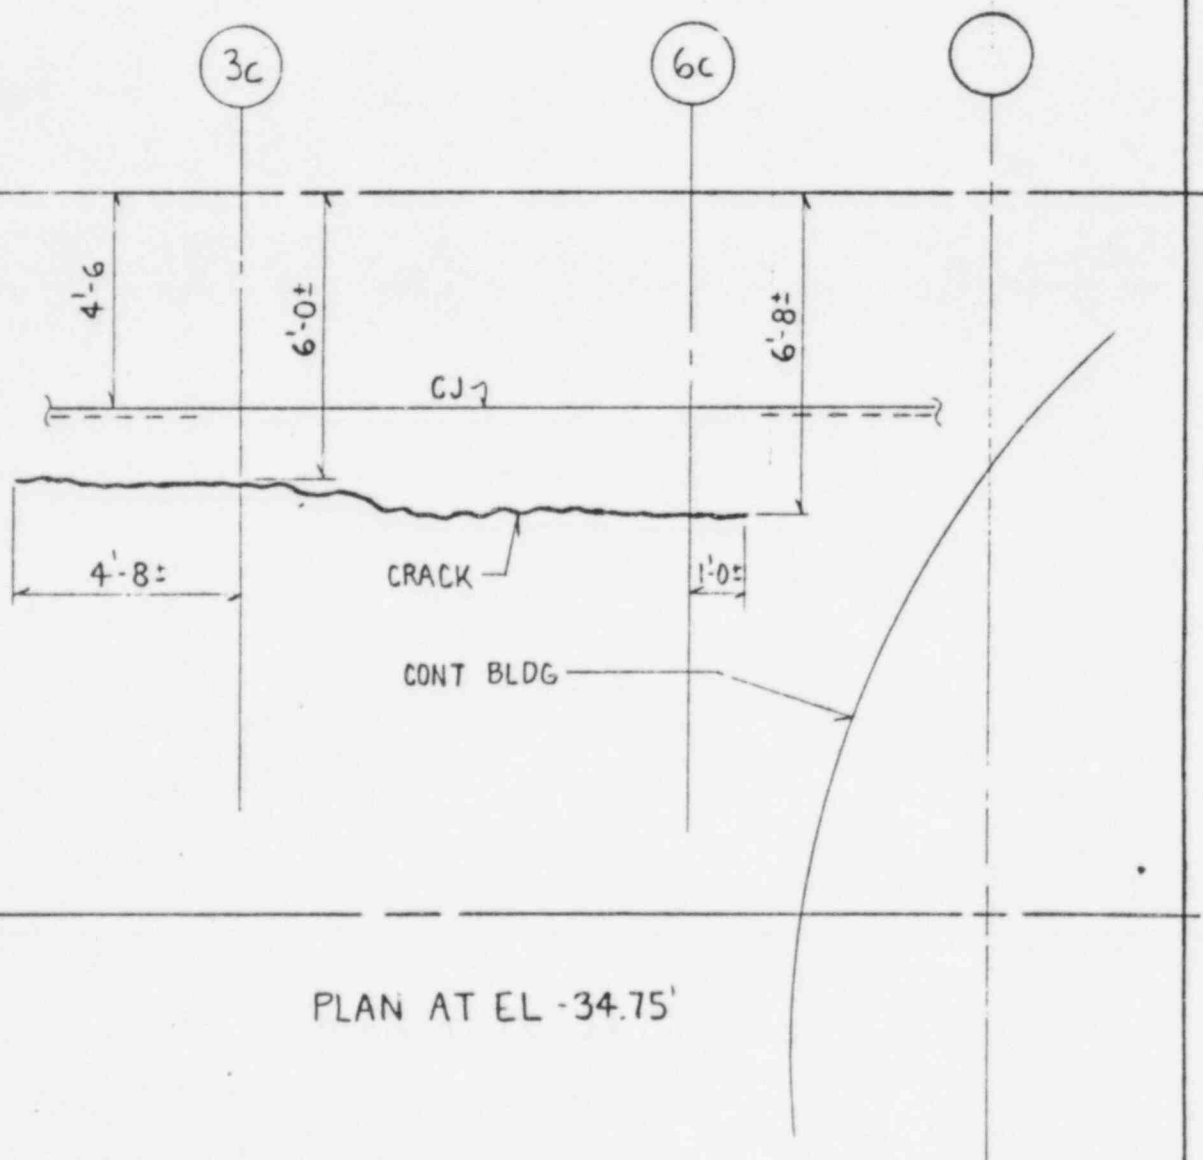
1. NO REPAIR
2. NO FLOOR FINISH
3. NO EVIDENCE OF SEEPAGE
4. HAIRLINE CRACK

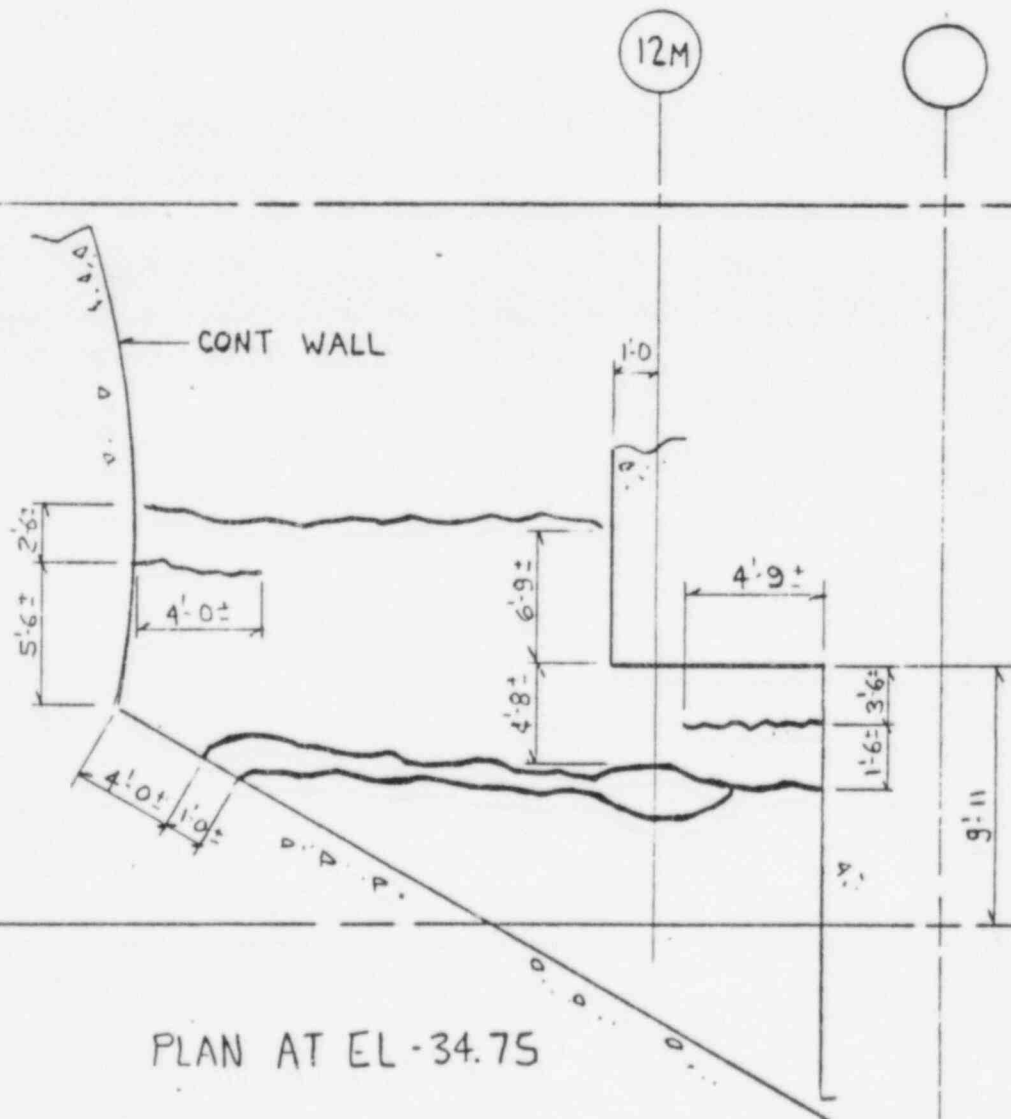
- 1 NO REPAIR
- 2 NO FLOOR FINISH
- 3 SOME SEEPAGE
4. HAIRLINE CRACK.

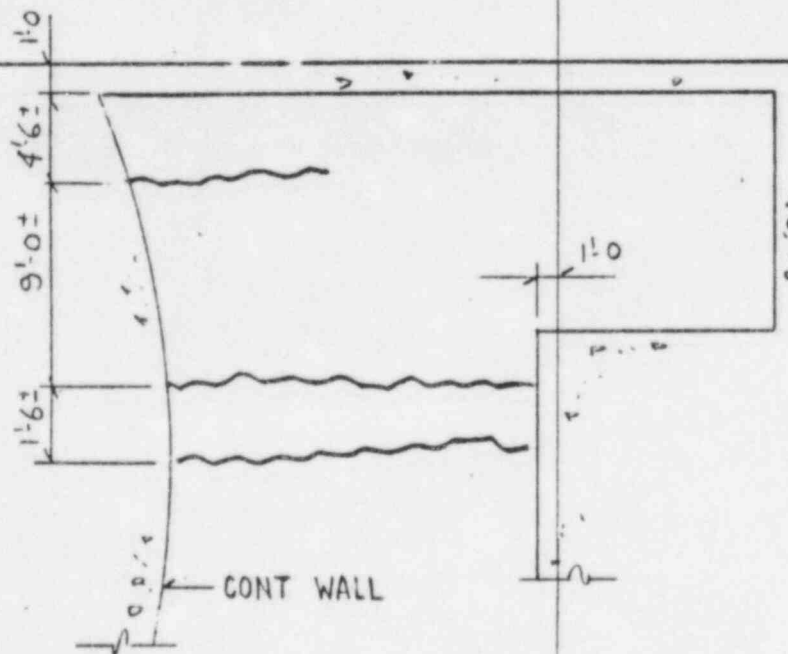
- 1 NO REPAIR
- 2 NO FLOOR FINISH
- 3 NO EVIDENCE OF SEEPAGE
- 4 HAIRLINE CRACK

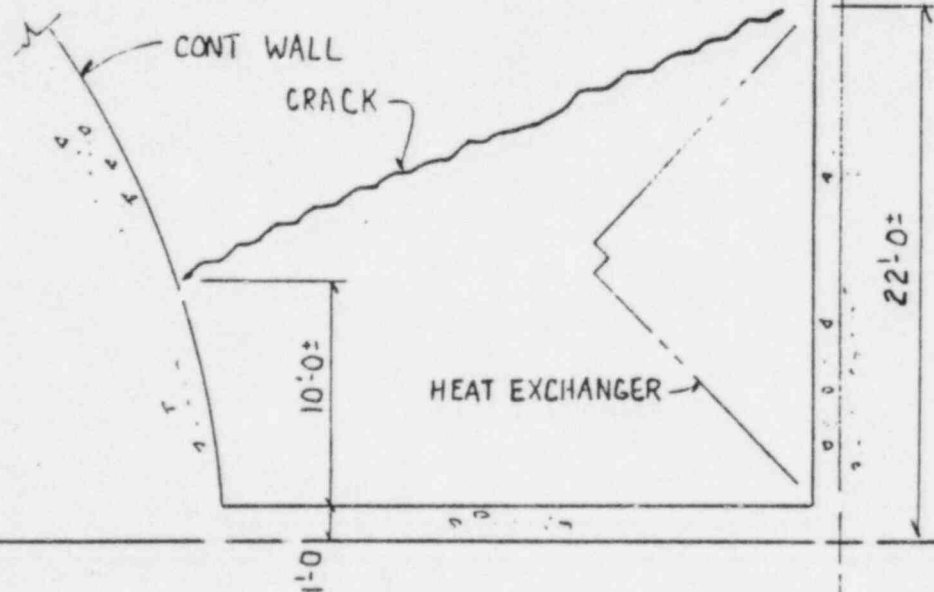
- 1 NO REPAIR
- 2 NO FINISH
- 3 NO SEEPAGE
4. HAIRLINE CRACK

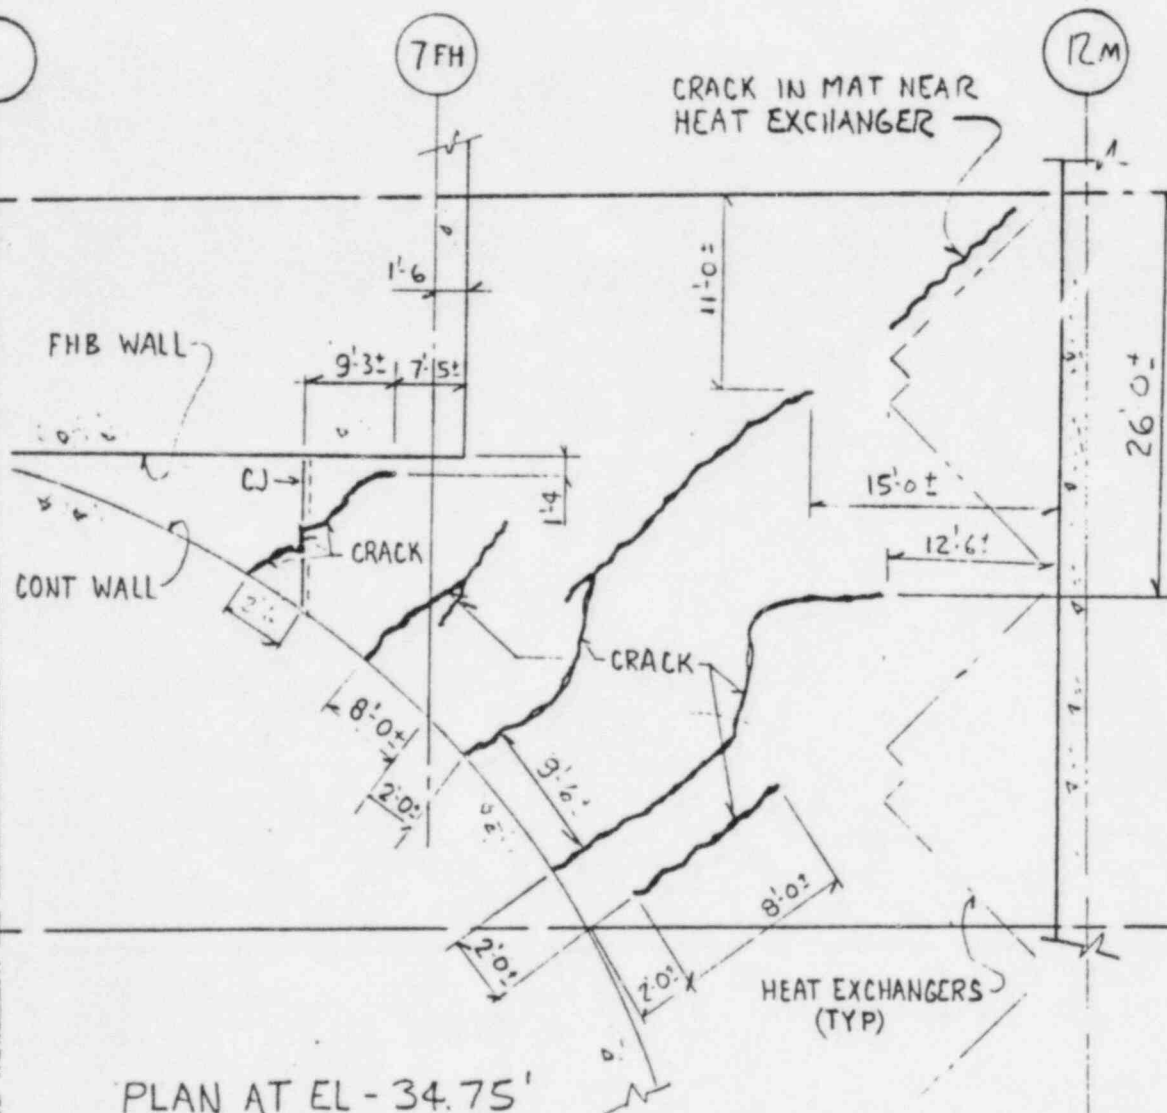
- 1 NO REPAIR
- 2 NO FINISH
- 3 SOME EVIDENCE OF SEEPAGE
4. HAIRLINE CRACK
