Project No. 8304
September 19, 1983
W3-HE-LP-007

Subject: Waterford III SES
Analysis of Cracks and Water Seepage in
Foundation
Report No. 8304-1

WATERFORD III SES
ANALYSIS OF CRACKS AND WATER SEEPAGE
IN FOUNDATION MAT
LOUISIANA POWER & LIGHT COMPANY
REPORT NO. 8304-1
SEPTEMBER 19, 1983

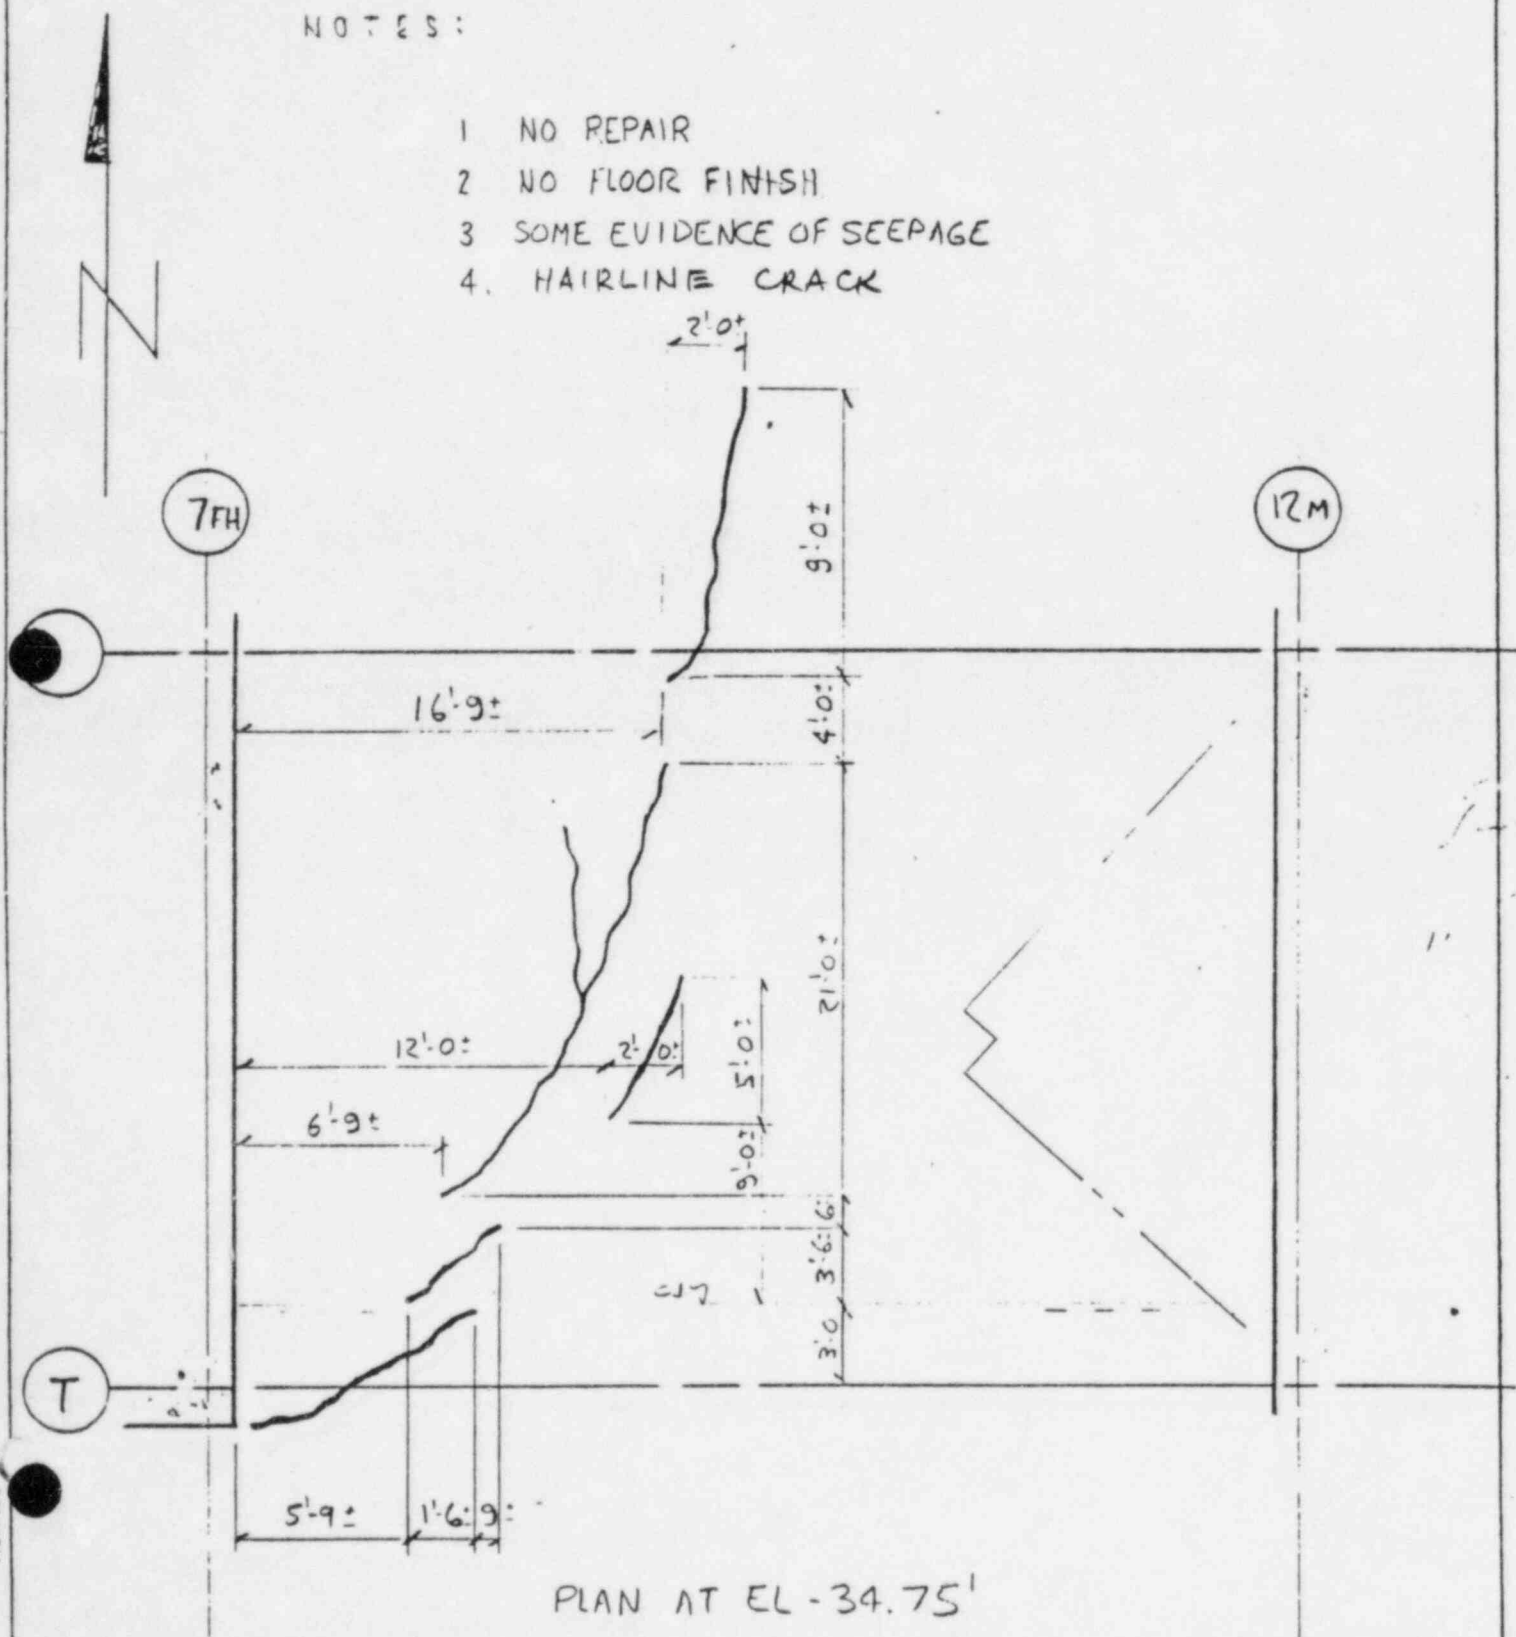
- 1 NO REPAIR
- 2 NO FLOOR FINISH
- 3 SOME EVIDENCE OF SEEPAGE
4. HAIRLINE CRACK

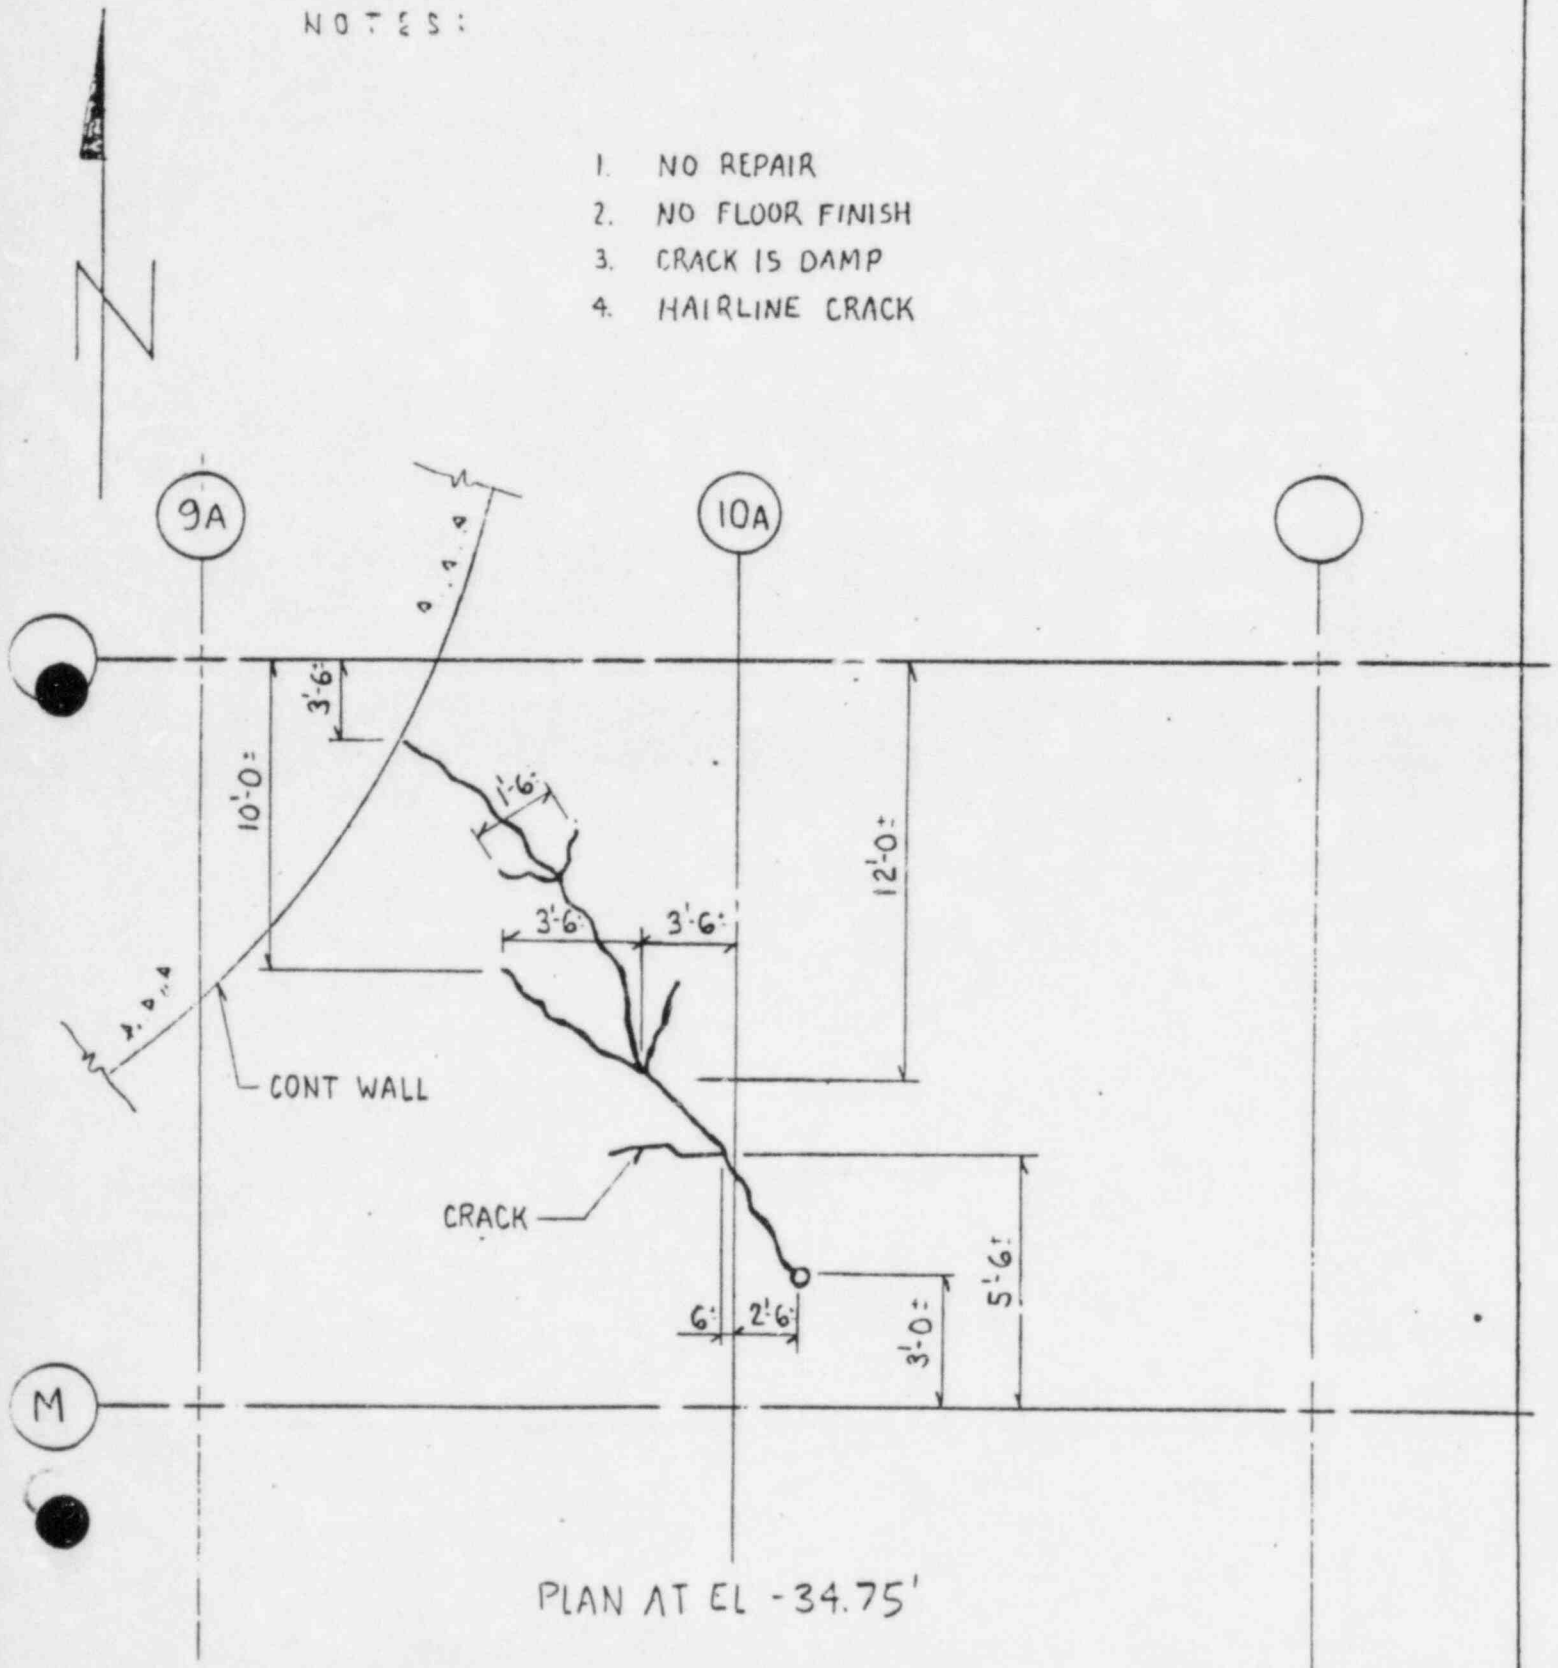
1. NO REPAIR
2. NO FLOOR FINISH
3. CRACK IS DAMP
4. HAIRLINE CRACK

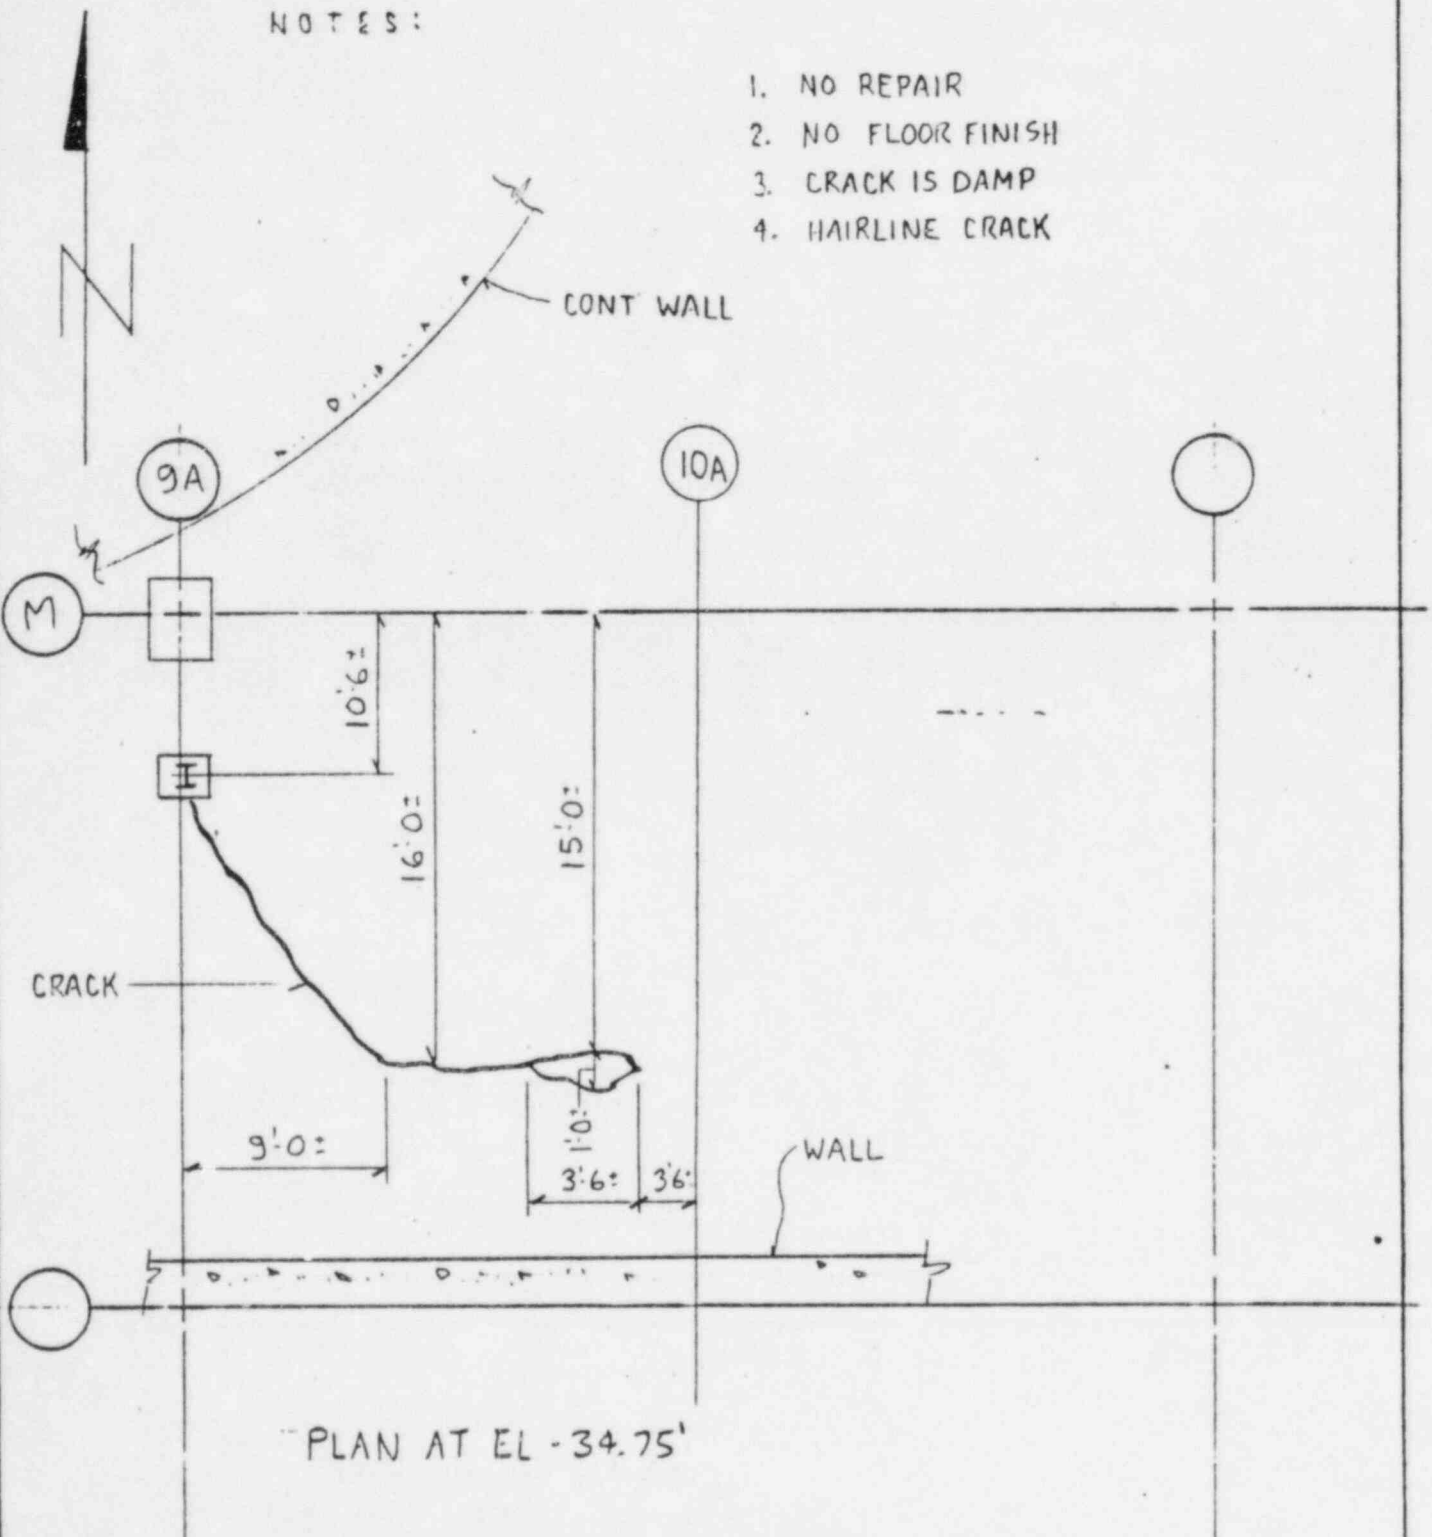
1. NO REPAIR
2. NO FLOOR FINISH
3. CRACK IS DAMP
4. HAIRLINE CRACK

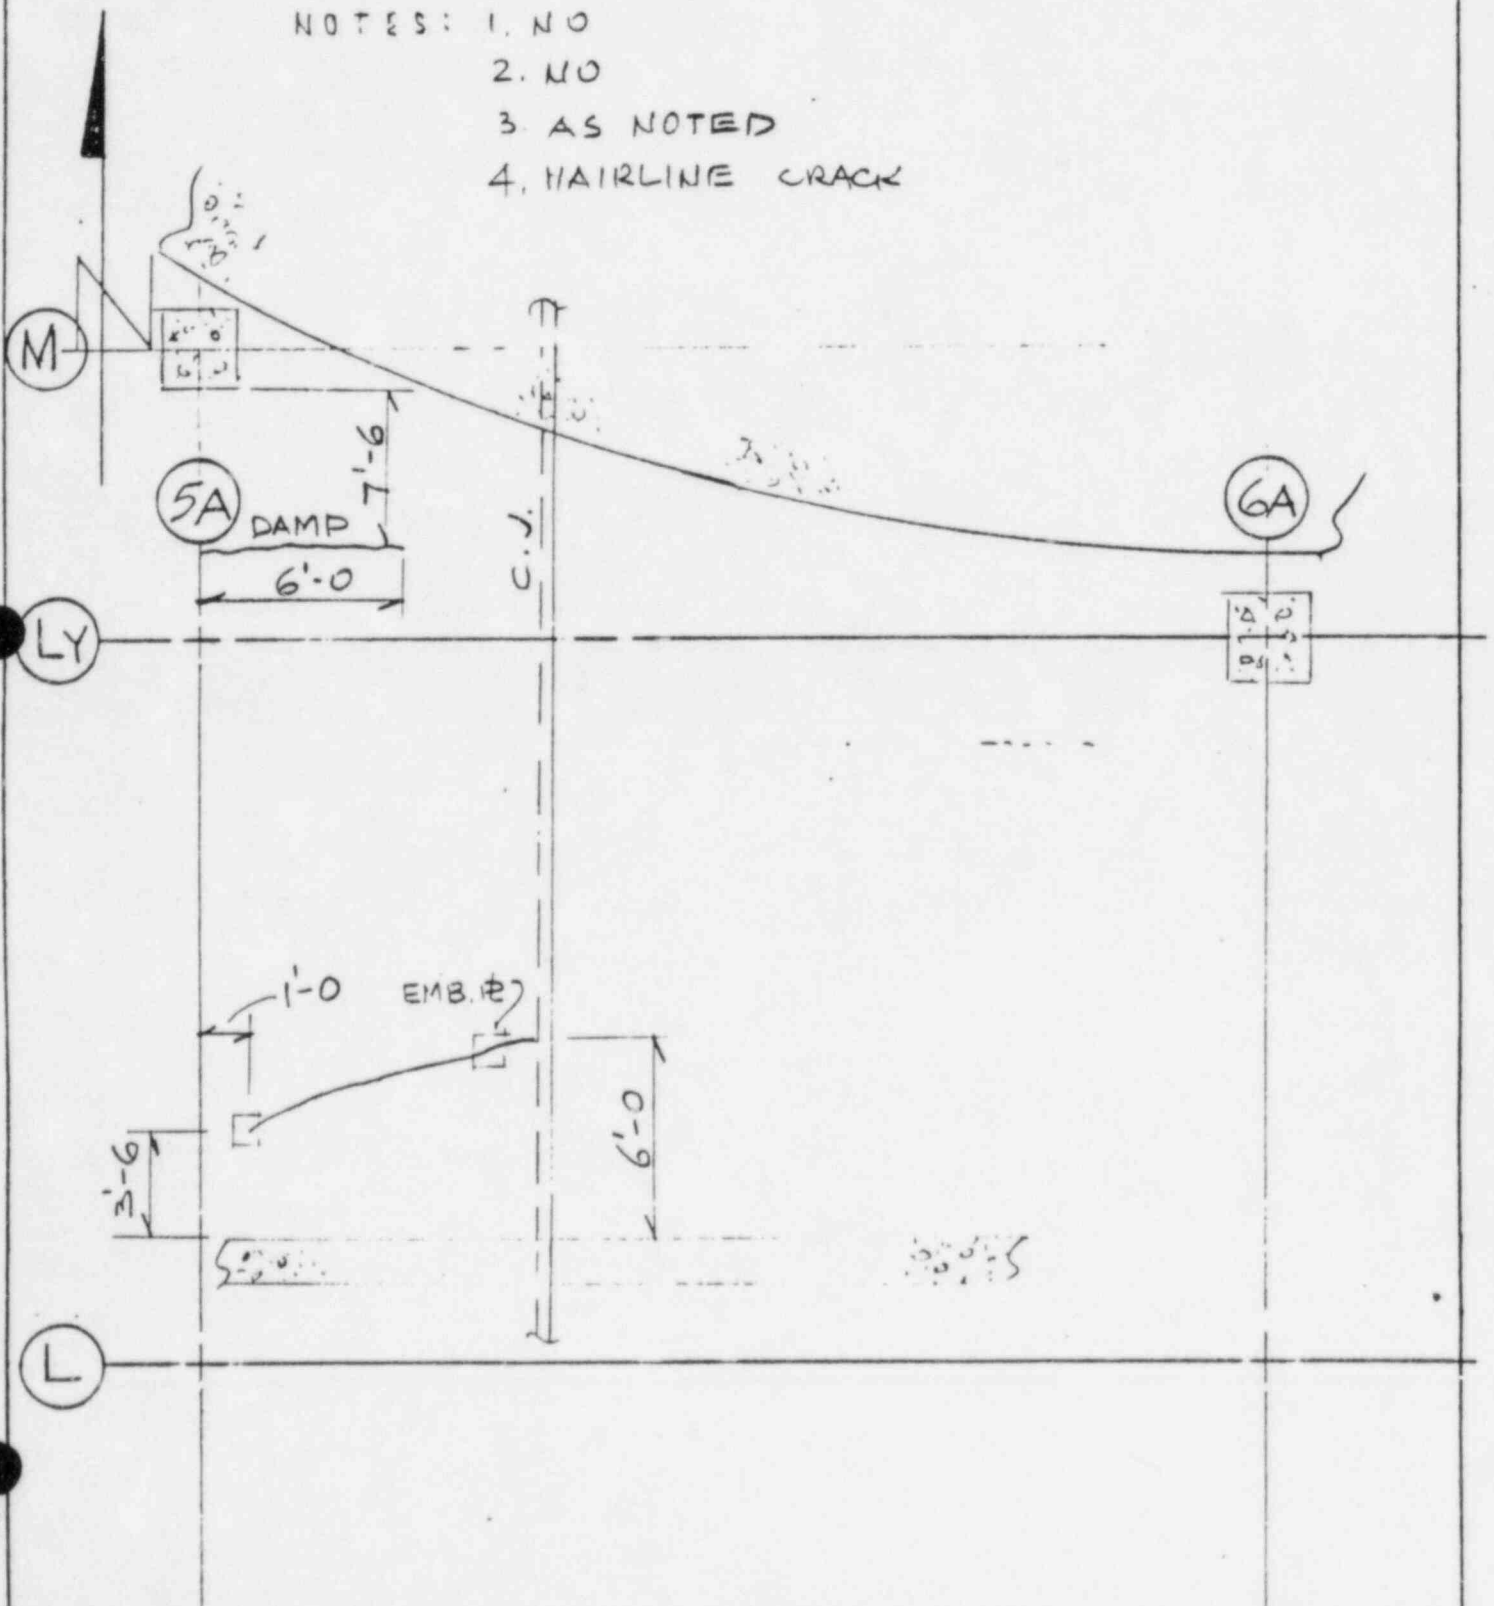
3. AS NOTED

4. HAIRLINE CRACK

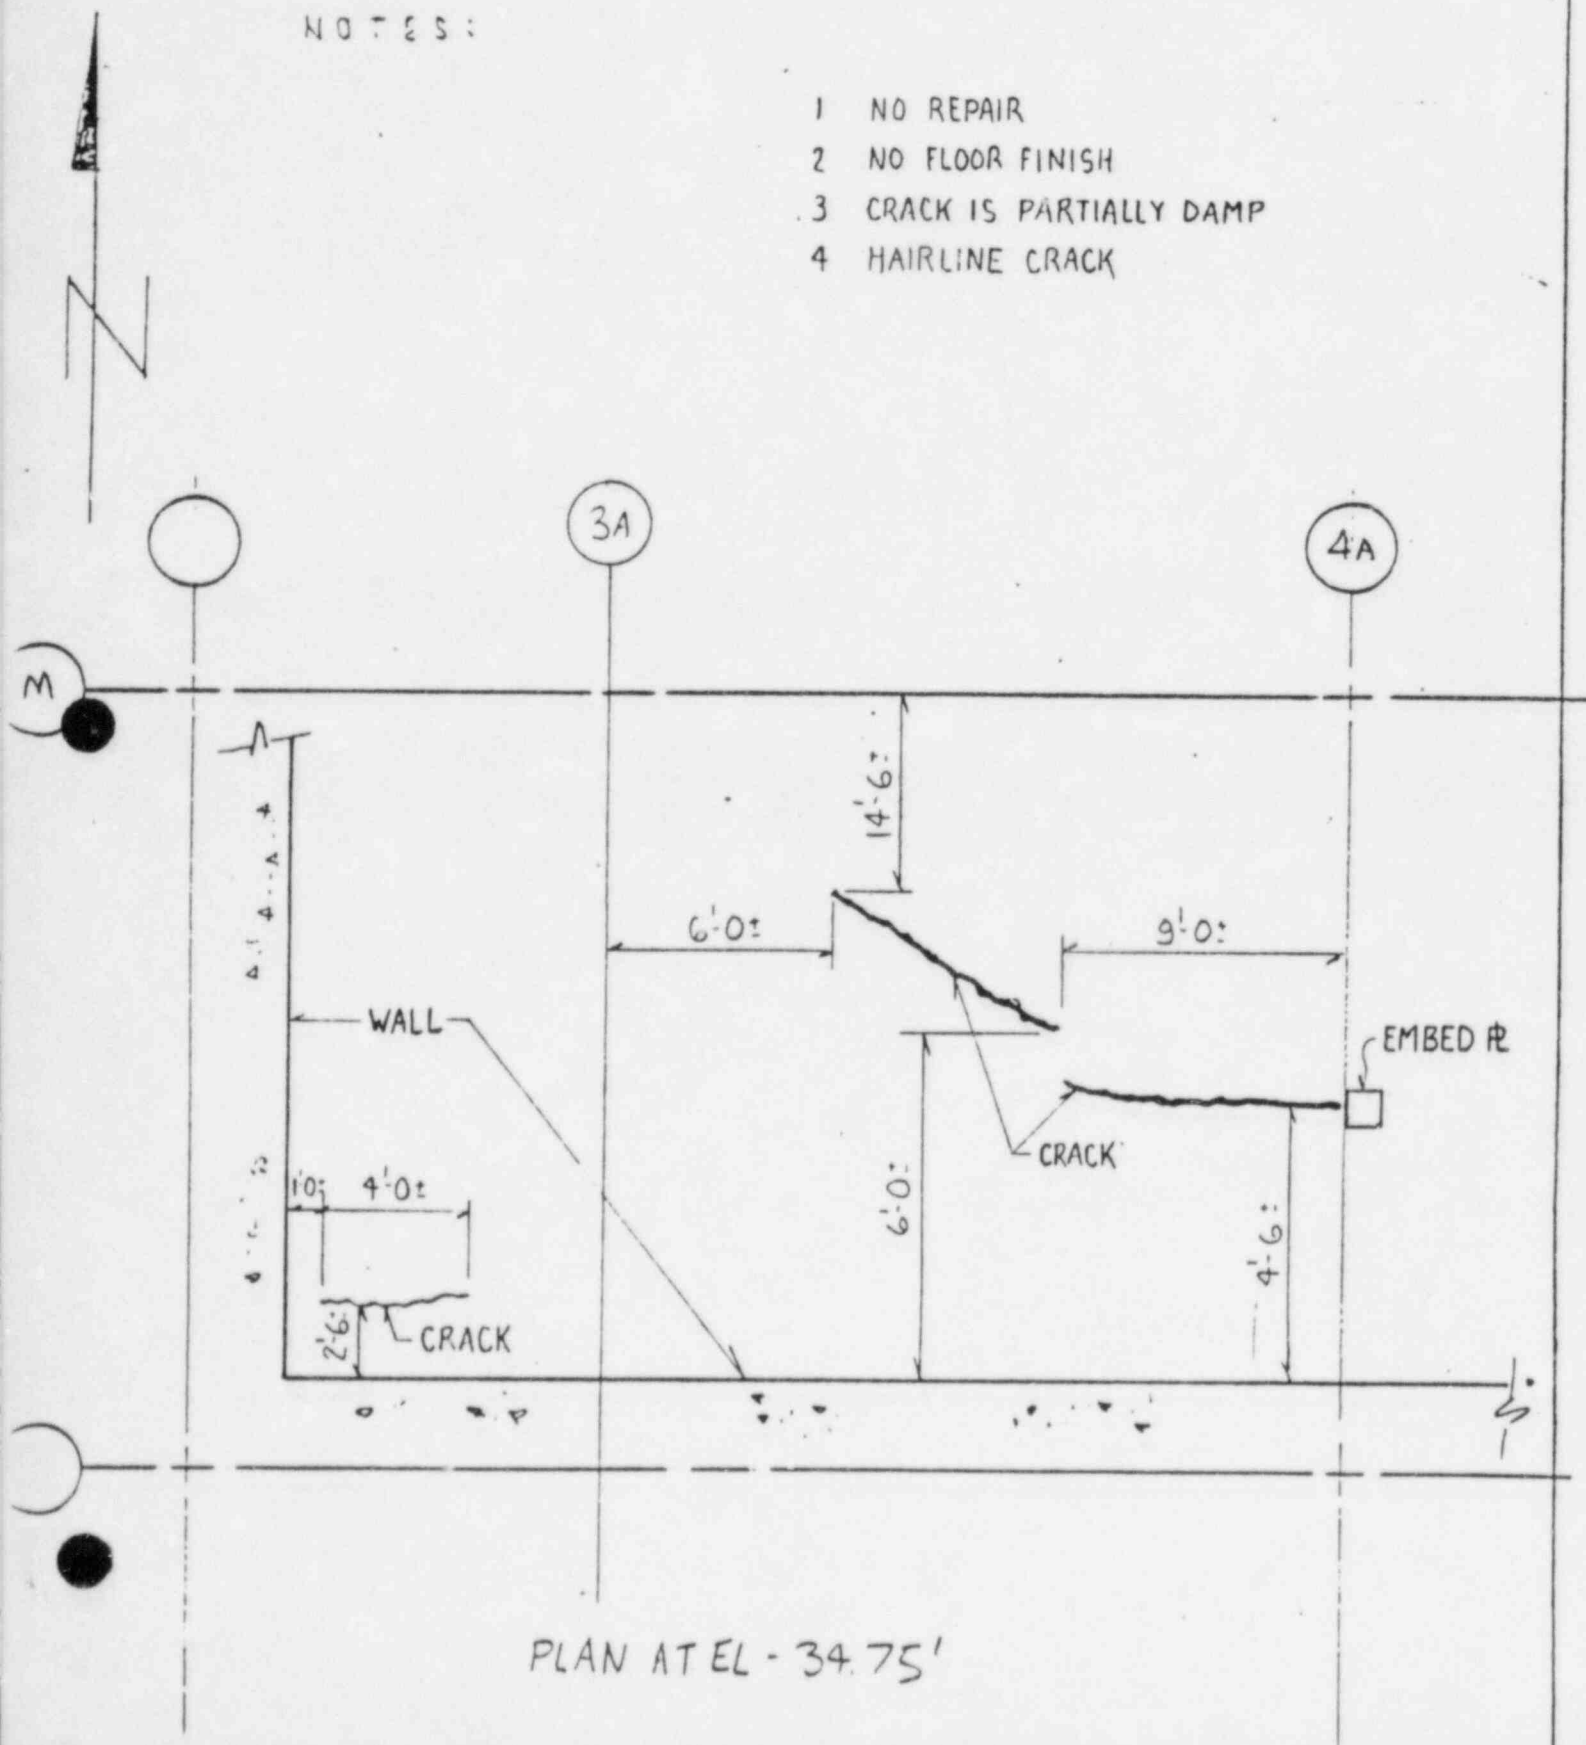
- 1 NO REPAIR
- 2 NO FLOOR FINISH
- 3 CRACK IS PARTIALLY DAMP
- 4 HAIRLINE CRACK

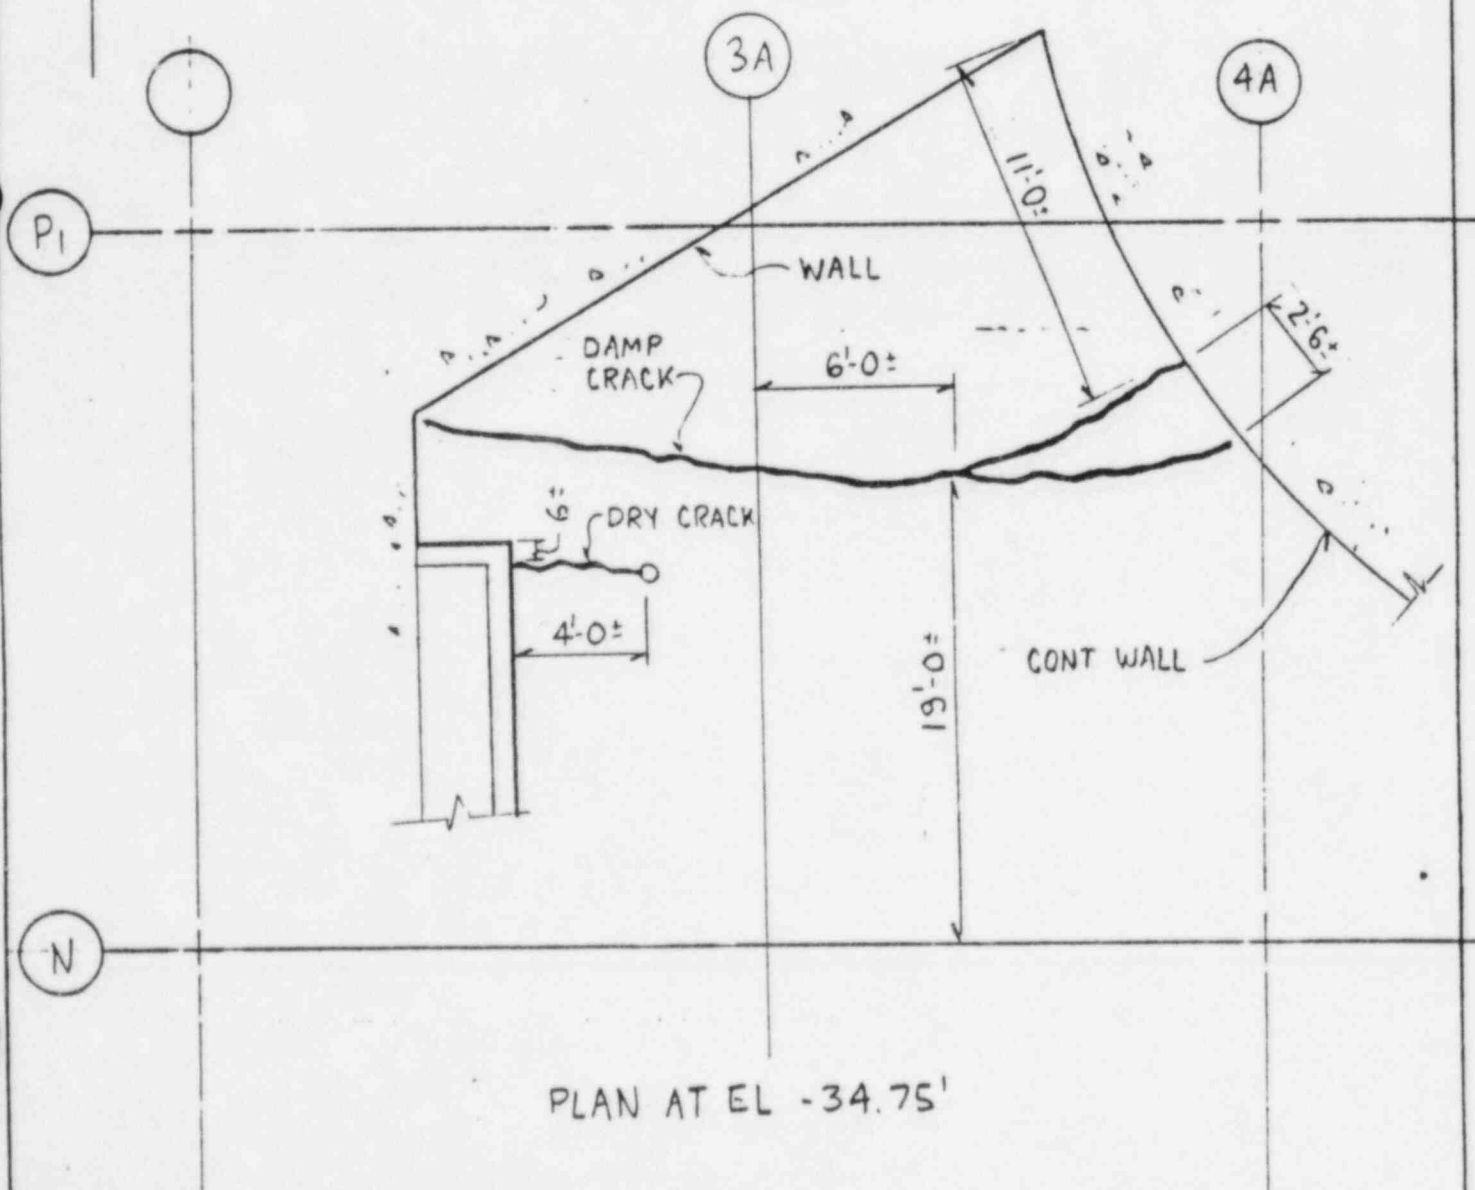
- 1 NO REPAIR
2 NO FLOOR FINISH
3 DAMP AS INDICATED
4 HAIRLINE CRACK

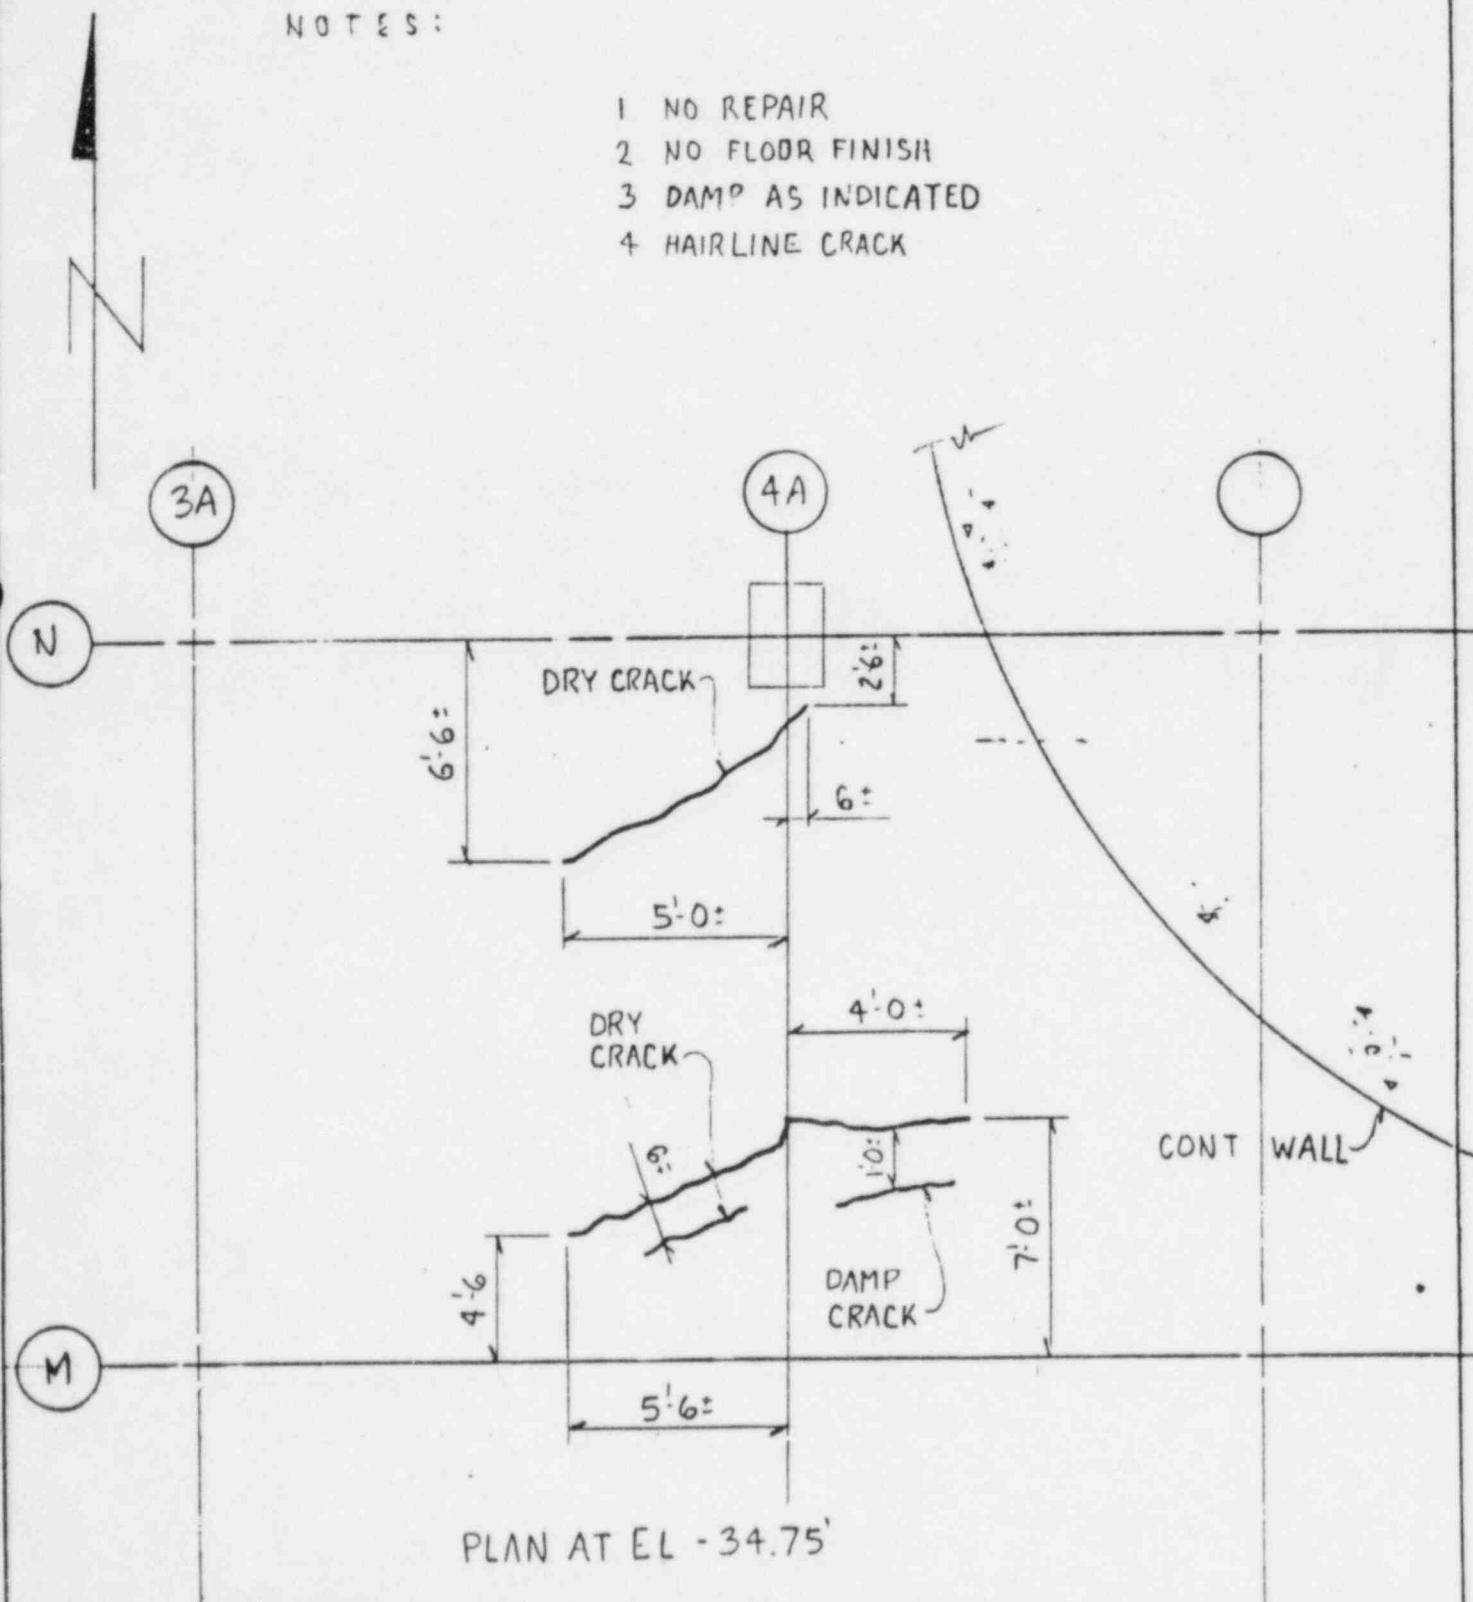
- 1 NO REPAIR
- 2 NO FLOOR FINISH
- 3 DAMP AS INDICATED
- 4 HAIRLINE CRACK
