Northern States Power Company

MONTICELLO NUCLEAR GENERATING PLANT
Docket No. 50-263 License No. DPR-22

Revision 1 to LER 94-008,
Structural Beam Connections Associated With the Cable
Spreading Room Floor Found to be Different Than Design

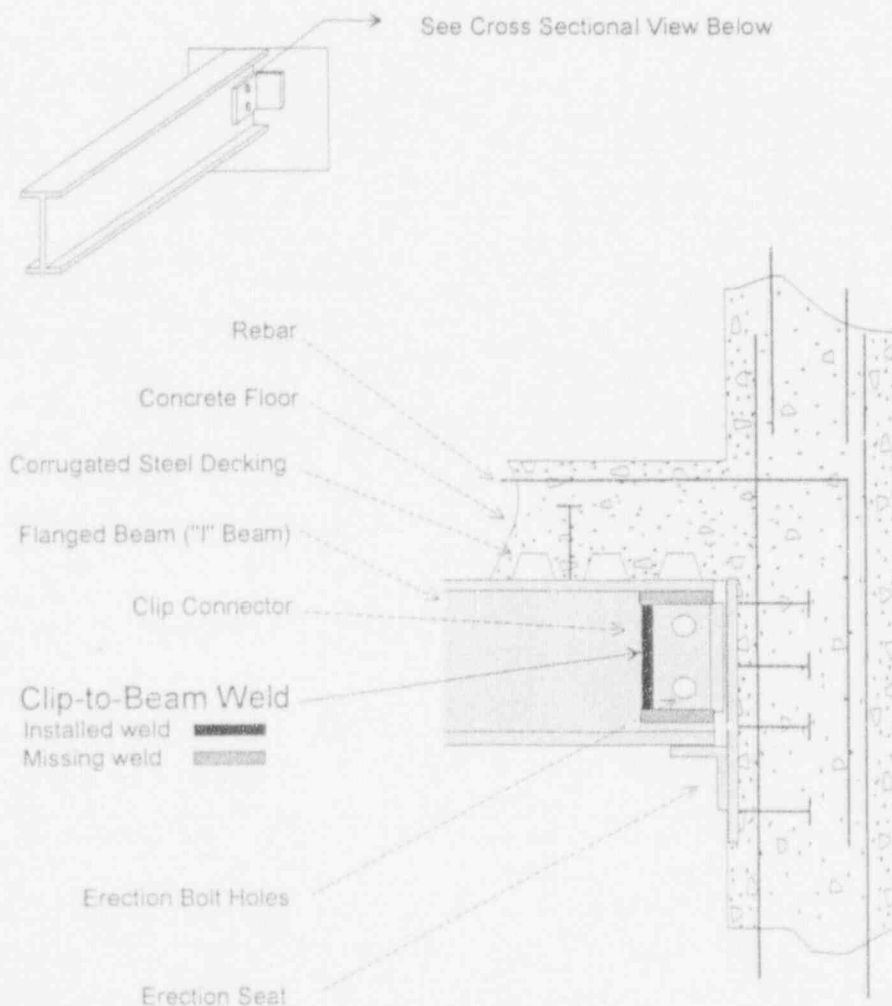
TYPICAL CABLE SPREADING ROOM FLOOR FIELD WELDED BEAM CONNECTIONS

This type of connection is shown in Figure 1. The original design specified a full weld between the clip and the beam, e.g., a vertical weld and a top and bottom weld. The engineer identified several beams in the Cable Spreading Room floor that did not have the top and bottom horizontal weld (only the vertical weld). Discussions with an individual on the original construction team indicated that documentation approving this variance may exist. A review of the original plant Field Change Requests and Design Change Requests did not locate any documentation of this variance.

During original construction (1968), the construction workers that welded the clips to the beams and girders did not install the clips in accordance with the specified design.

2. At the same time the additional analysis was being conducted, high strength bolts (A325) were purchased to be placed in the erection bolt holes (See

Figure). These bolts were added to five of the higher stressed connections to increase their load carrying capacity by developing friction type connections. It was later determined that the connections did not require the high strength bolts to be operable.
