In the Matter of)	ASLBP Nos. 78-389-03 OL
)	80-429-02 SP
CONSUMERS POWER COMPANY)	Docket Nos. 50-329 OL
)	50-330 OL
(Midland Plant, Units 1 and 2))	Docket Nos. 50-329 OM
)	50-330 OM

SECOND SUPPLEMENTAL MEMORANDUM IN SUPPORT OF INTERVENOR
BARBARA STAMIRIS' MOTION TO LITIGATE DOW ISSUES

FOUNDATION SETTLEMENTS

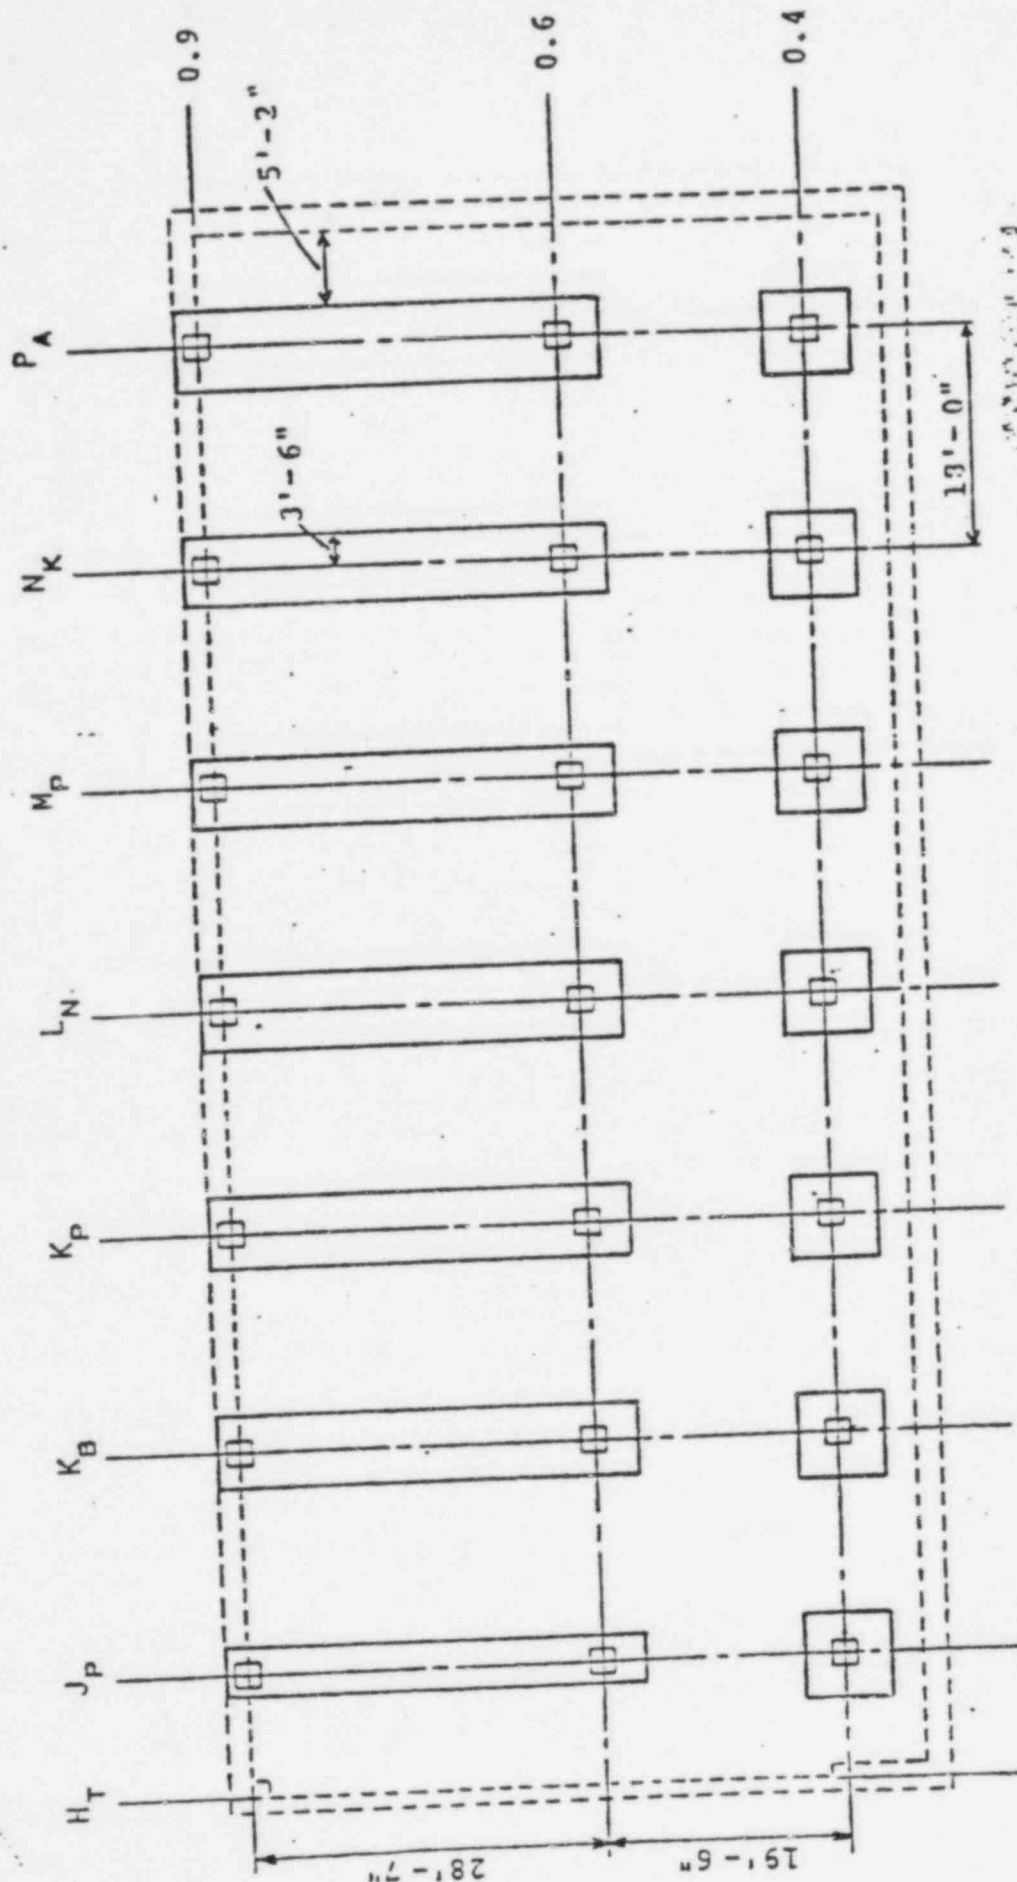
FOUNDATION LOCATION PLAN

Early in September, 1977, we were requested by project engineering to assist in reviewing conditions surrounding footing settlements during construction of the Midland Project Administration Building. The foundation location plan for this building is shown in Figure 1. The affected foundations are those along Column Line 0.4.

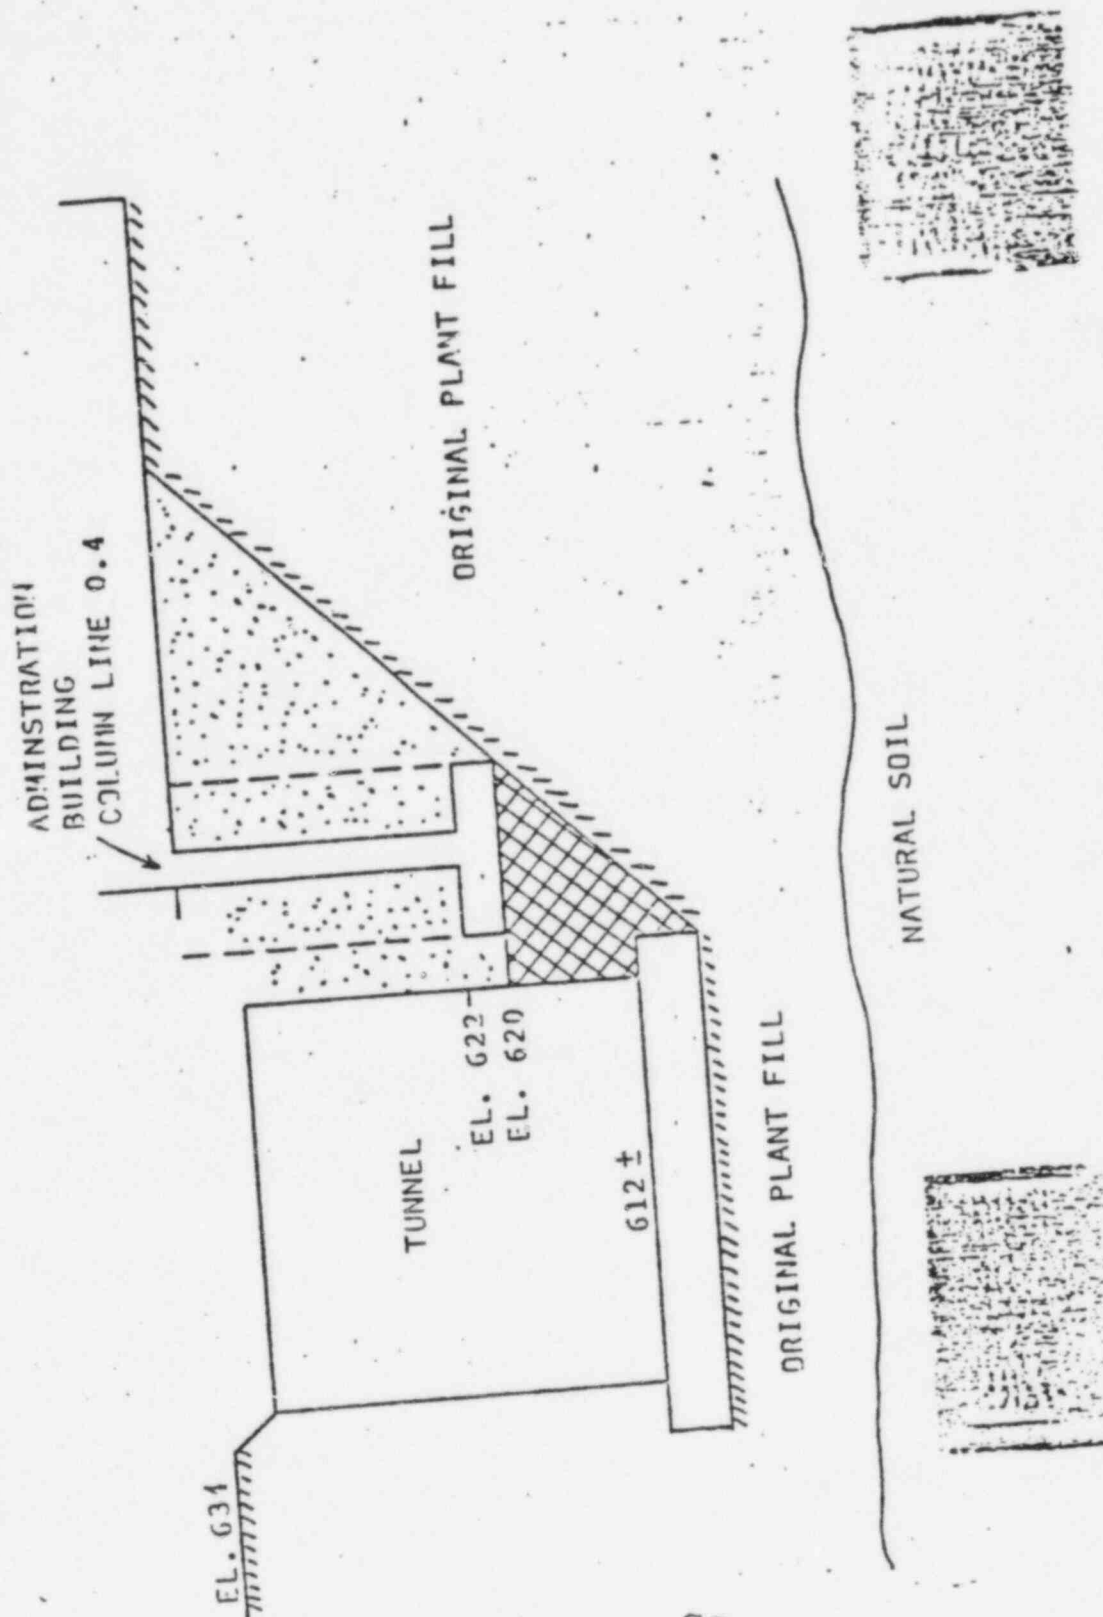
The original ground at the Midland site was at approximately Elevation 608 in the vicinity of the administration building. After ground surface preparation, plant area fill was placed to approximately Elevation 634. An excavation was later made to about Elevation 610 to accommodate construction of the steam tunnel. Figure 2 shows a cross-section of the tunnel and the approximate excavation scheme. After construction of the tunnel, the west side of the tunnel excavation was backfilled to approximate Elevation 620 to construct the foundations along Column Line 0.4 of the administration building. After foundation construction, the remainder of the excavation was backfilled with sand to grade as shown in Figure 2.

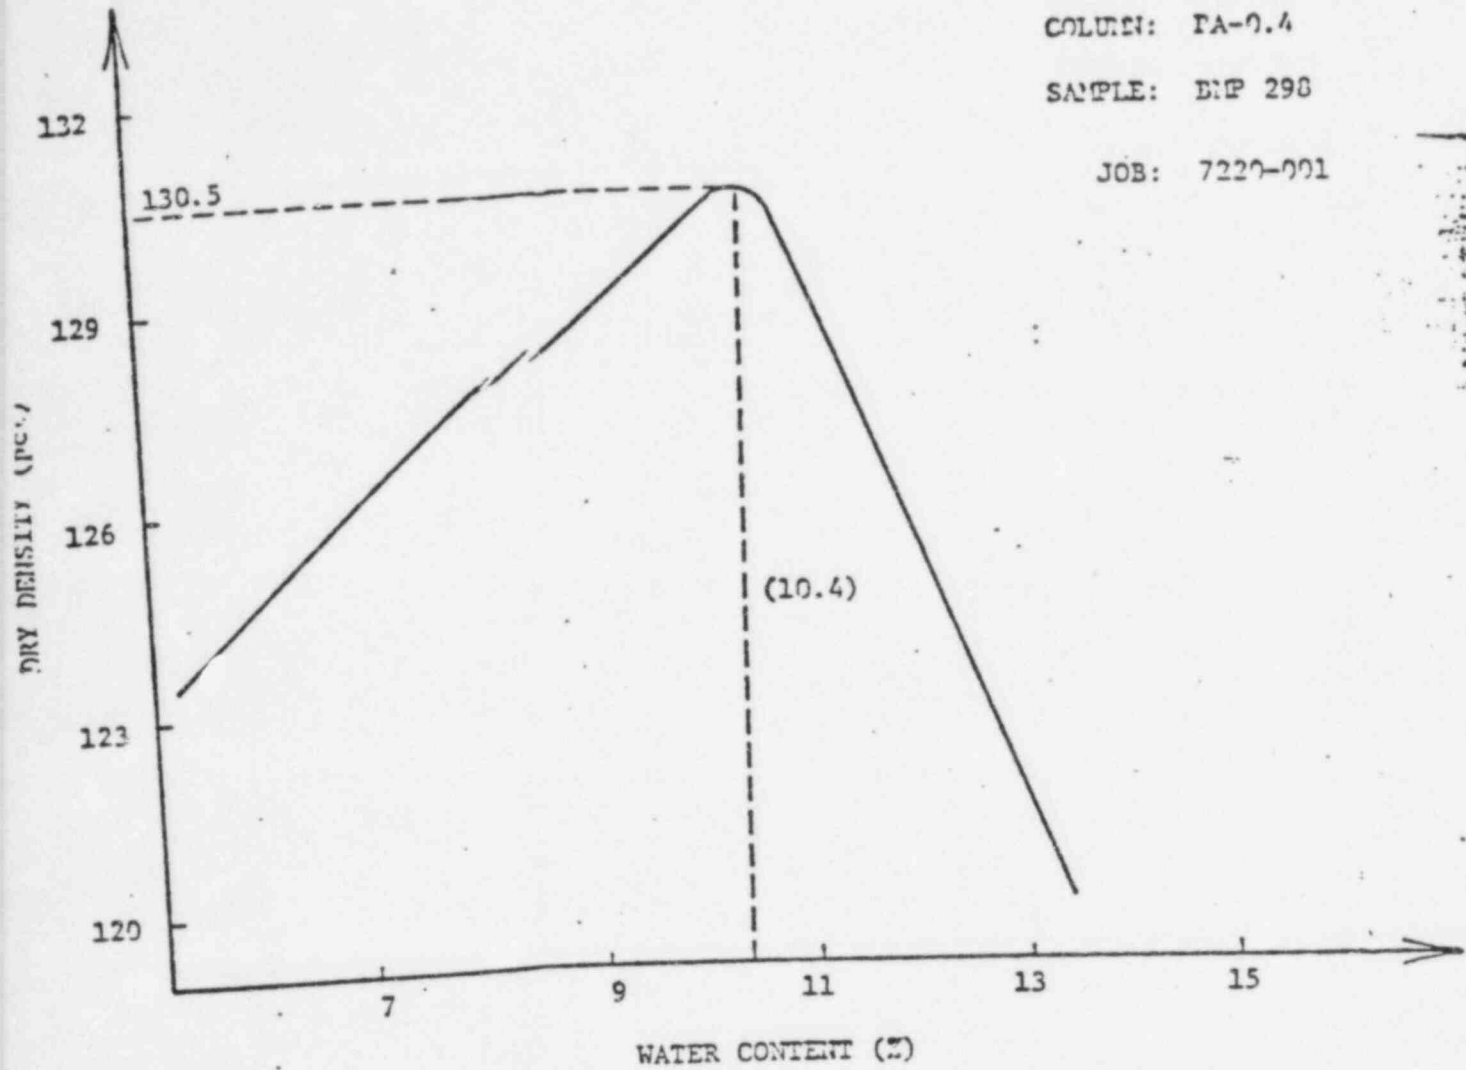
Figure 9

It was also decided to run Proctor tests on the samples taken directly under and adjacent to footings in order to determine the standard to be used in calculating the in situ percent compaction. These results are found in Figures 8, 9, and 10.

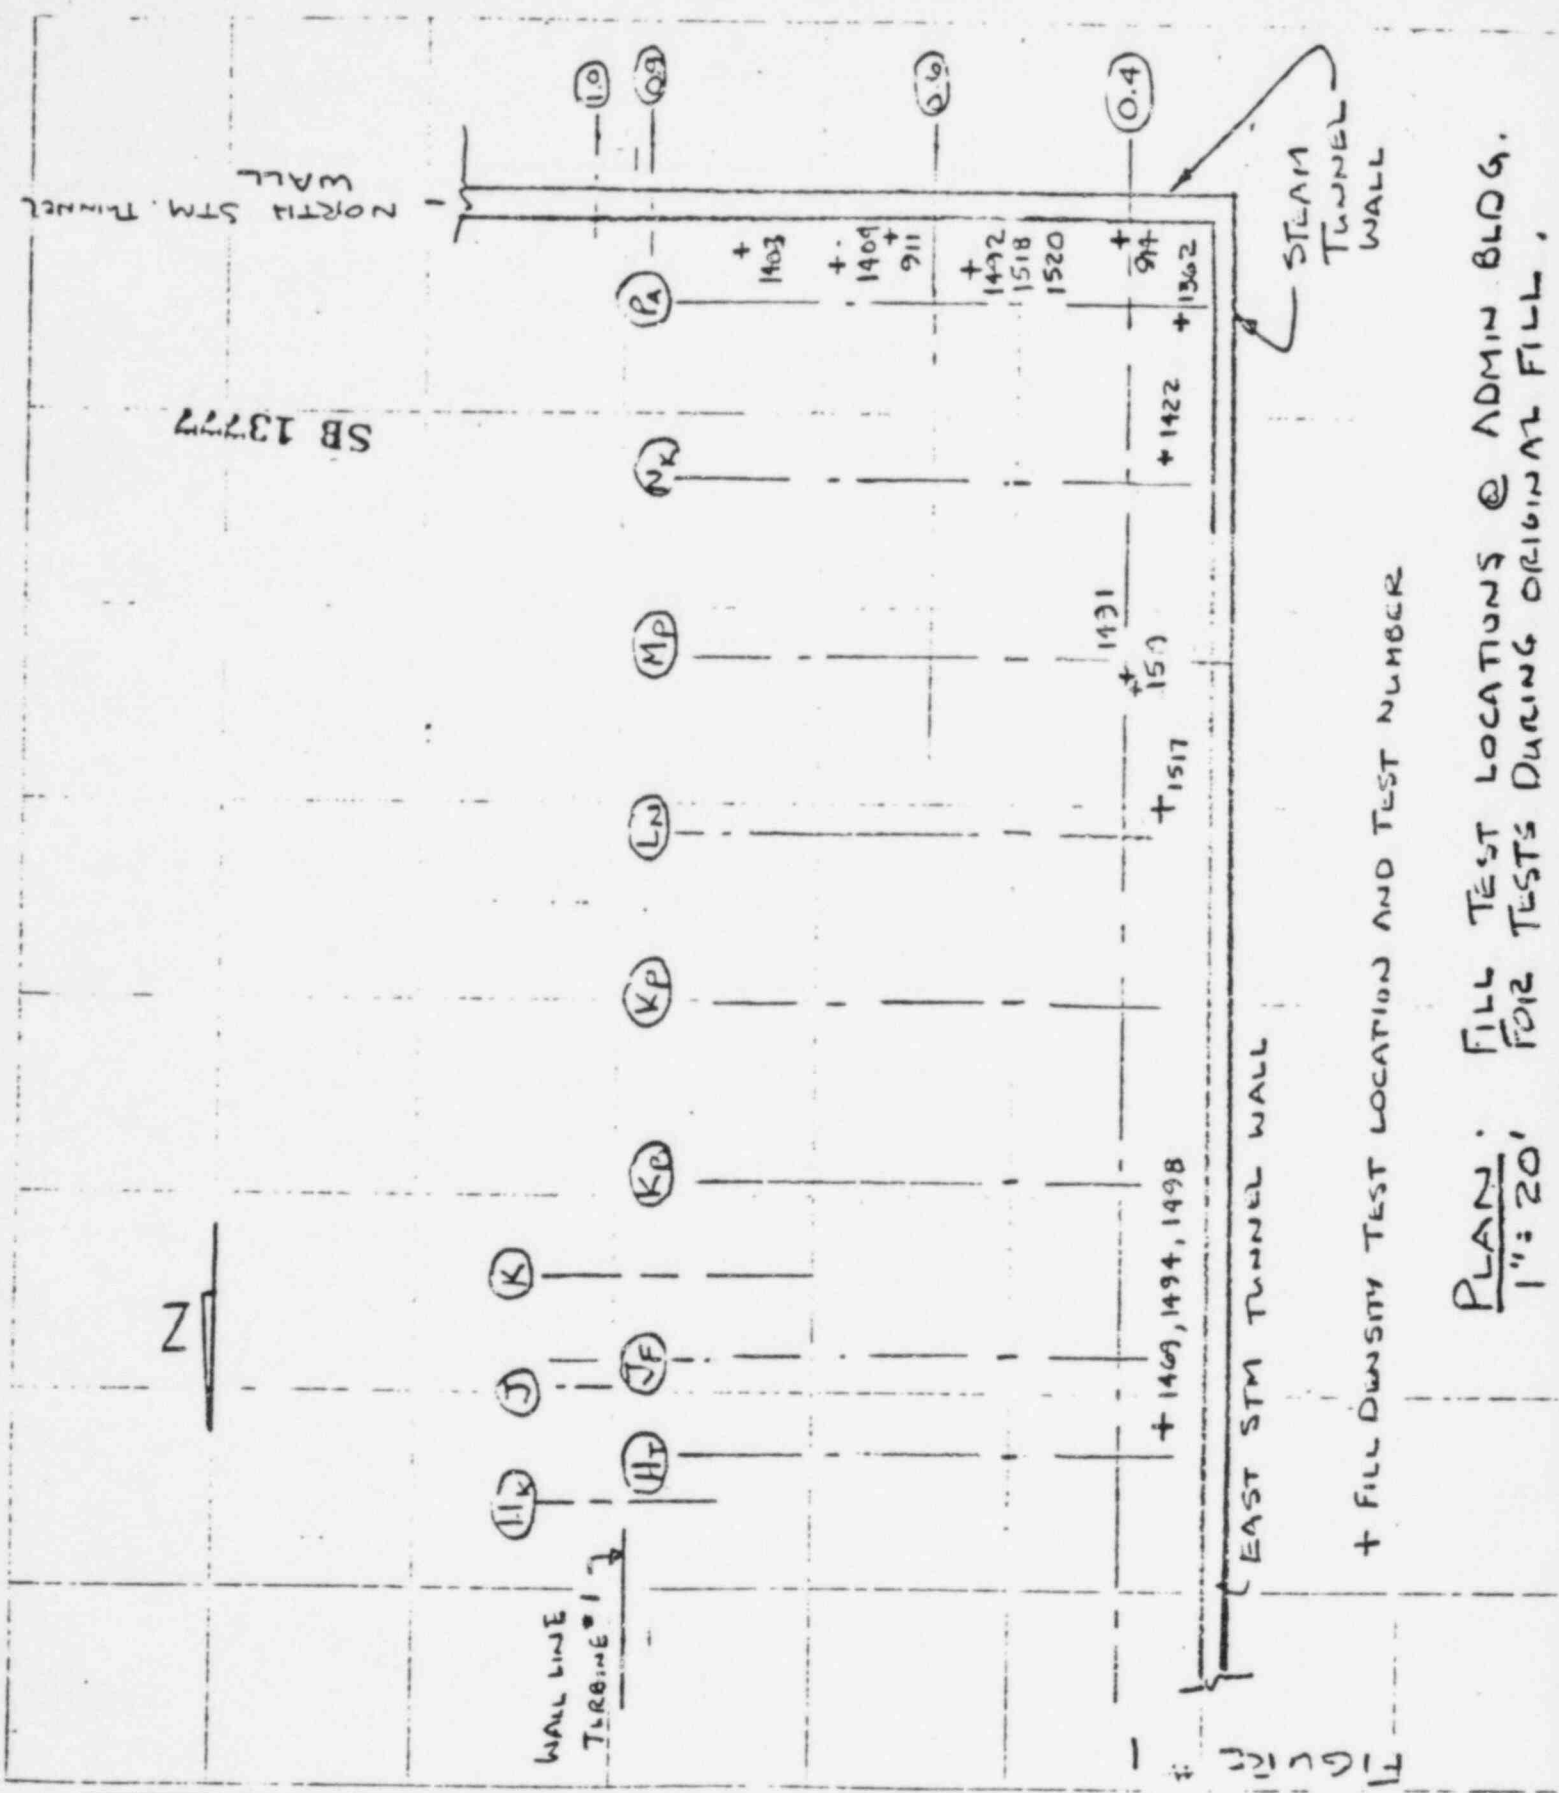
FIGURE # 2

PLAN: FILL TEST LOCATIONS @ ADMIN BLDG.
 1" = 20'
 FOR TESTS DURING ORIGINAL FILL.

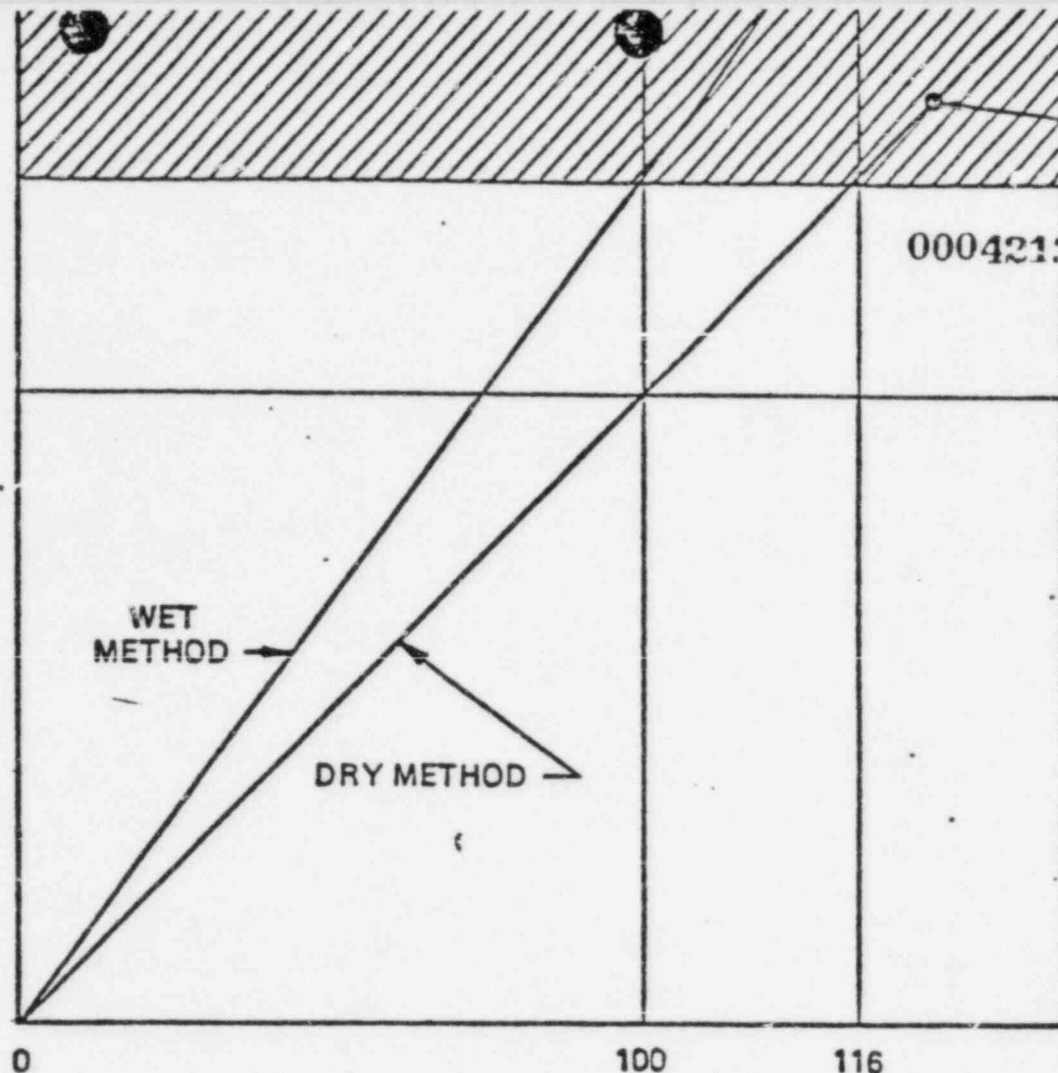
NOTE: VALUES FOR DRY DENSITY ARE TYPICAL OF A RANDOM FILL SAND. ANY TESTS SHOWING MORE THAN 117% RELATIVE DENSITY WOULD BE SUSPECT IN THIS EXAMPLE. STRUCTURAL SANDS TEND TO SHOW ONLY 2 OR 3 PCF INCREASE IN MAXIMUM DENSITY AND THUS RESULTS AT MUCH LOWER RELATIVE DENSITY WOULD BE SUSPECT, SAY 105 - 110 PERCENT
