Washington Public Power Supply System

Subject: NUCLEAR PROJECT 2
NRC INSPECTION REPORT 50-397/83-38 NOTICE OF VIOLATION

RESPONSE TO INSPECTION REPORT 83-38
NOTICE OF VIOLATION

BURNS AND ROE, INC.
PROCEDURE FOR EVALUATION OF CONCRETE
FOR
WASHINGTON PUBLIC POWER SUPPLY SYSTEM
UNIT 2
AUGUST 24, 1983

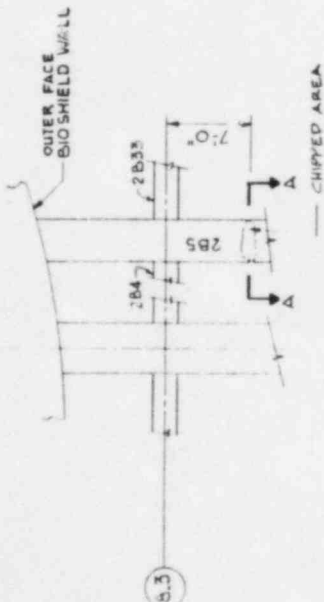
1) Excavation demonstrated that concrete is fully consolidated and is tightly bonded to rebars. The rebar spacing deviation has not ad- versely affected placement of concrete and is acceptable.				1) Beam 2B3 has been reanalyzed and checked and found to be structurally adequate. Reanalysis indicates a large design margin.

2) Dimensions and bar sizes shown on as-built sketch SK-1 have been verified.	
				3) Honeycomb, which was originally identified in Nonconformance Report 1851, was repaired prior to the NRC CAT inspection.
