## SUPPLEMENTARY INFORMATION

REPORT NO.: 50-302/83-023/01X-2

FACILITY: Crystal River Unit 3

REPORT DATE: October 3, 1983

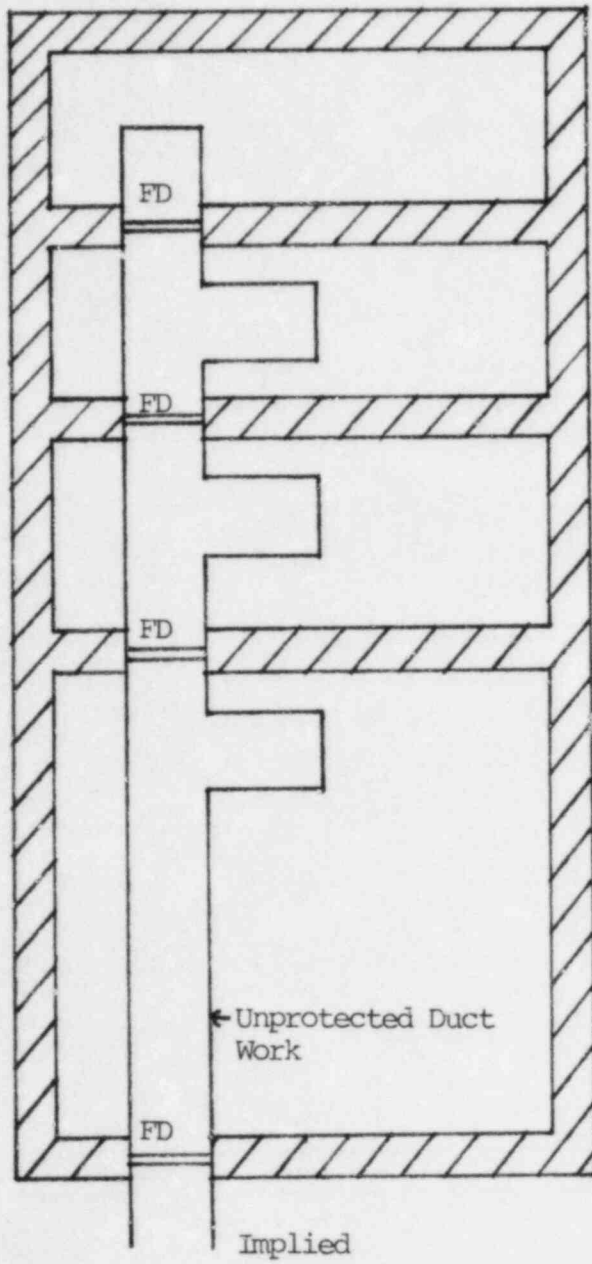
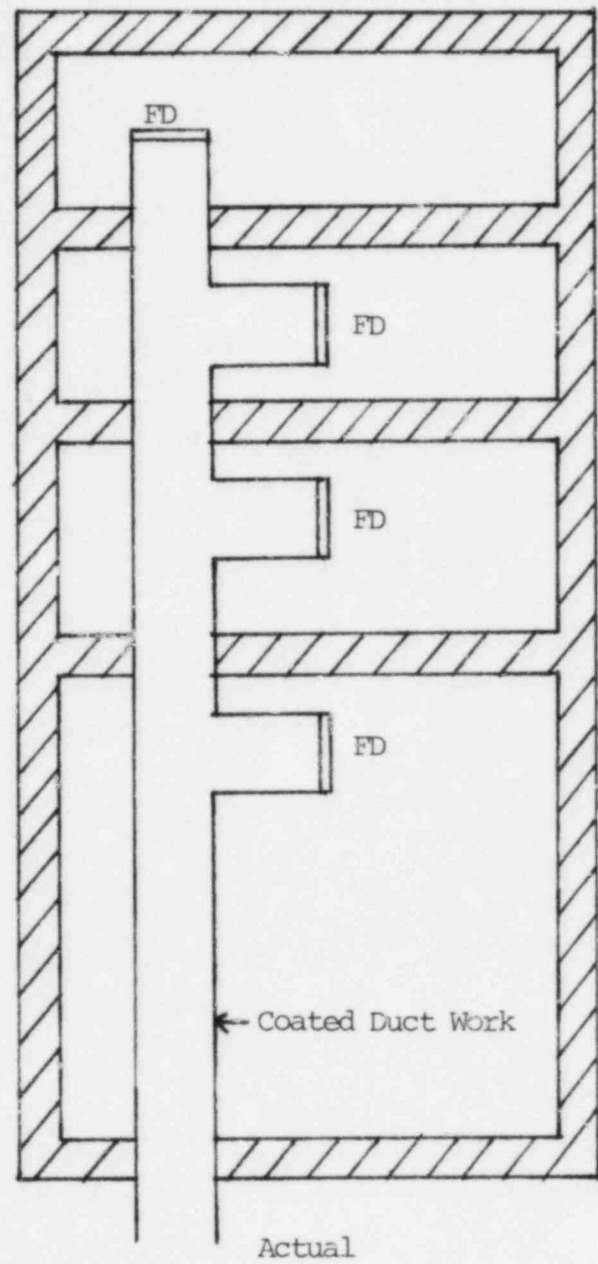
Figure 1 Fire Damper Location Schemes

Further investigation also revealed that 21 of the 55 fire dampers were installed in the duct work (see Figure 1, attached). The 1977 FPPR implied that the fire dampers were located in the fire barriers.

redesigning the entire HVAC system. Therefore, in 1971, GAI suggested enclosing the duct work with a fire resistant covering in an attempt to meet the fire codes. By enclosing the duct work with a fire resistant covering the duct could be considered an extension of the fire barrier; thus, the fire dampers installed in the duct work would in effect be installed in the fire barrier. GAI fire protection engineers and architects selected plaster walls for vertical duct risers and Albi Clad 89S intumescent mastic fireproofing for horizontal duct work as the materials in which the Control Complex duct work would be enclosed. This resulted in the following HVAC fire protection features:

1. The specification of 1-1/2 hour rated fire dampers.
2. The placement of some fire dampers in or at the fire barrier.
3. The placement of some fire dampers in the duct work (not in or at fire barrier) with a fire resistant covering.

Of the 21 remaining fire dampers that are 1-1/2 hour rated and are not located in or at a fire barrier:

- a. All twenty-one (21) fire dampers will be deleted from the Fire Protection Program but wired open and allowed to remain in place.
- b. Newly located, 3 hour rated fire dampers will be installed in the fire barriers to protect the areas initially protected by the 21 above. An engineering evaluation is being conducted to determine the location of the new 3 hour fire dampers. This evaluation is expected to be completed by October 31, 1983.
